# SLIDING FAILURES AT FIVE LOCK AND DAM PROJECTS

## Dam and Cofferdam Failures within the Ohio River Basin

AEG 62<sup>nd</sup> Annual Meeting  
September, 2019

Mike Nield, Senior Engineering Geologist  
U.S. Army Corps of Engineers, Huntington WV  
LRD Dam Safety Production Center  
Dam Safety Modification Mandatory Center of Expertise

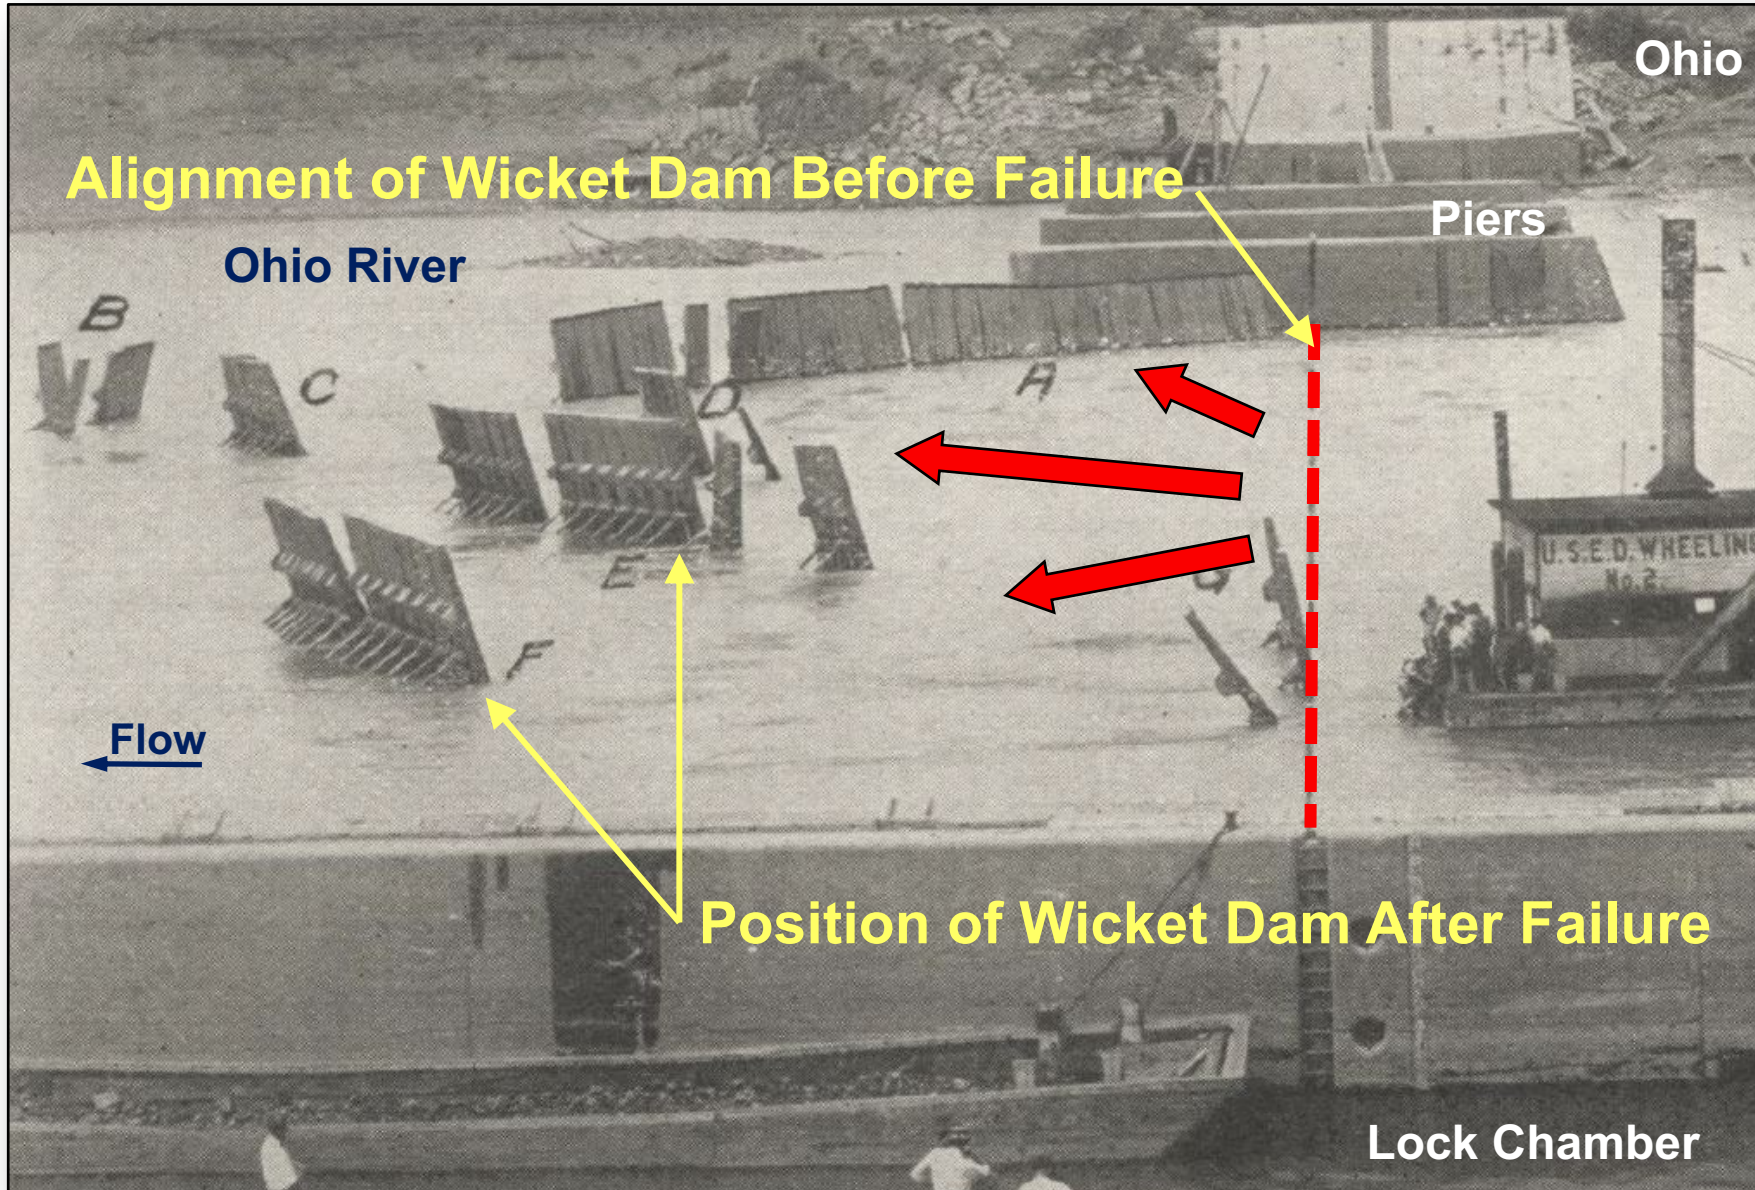
- Second time wickets were raised
- 10.7' head of water
- Failed on Aug 8, 1912 at 6:30 am
- Initiated in middle of 600' long dam
- Slid up to 157 feet downstream

Photo taken from West Virginia Side – After Failure

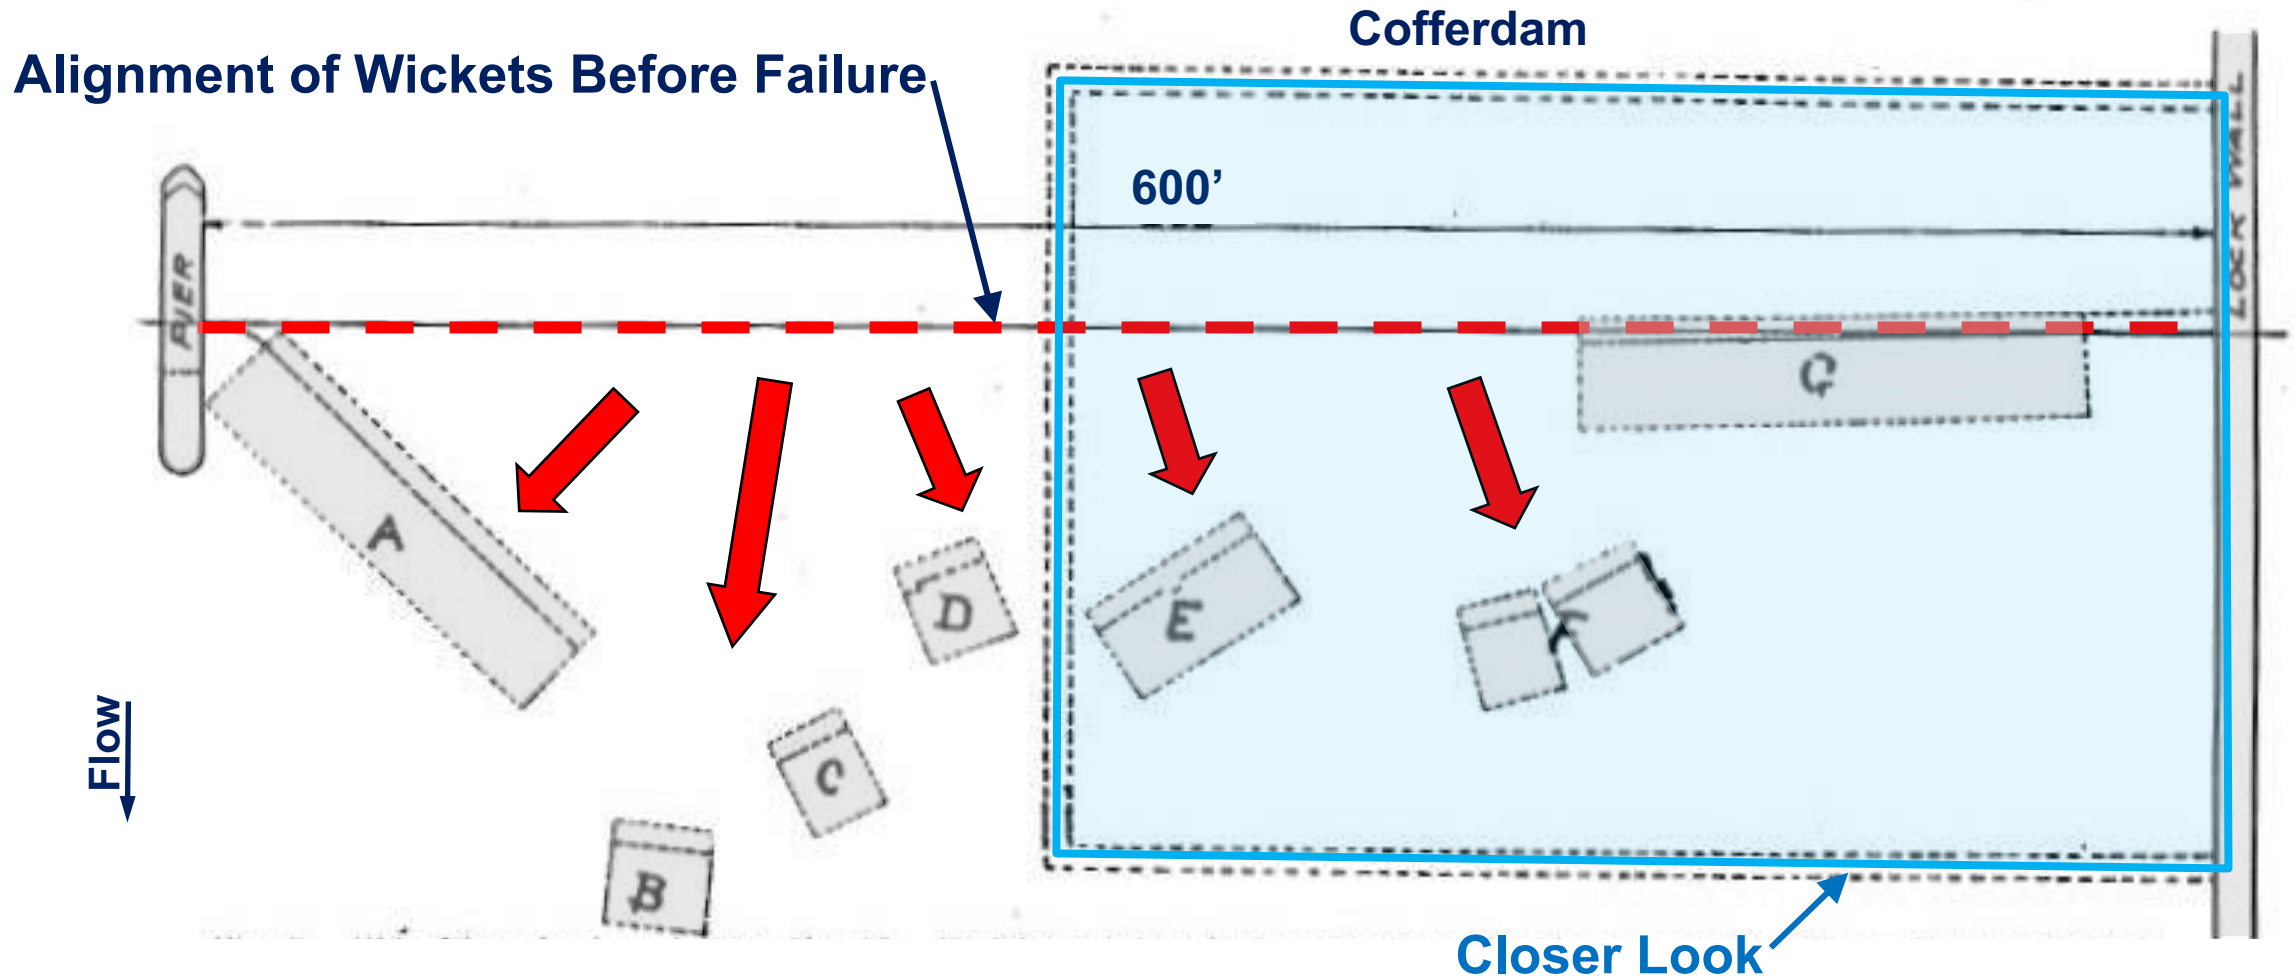
Plan View – Position of Navigable Pass Foundations After Failure

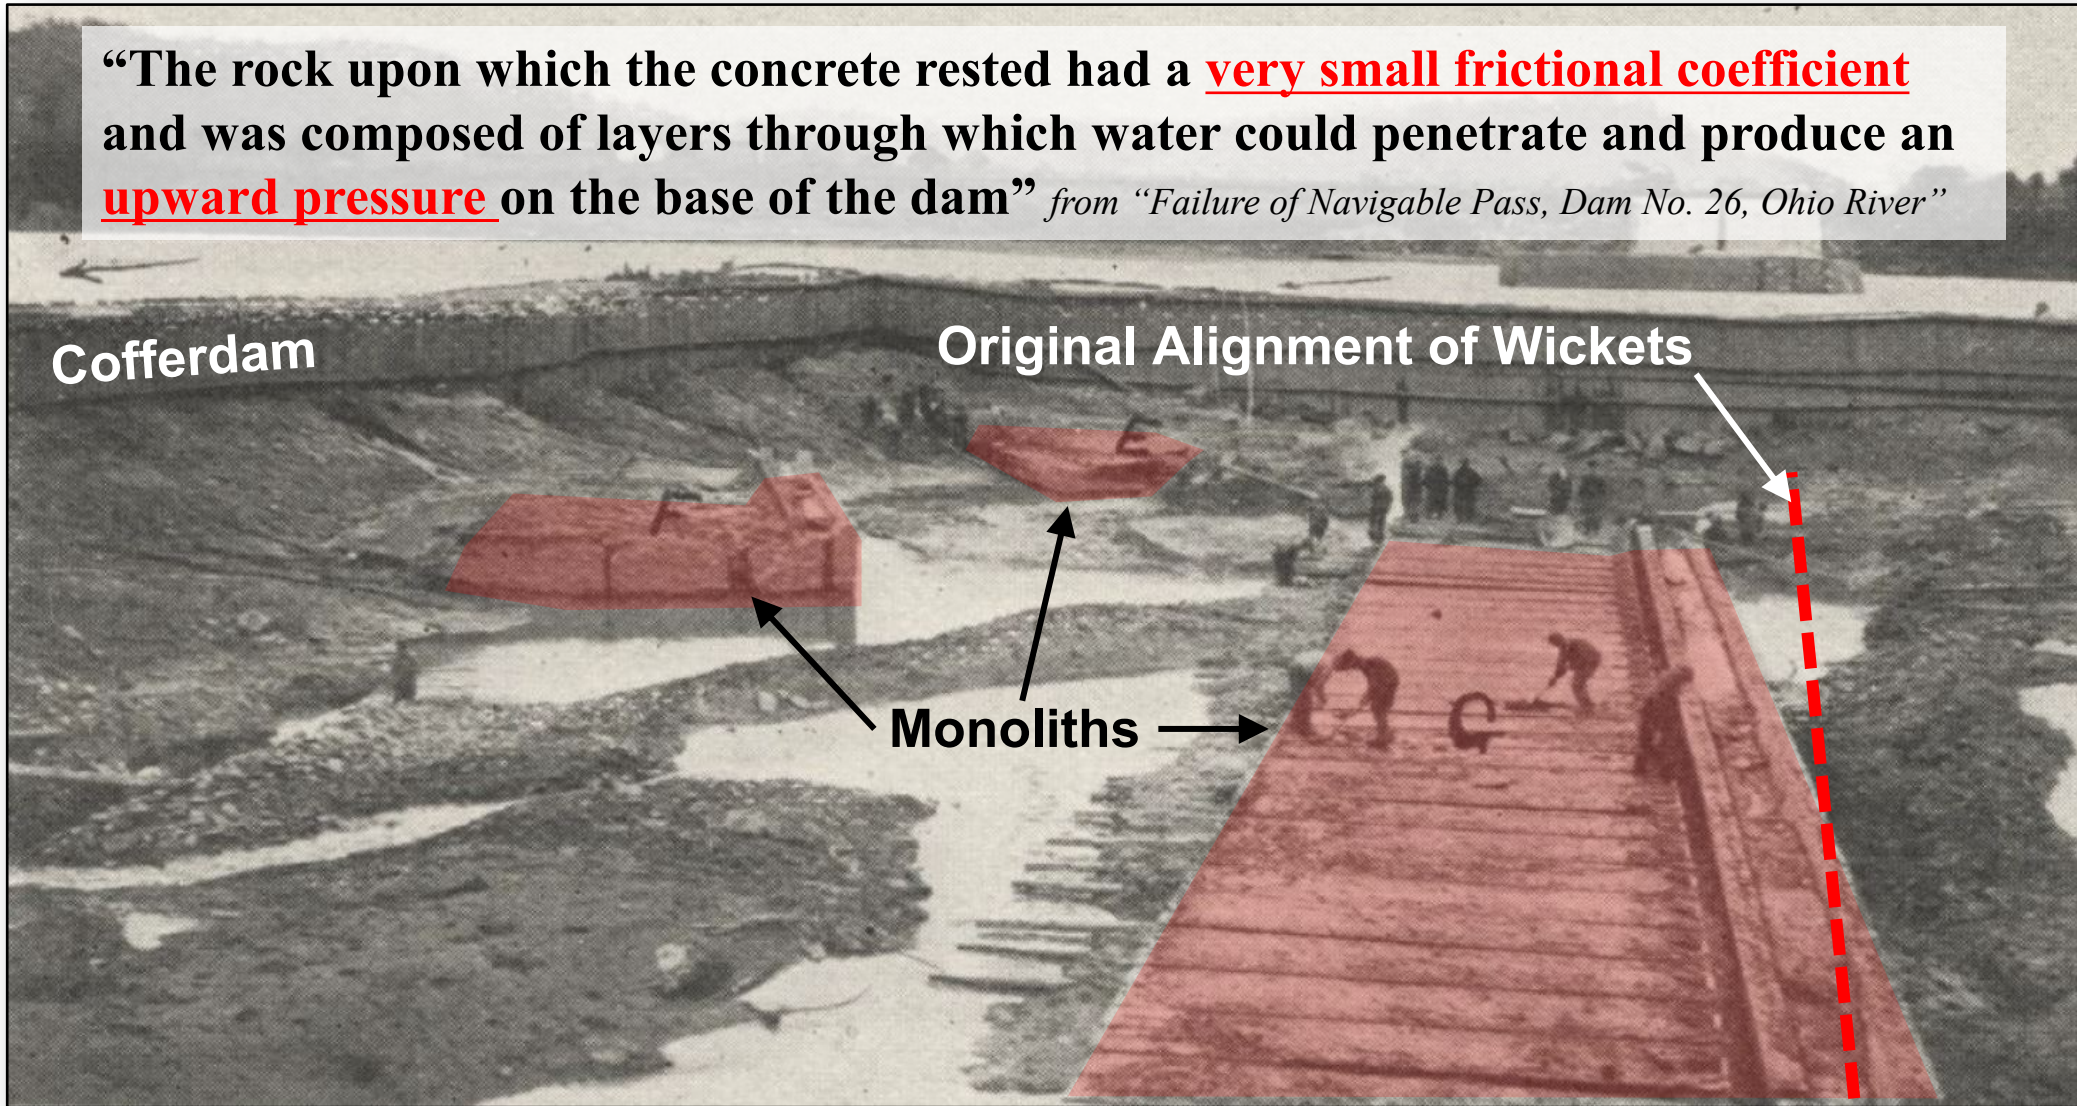
“The rock upon which the concrete rested had a very small frictional coefficient and was composed of layers through which water could penetrate and produce an upward pressure on the base of the dam” from “*Failure of Navigable Pass, Dam No. 26, Ohio River*”

Photo Taken Within Cofferdam Showing Location of Failed Monoliths

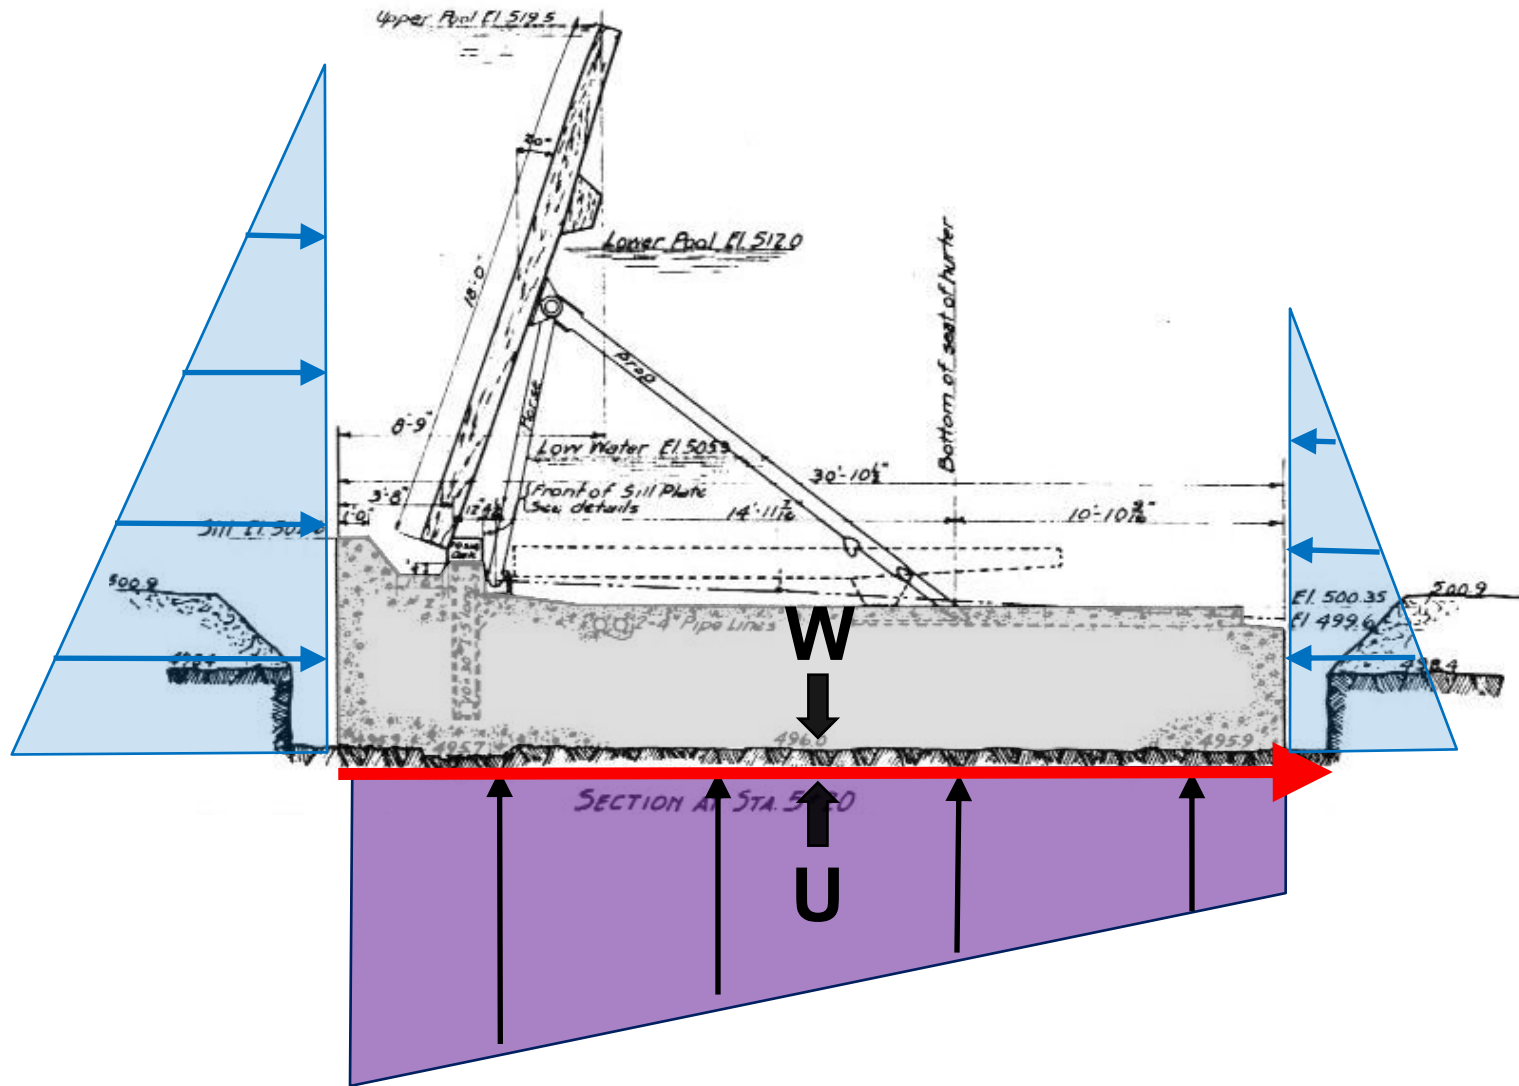
- Sliding plane was slightly below base.
- Original design: full uplift acting on 50% of foundation (typical for that era).
- Today, without drains, full uplift would be applied to 100% of foundation.

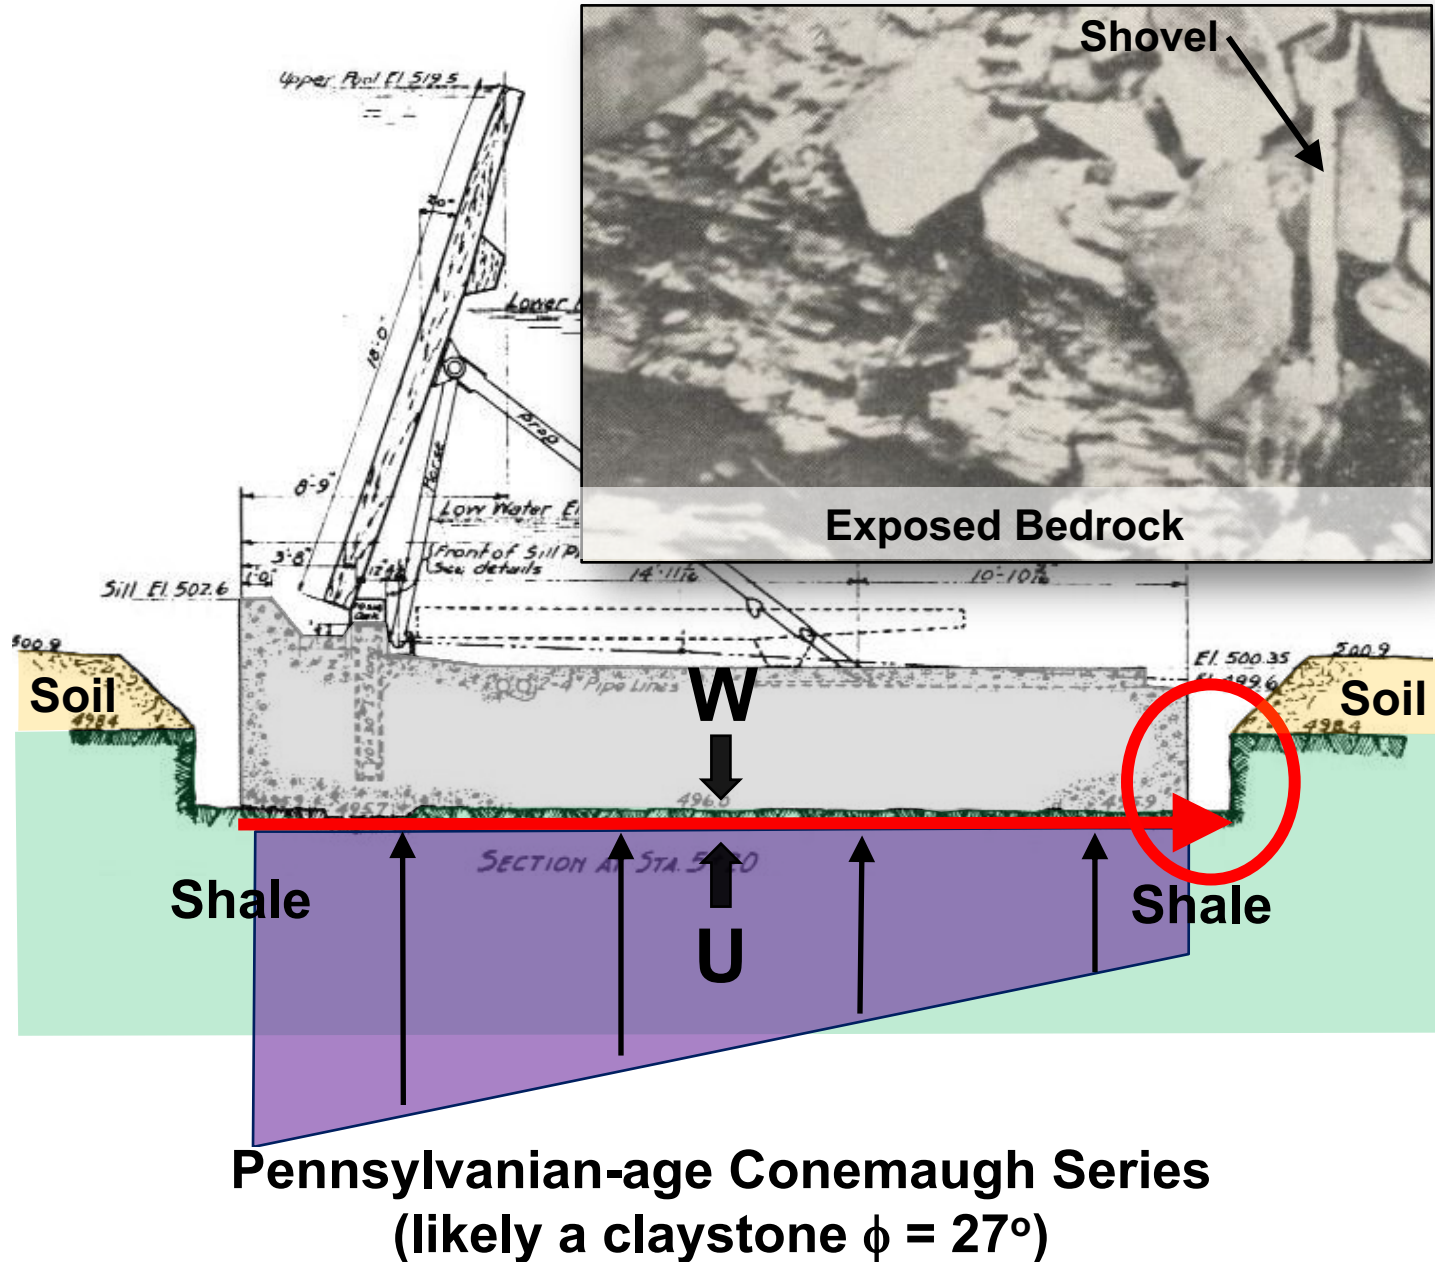
- Sliding plane was slightly below base.
- Original design: full uplift acting on 50% of foundation (typical for that era).
- Today, without drains, full uplift would be applied to 100% of foundation.
- Sliding resistance of bedrock (shale) was overestimated
- No passive wedge

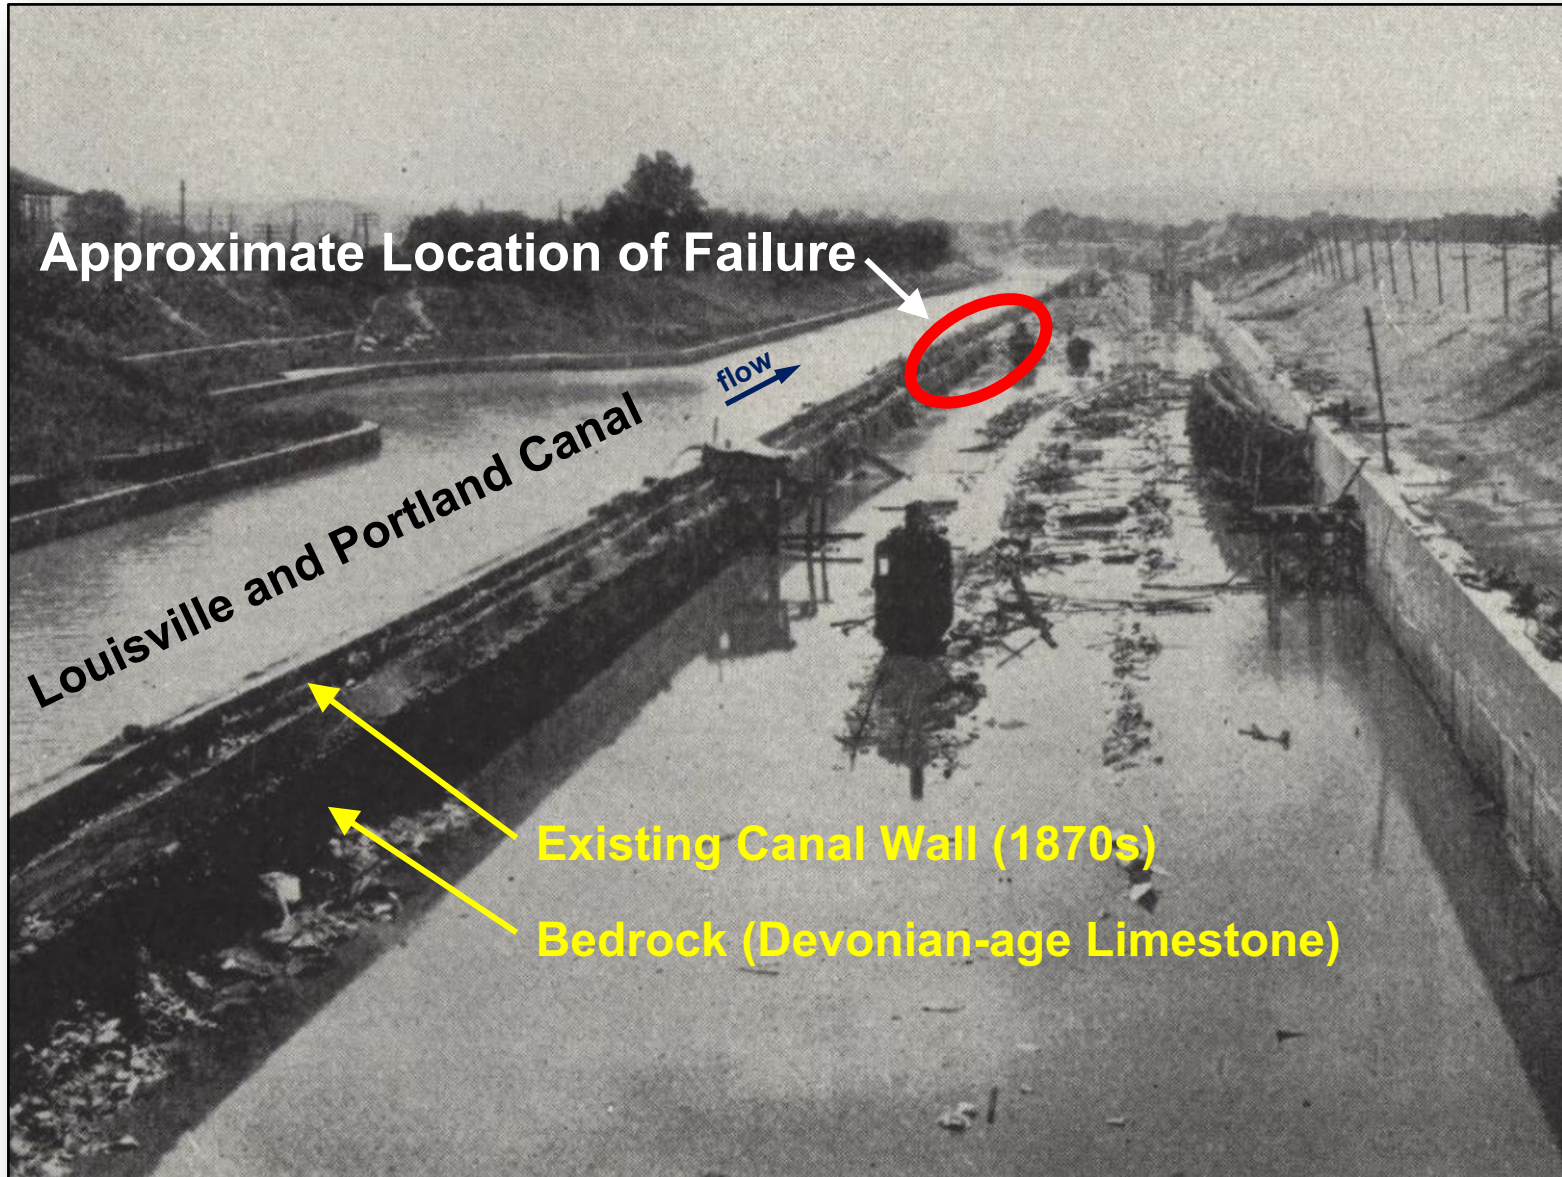
Construction Photo – Widening Canal

- Widening canal from 87' to 200'
- Construction contractor used the pre-existing canal wall (built 1870s) and underlying limestone as a cofferdam
- Cofferdam failed at 7:50am on Oct. 5, 1915
- One death

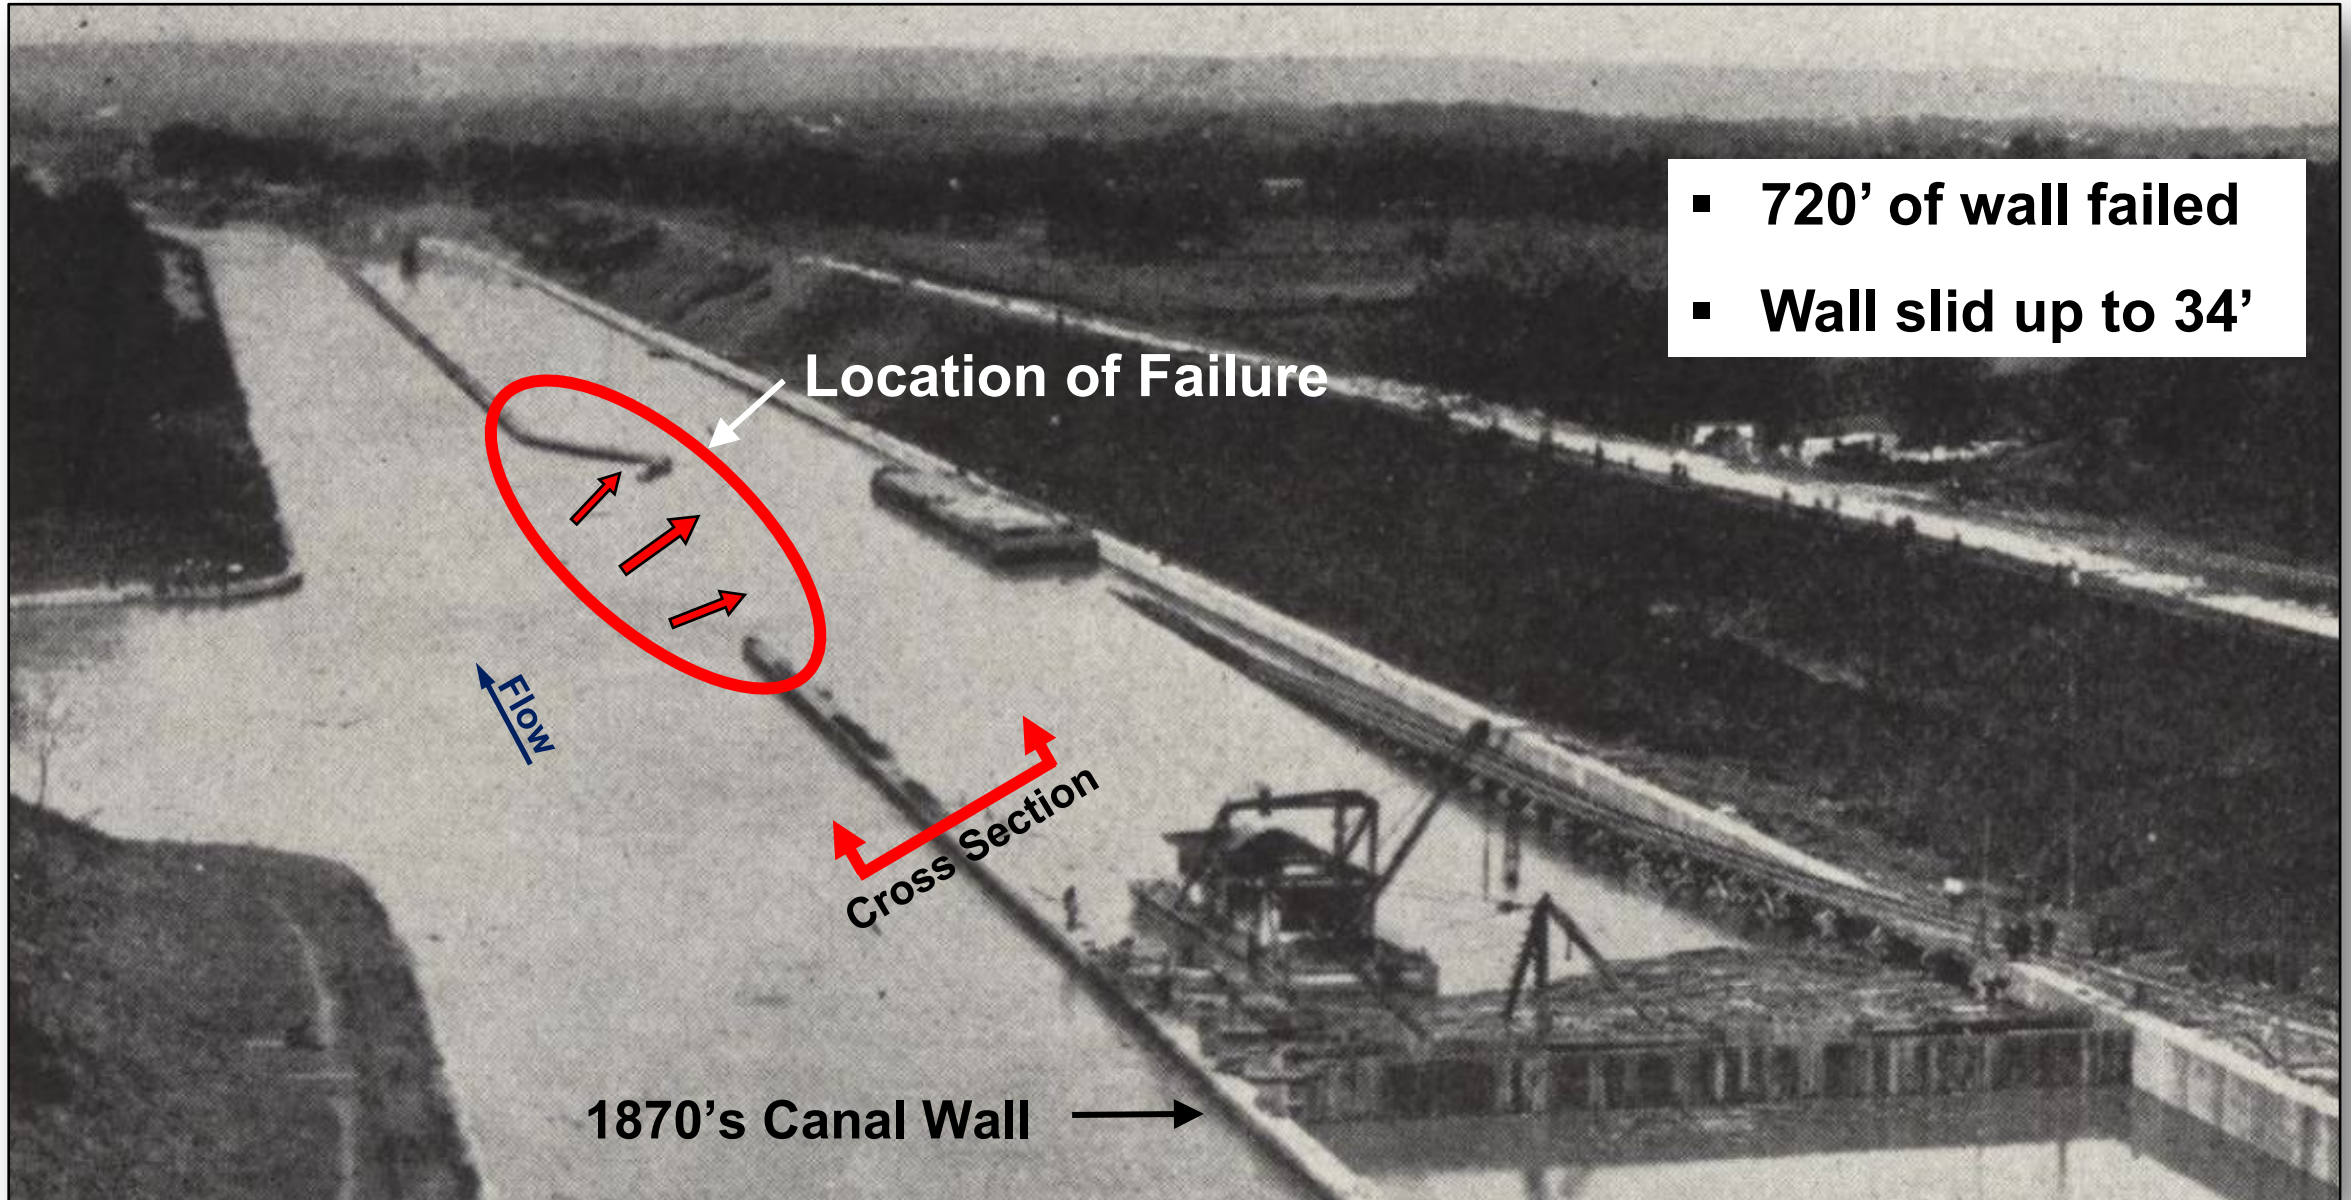
Photo – Location of Failed Section of Cofferdam

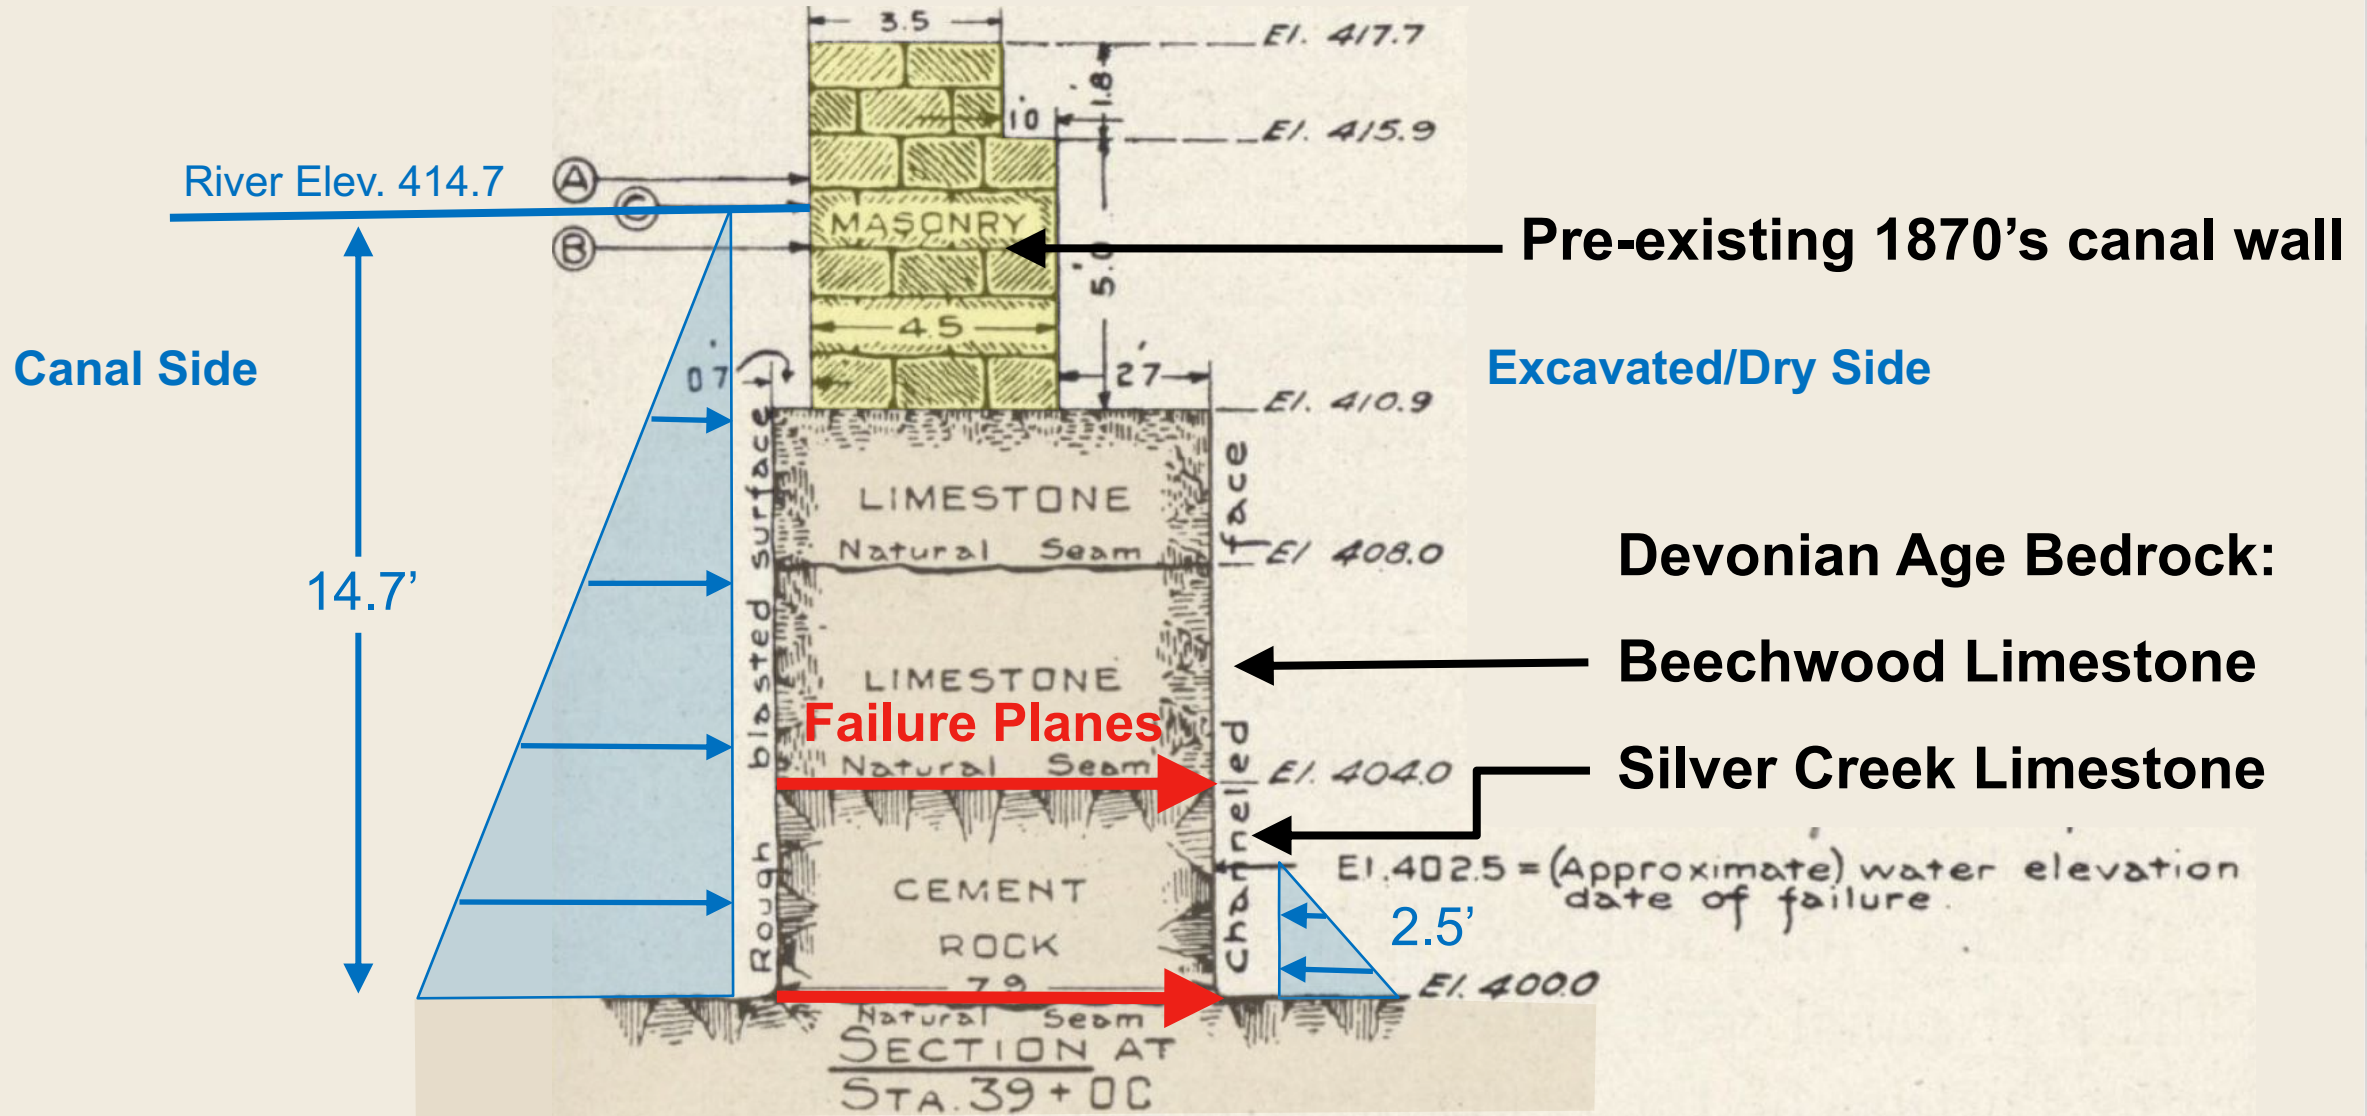
Cross Section - Cofferdam

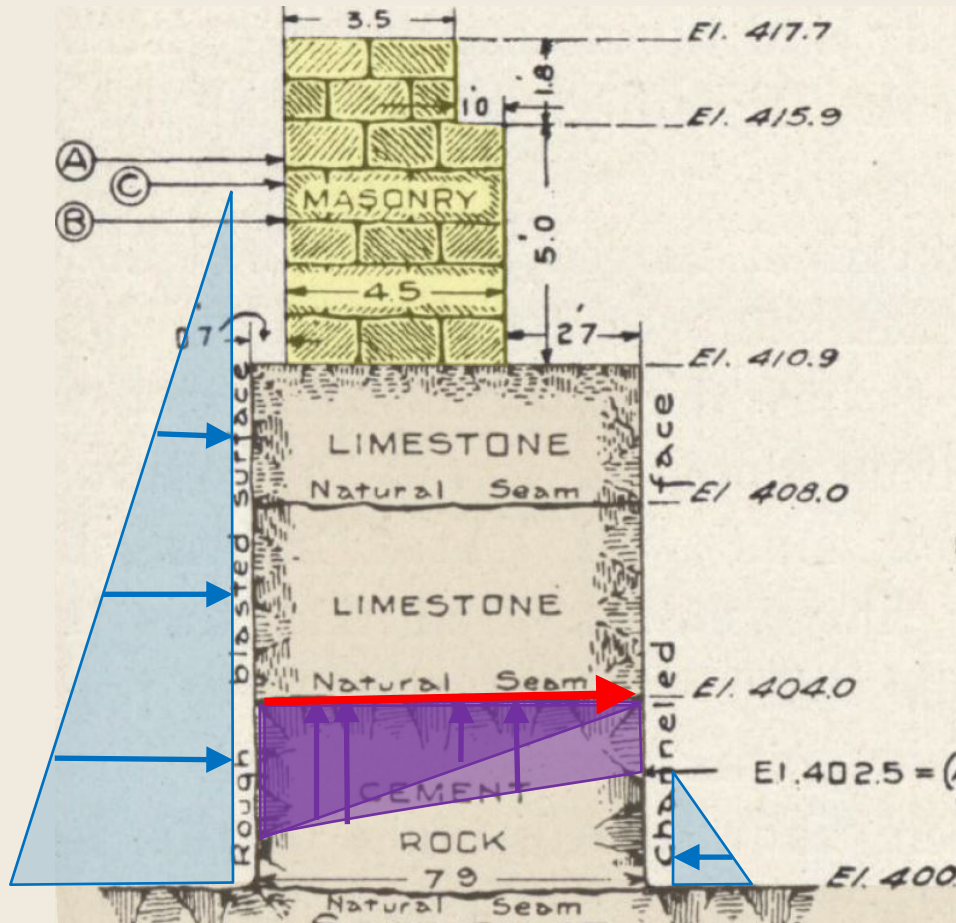
CONDITIONS	Base at El. 404
	Ratio of Hor. to Vert. Forces
ASSUMED	
No upward pressure on base.	0.28
Full upward pressure at outside edge varying uniformly to zero pressure at inside edge of base.	0.35
Full upward pressure over $\frac{1}{2}$ base	0.35
Full upward pressure over entire base	0.49

Could fail if phi angle is 16° or less

Could fail if phi angle is 19° or less

Could fail if phi angle is 26° or less

- Wedges were used to stop seepage from dry side (increased uplift pressure)
- Some borings had “silt or clay seam” at elev. 404 (lower phi angle)
- Blasting may have moved/shifted bedrock (post-peak rock strength)

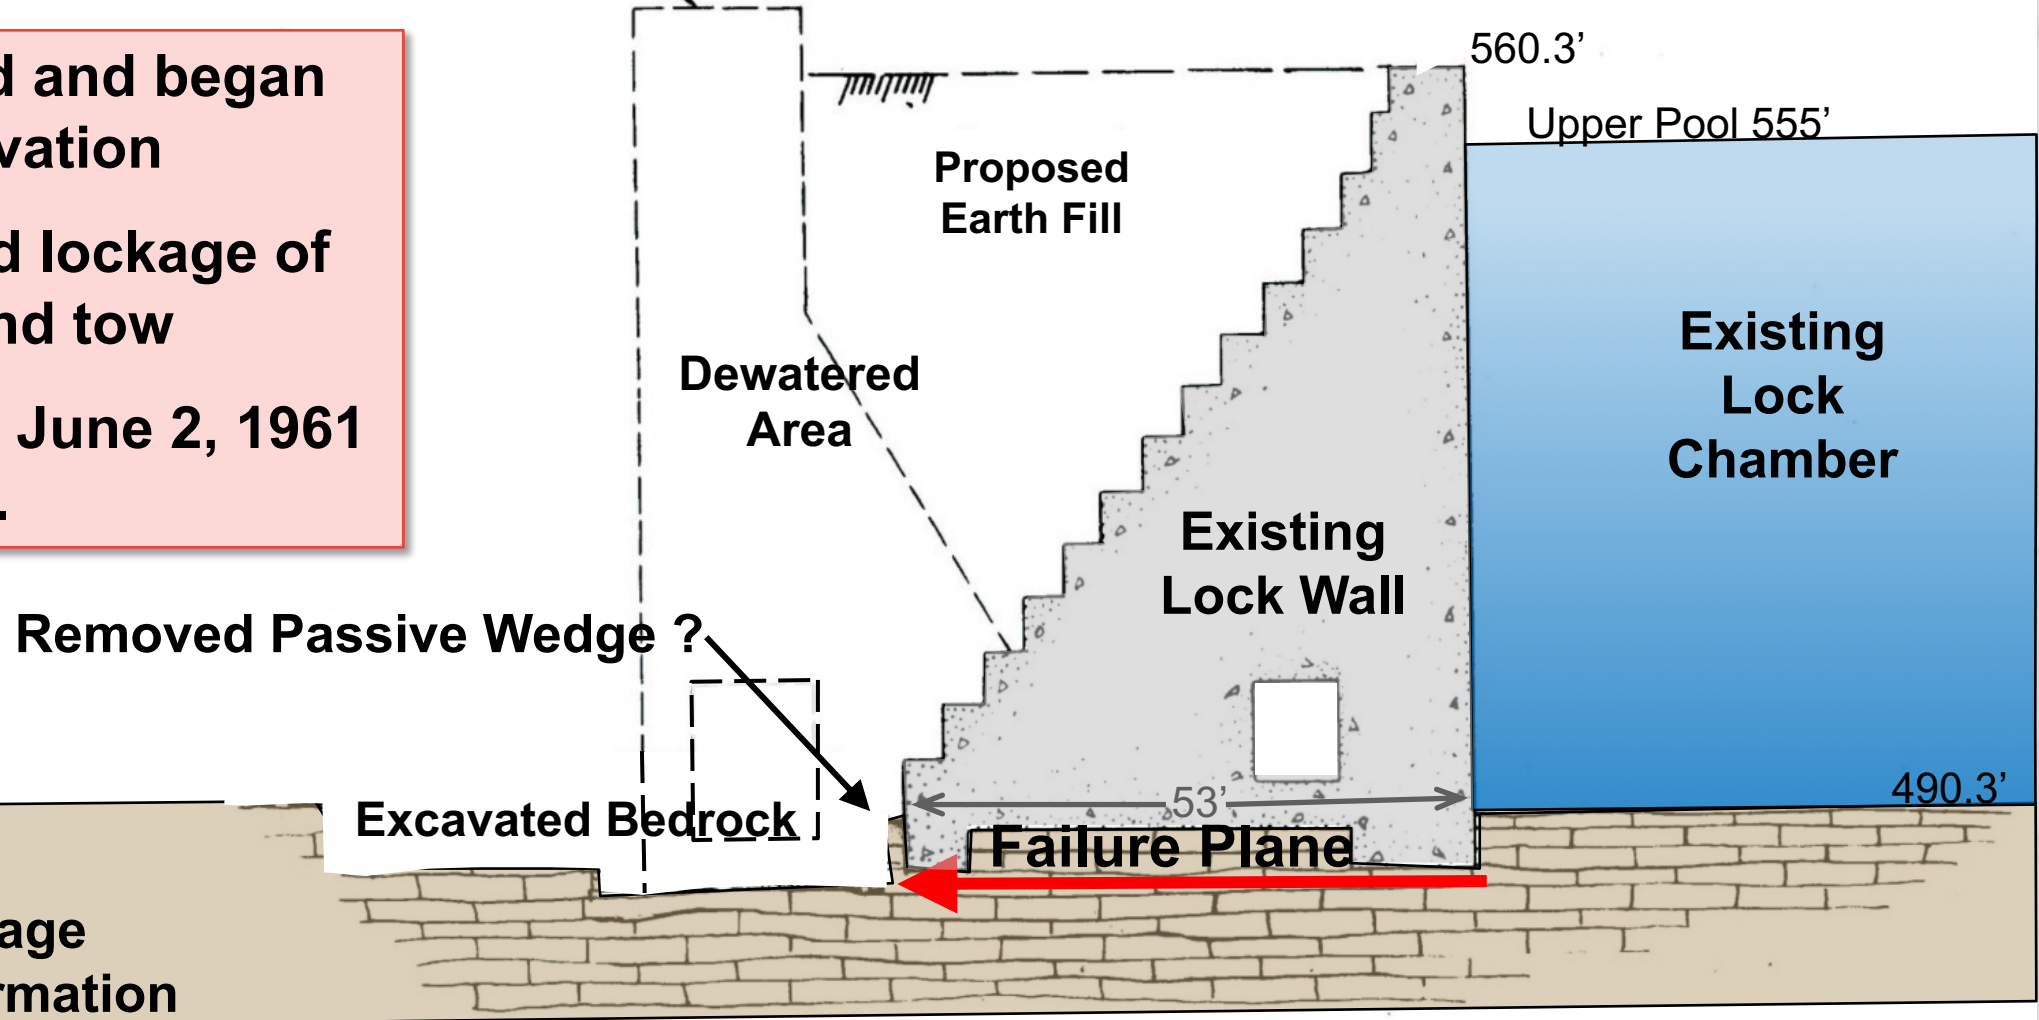
- Dewatered and began rock excavation
- Completed lockage of an upbound tow
- Failure on June 2, 1961 at 9:30pm.

Limestone:  
Mississippian-age  
Fort Payne Formation

Cross Section – Lock Wall – Before Failure

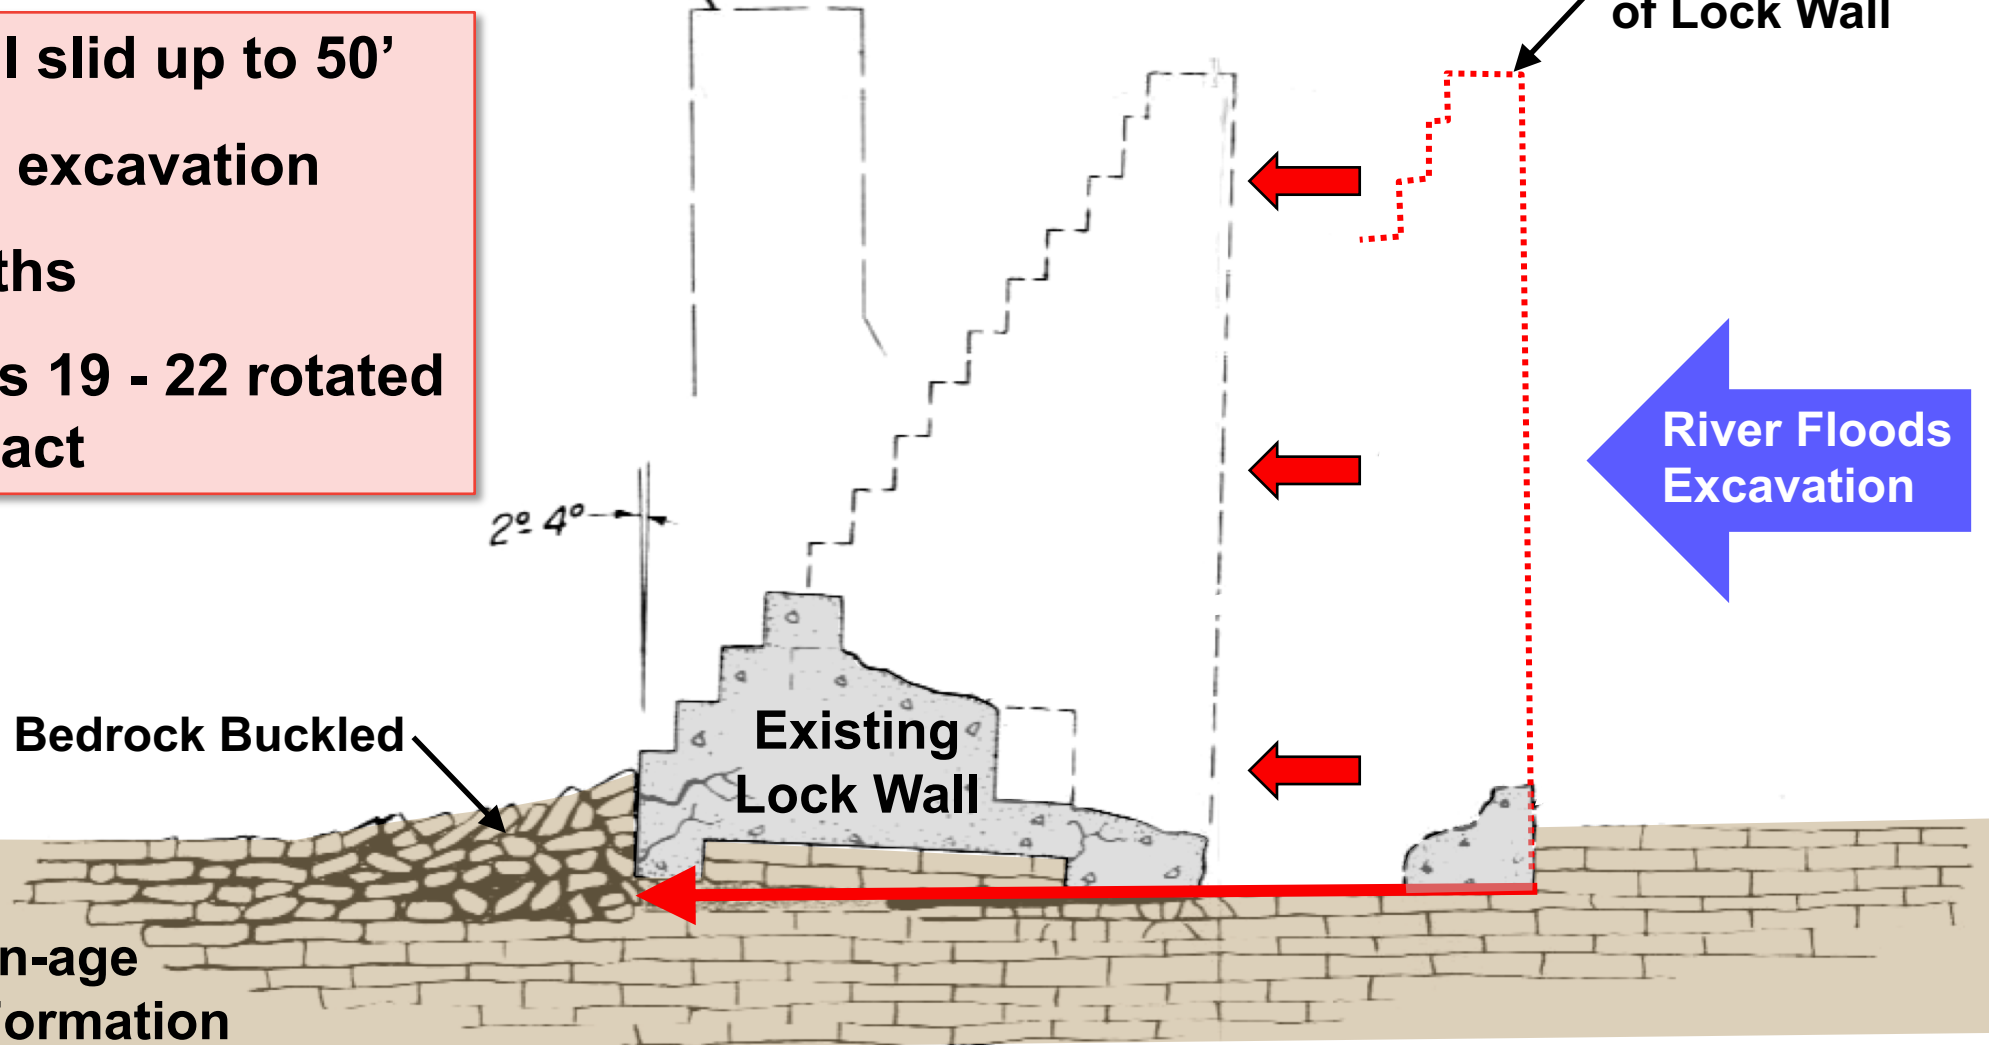
- Land wall slid up to 50'
- Flooding excavation
- Two Deaths
- Monoliths 19 - 22 rotated after impact

Cross Section – Lock Wall – After Failure
