# SLIDING FAILURES AT FIVE LOCK AND DAM PROJECTS

## Dam and Cofferdam Failures within the Ohio River Basin

AEG 62<sup>nd</sup> Annual Meeting  
September, 2019

Mike Nield, Senior Engineering Geologist  
U.S. Army Corps of Engineers, Huntington WV  
LRD Dam Safety Production Center  
Dam Safety Modification Mandatory Center of Expertise

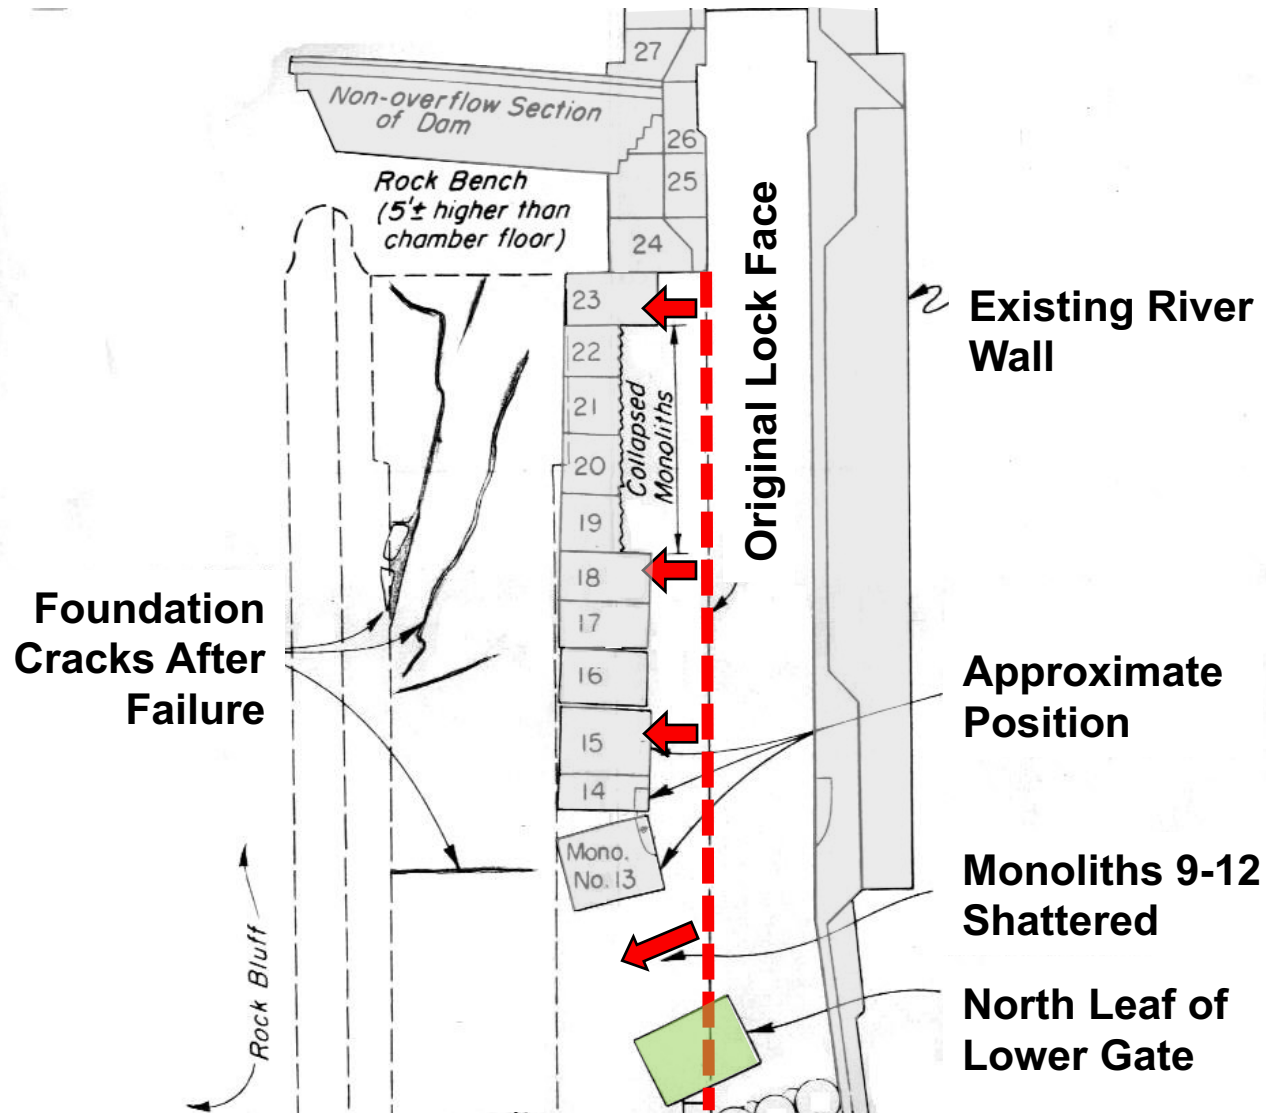
Plan View – After Failure

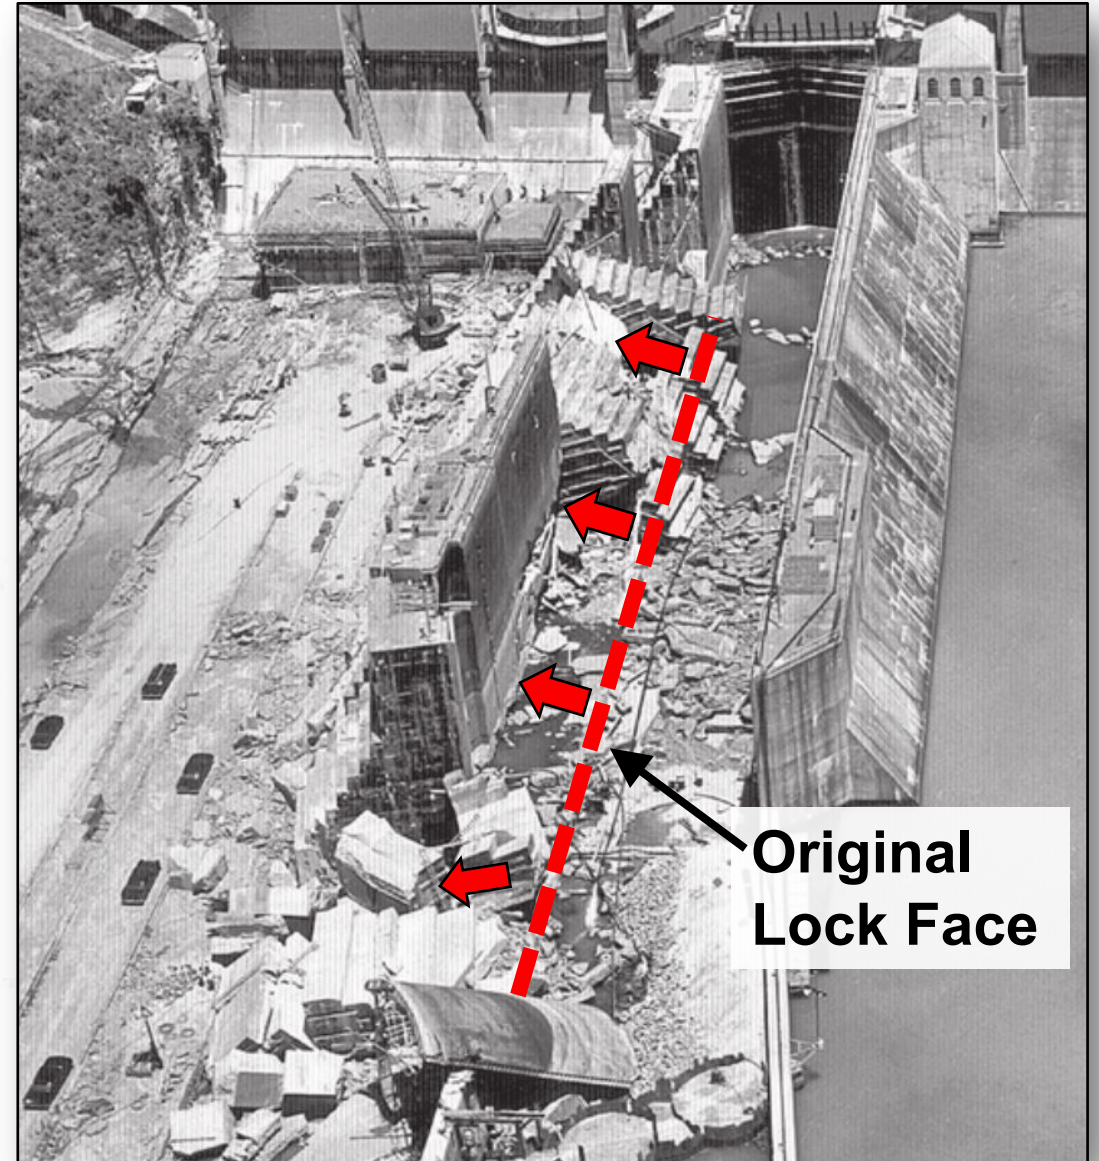
Aerial Photo – After Failure - Dewatered

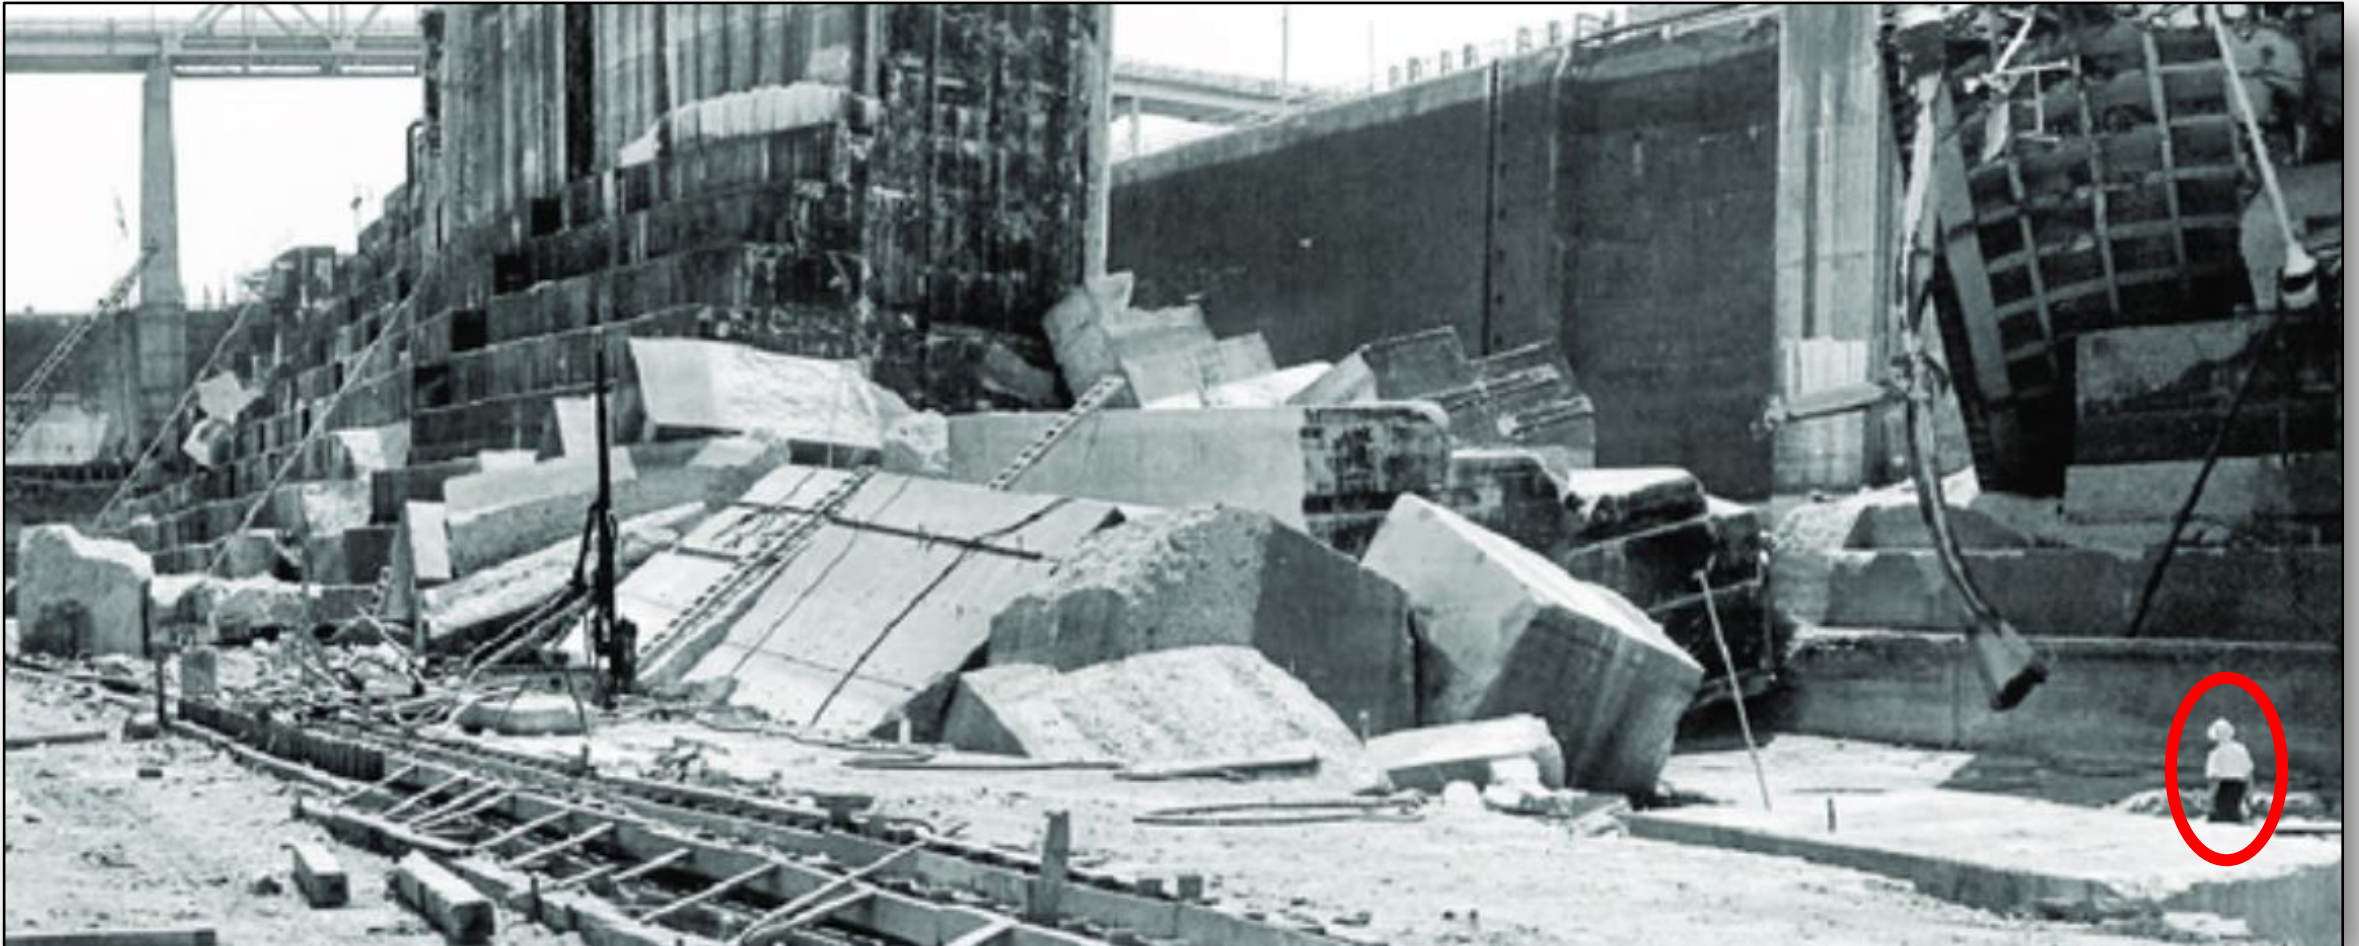
- Seepage noted during lockage
- Blast may have been concurrent with failure

**Photo Viewed from Proposed New Lock After Failure of Original Lock**

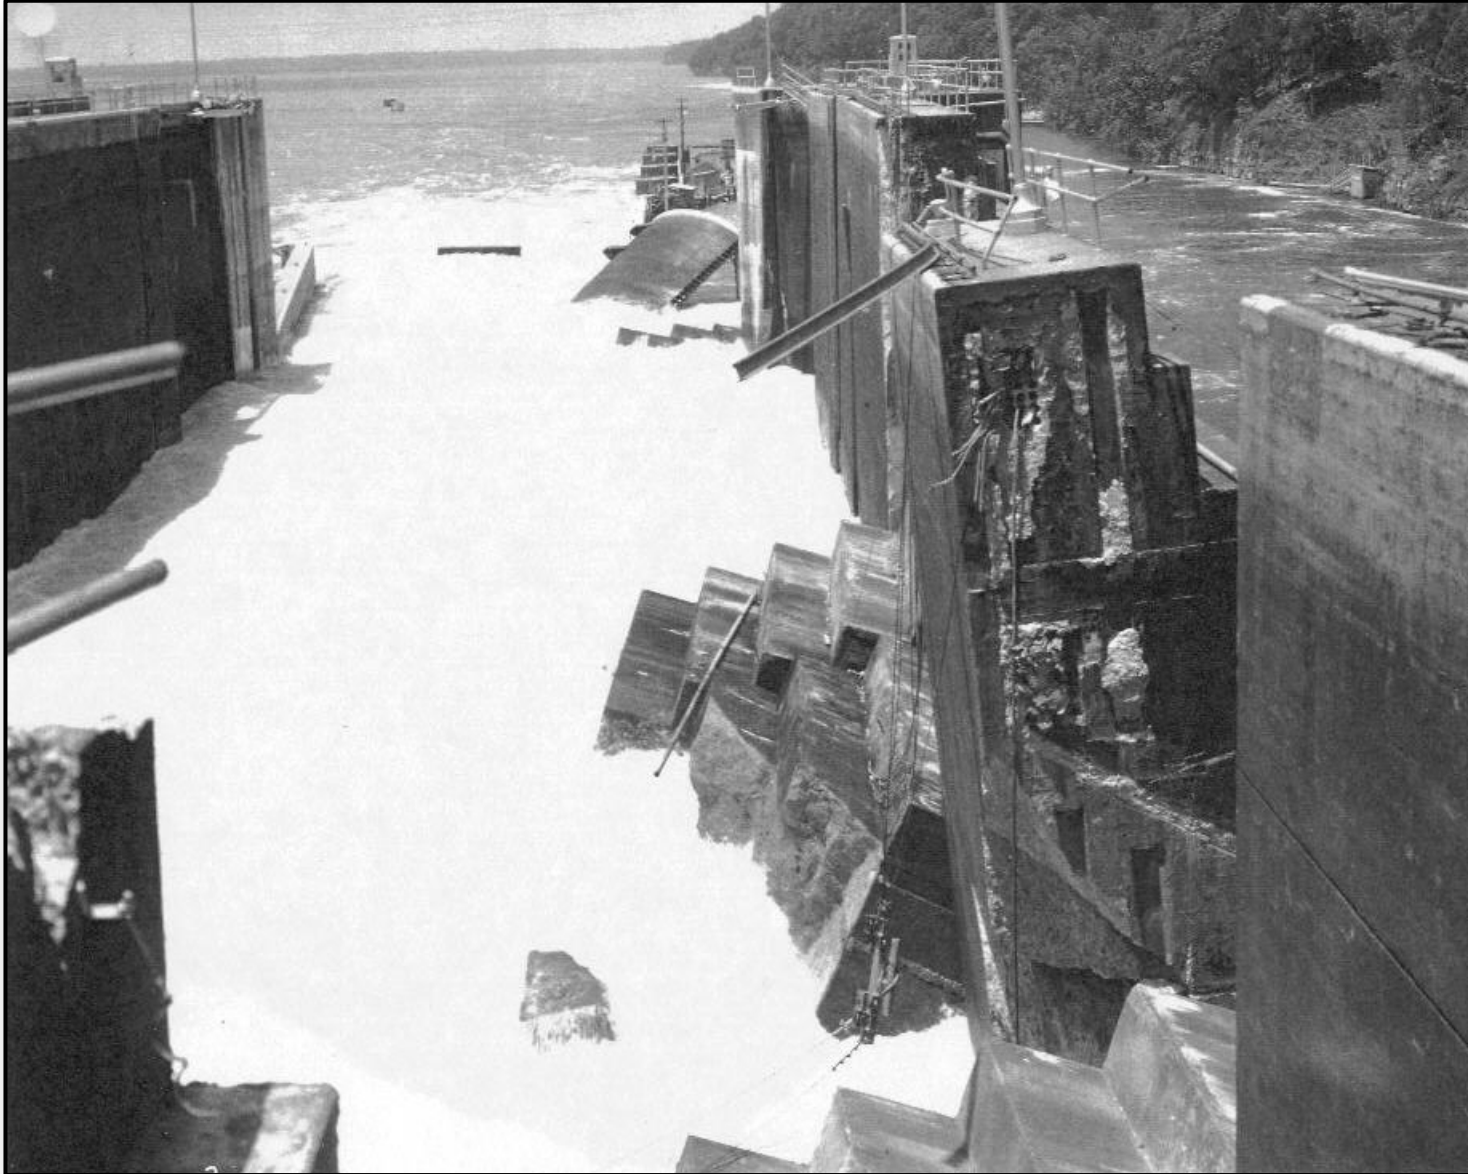
Photo Looking Downstream – After Failure

- Thick limestone foundation having a shale seam (0.5' thick), with an undetected **thin clay seam** (1/16 to 3/8" thick) at the base of the shale.
- Overestimated sliding resistance of bedrock
- Excavation “daylighted” clay seam, removing the passive wedge (blasting impact?)

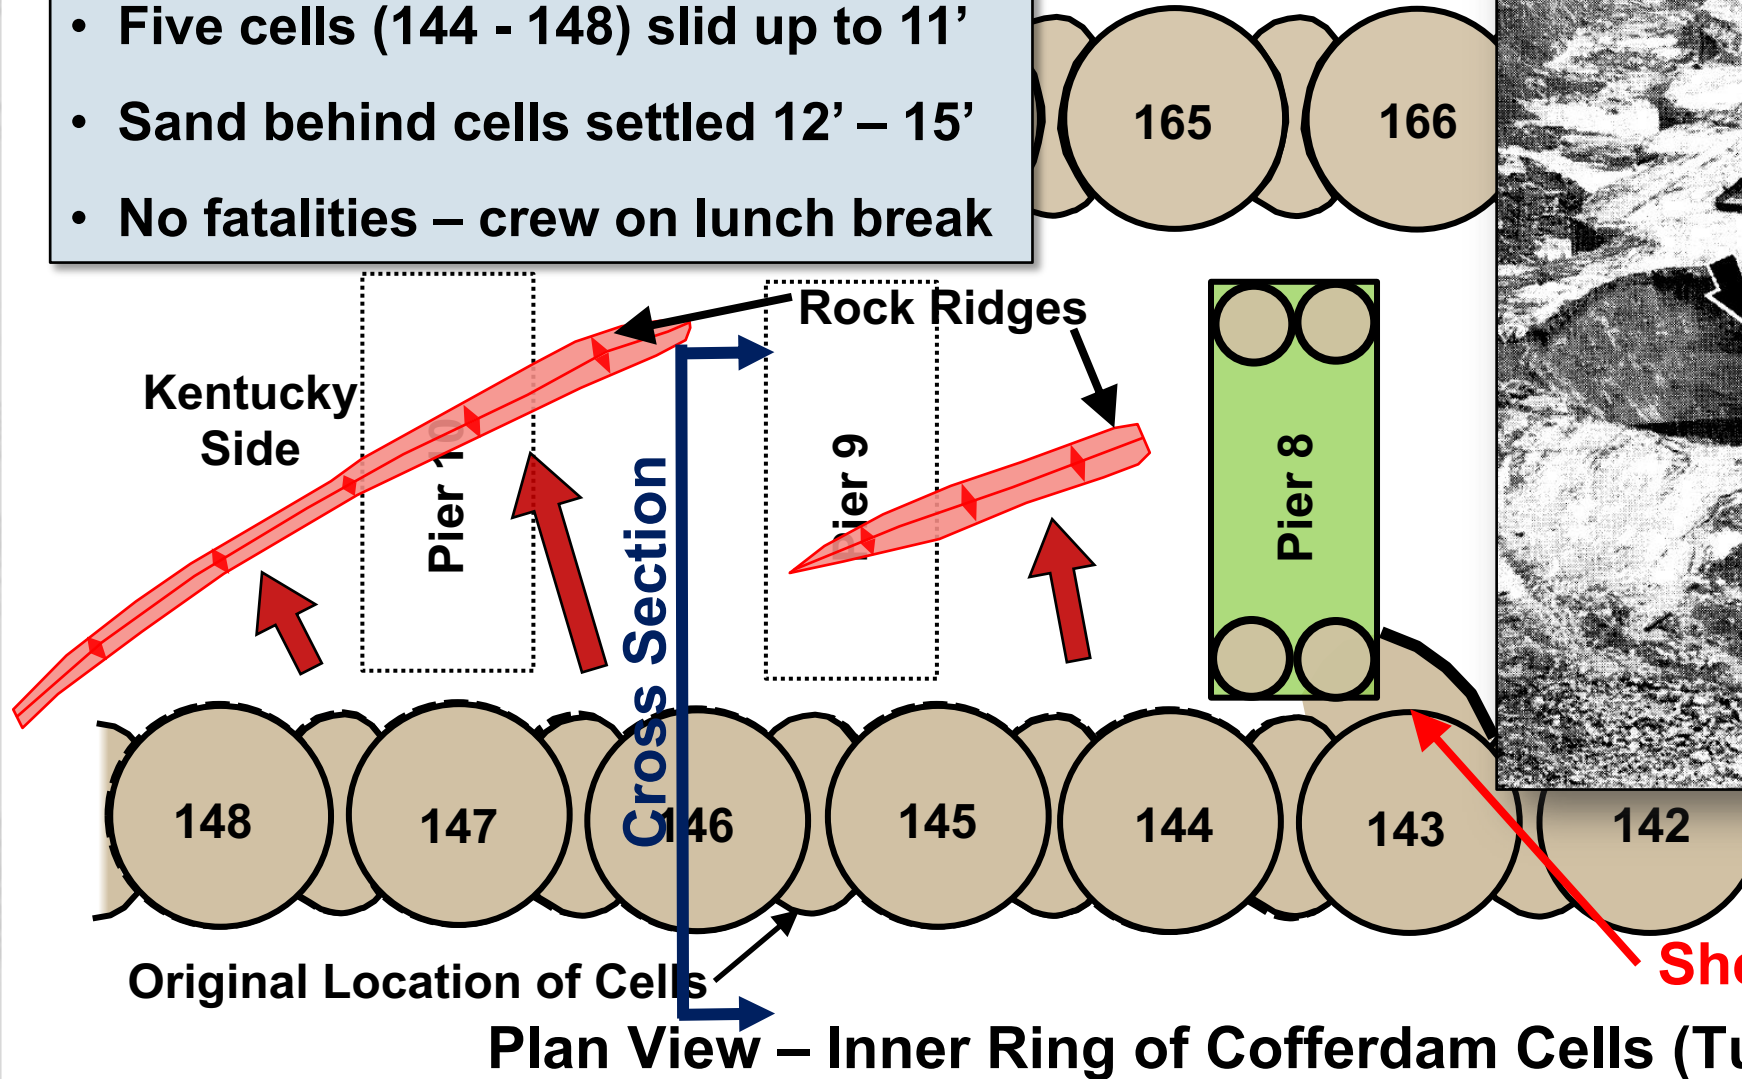
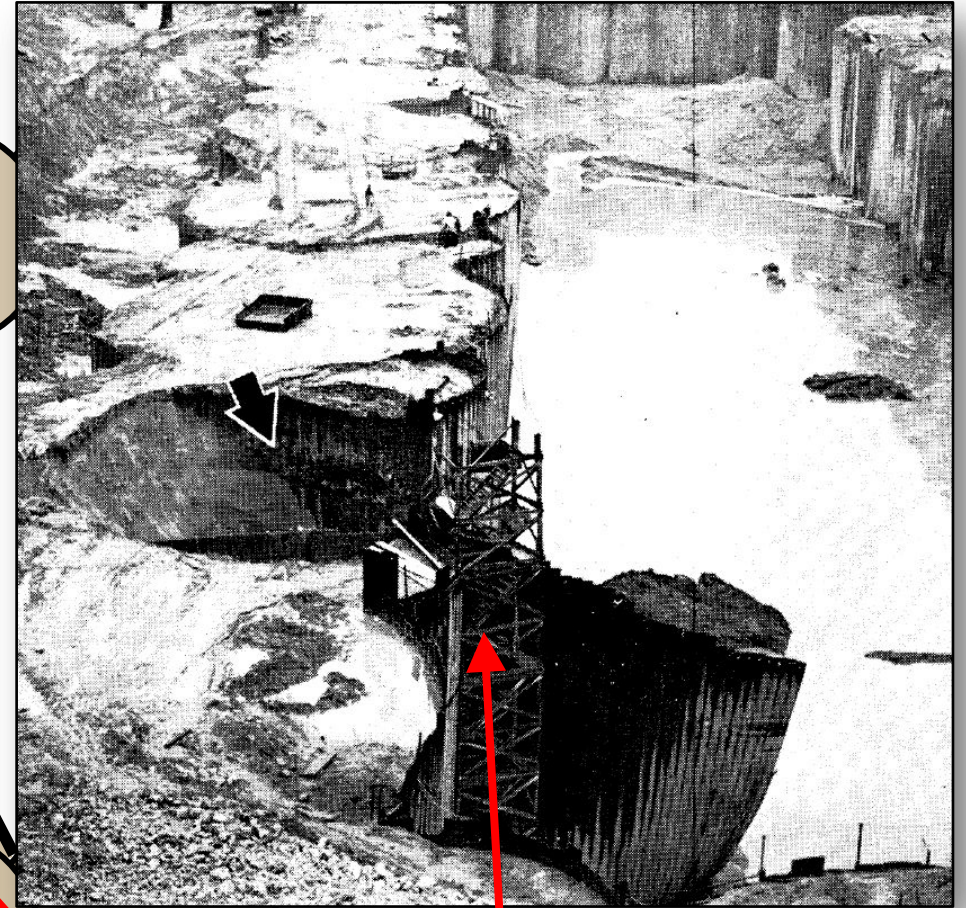
- Cell 143 sheet pile interlock split
- Five cells (144 - 148) slid up to 11'
- Sand behind cells settled 12' – 15'
- No fatalities – crew on lunch break

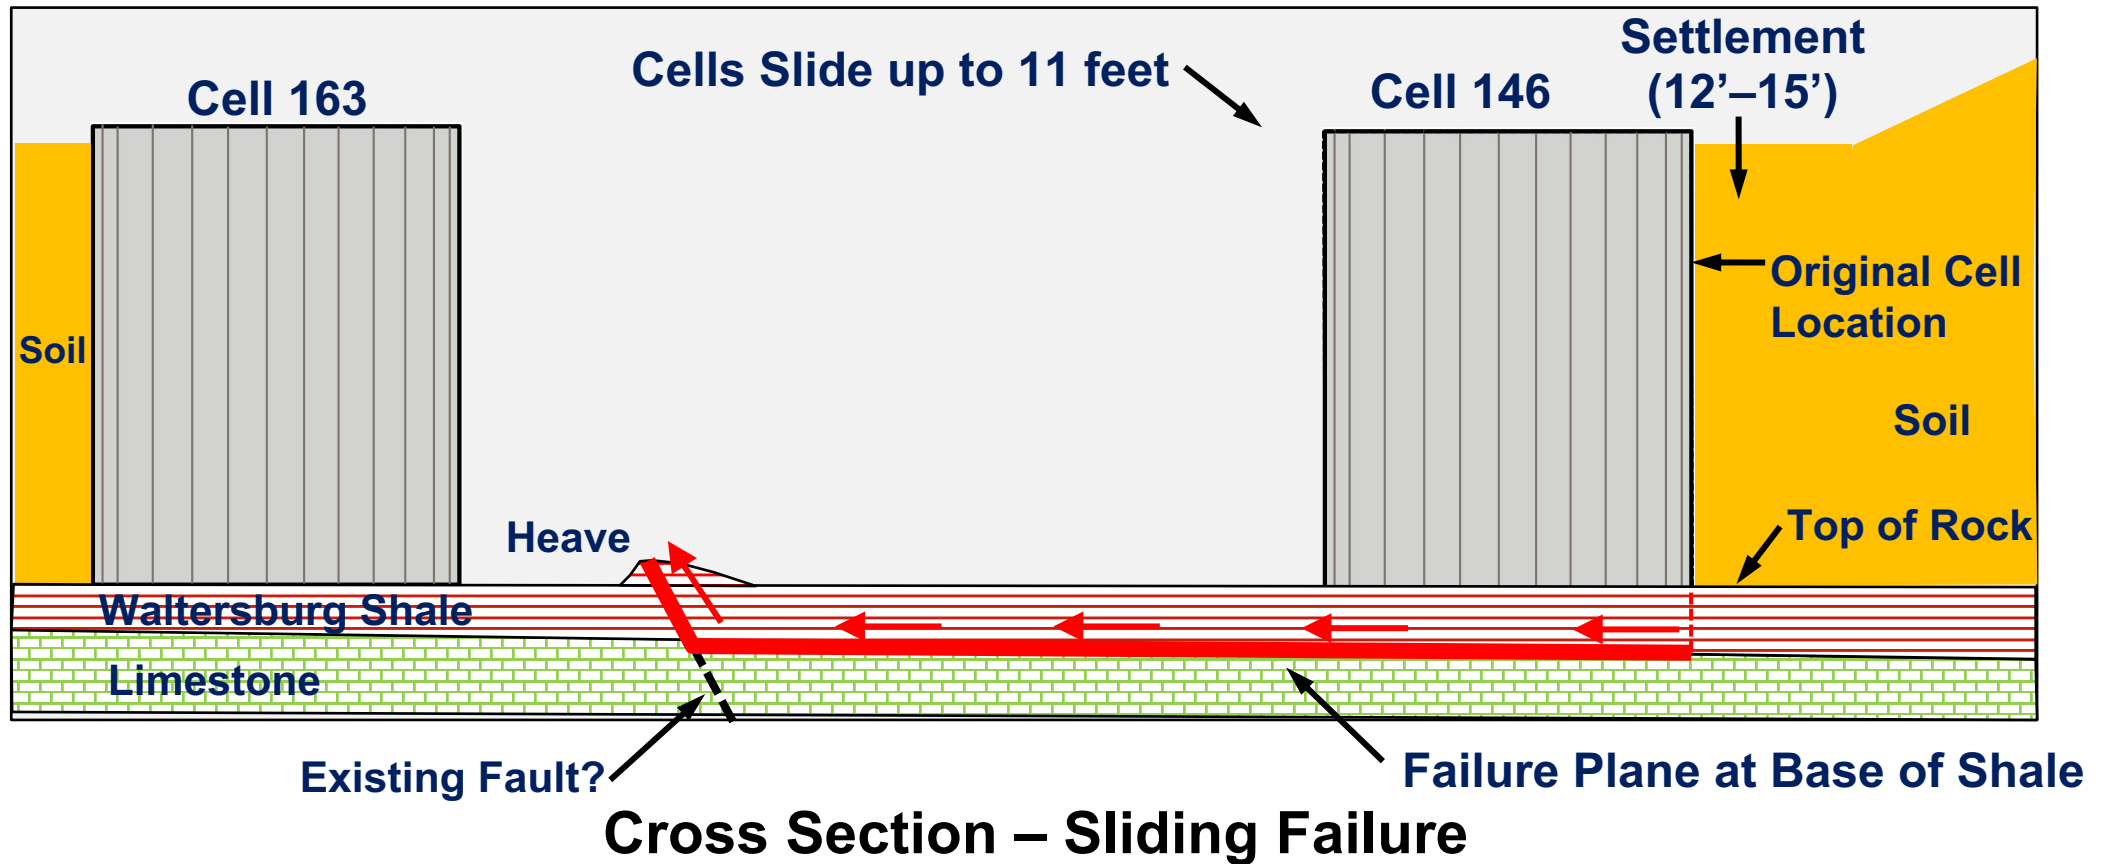
- Sliding along the base of the Mississippian-age Waltersburg Shale (clayey shale)
- Overestimated the sliding resistance at the base of the shale, with a back-calculated phi angle of  $13^\circ$  (possible clay seam)
- Reversal of stresses in shale may have reduced sliding resistance to residual strength

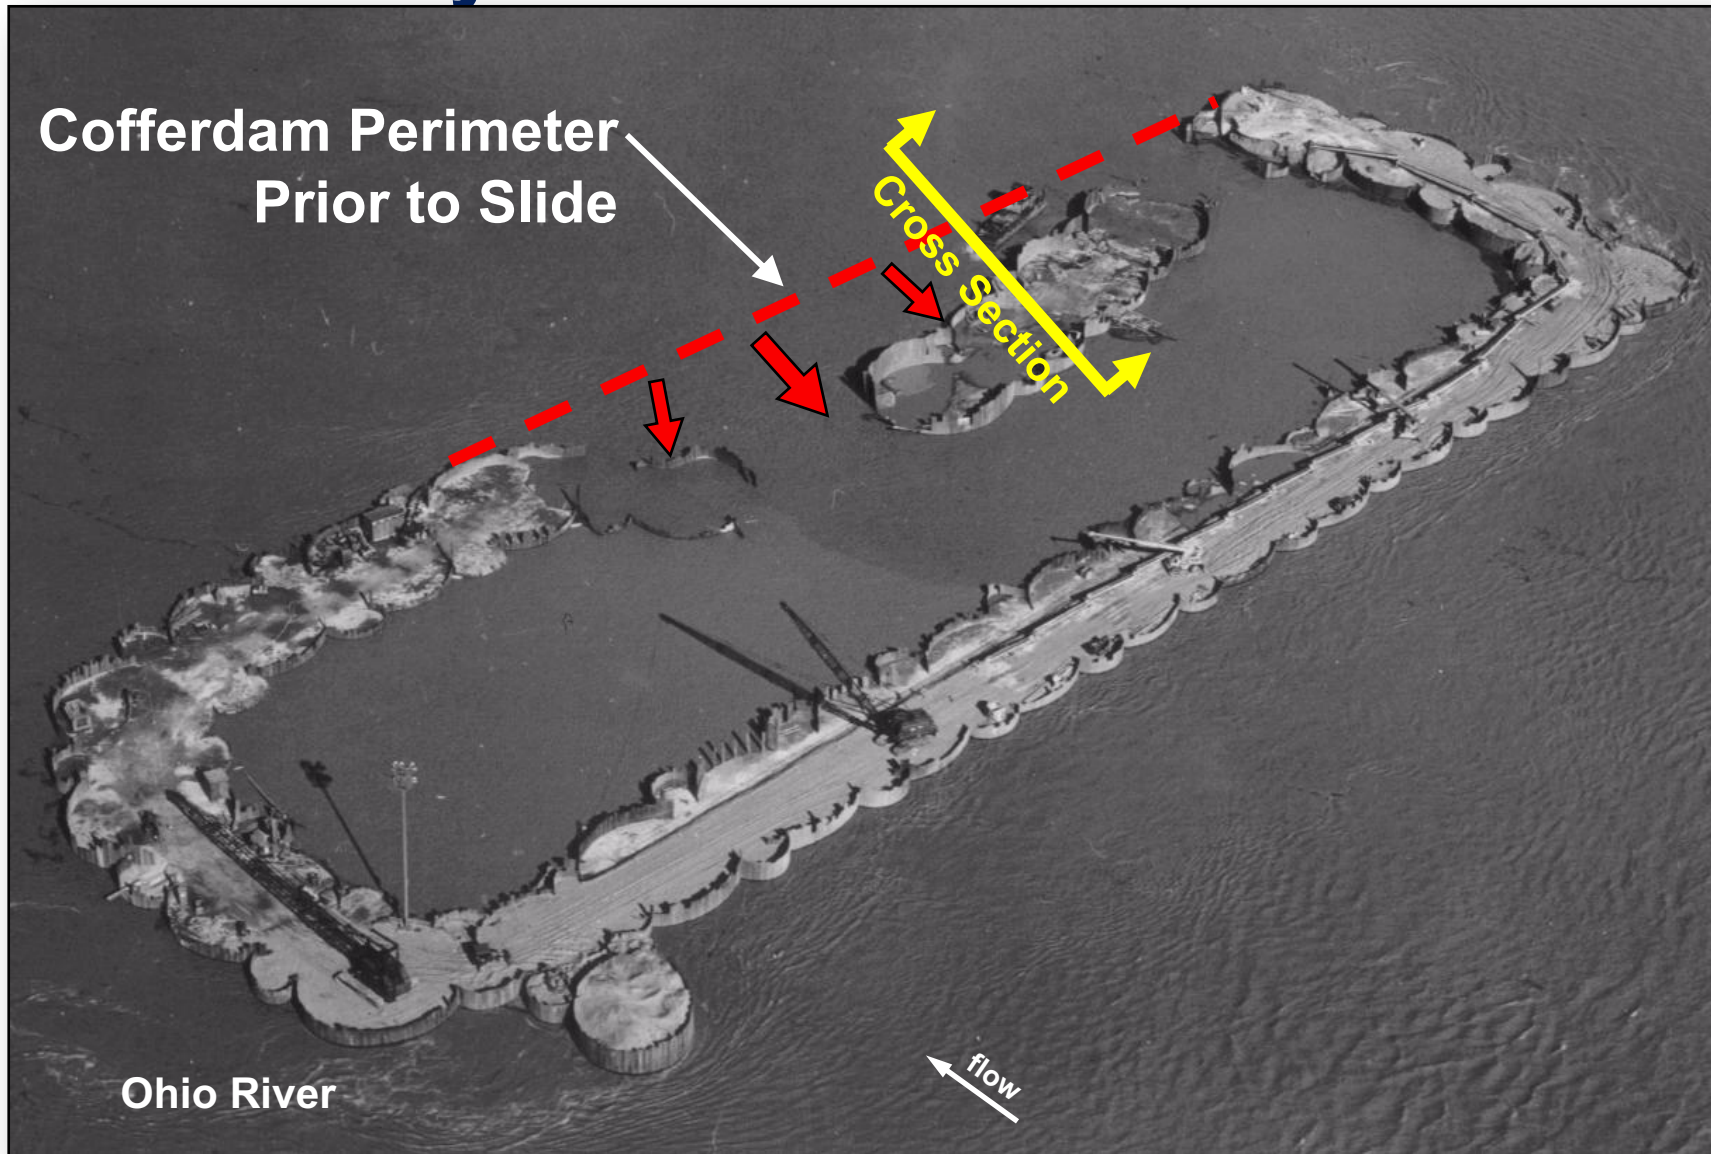
**Aerial Photo – After Failure**

- One cell ruptured
- Five cells slid 32' to 71' upstream direction
- One cell slid and collapsed

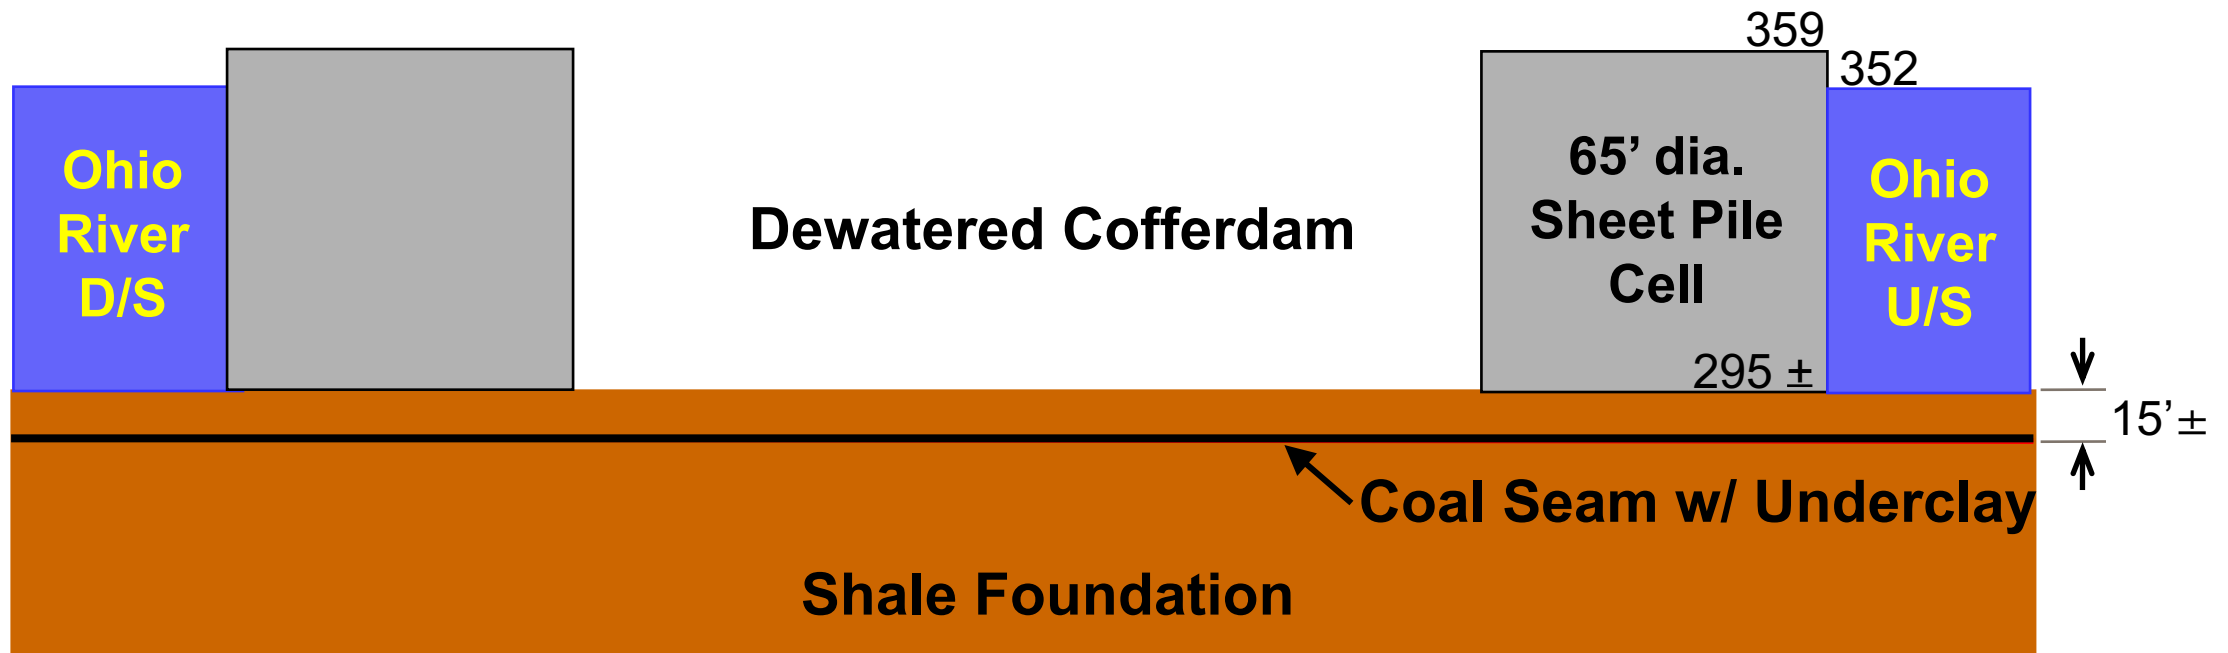
- Sliding horizontally along a coal seam underclay, 15' below top of rock
- Pennsylvanian-age Sturgis Formation (previously Lisman Formation)

Cross Section – Cofferdam Failure – Deep Seated Sliding

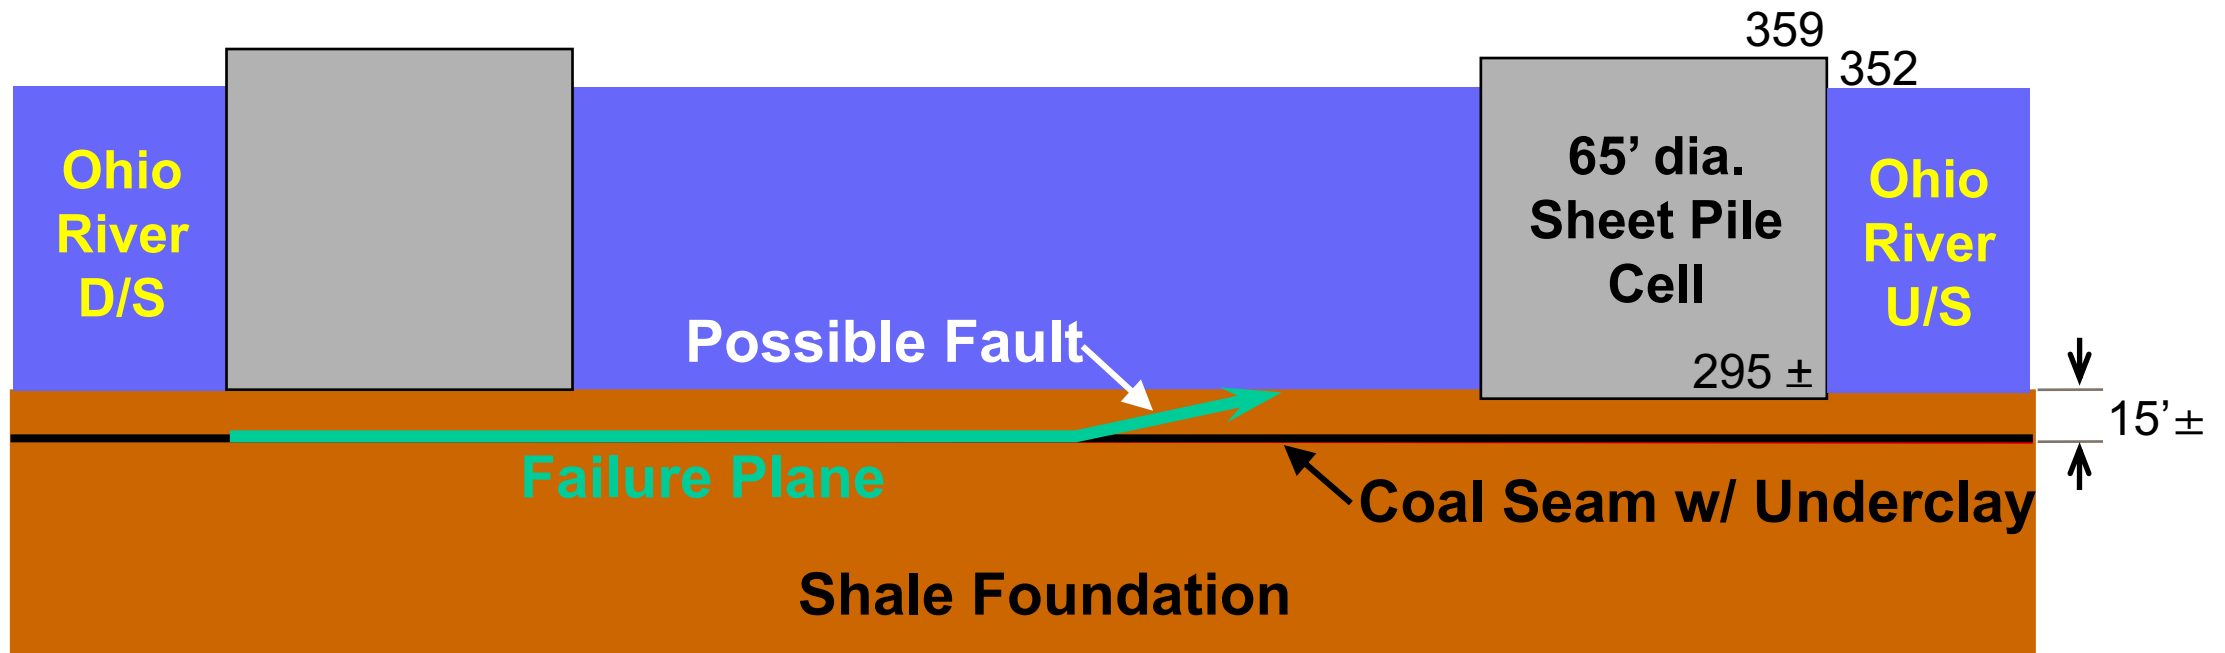
- Overestimated sliding resistance of underclay
- Sliding resistance of passive wedge was reduced, due to possible fault planes

Cross Section – Cofferdam Failure – Deep Seated Sliding
