Dissecting the Failure of a Newly Constructed Dam

Rodney E. Holderbaum, PE

Hope Mills Dam – Hope Mills, NC

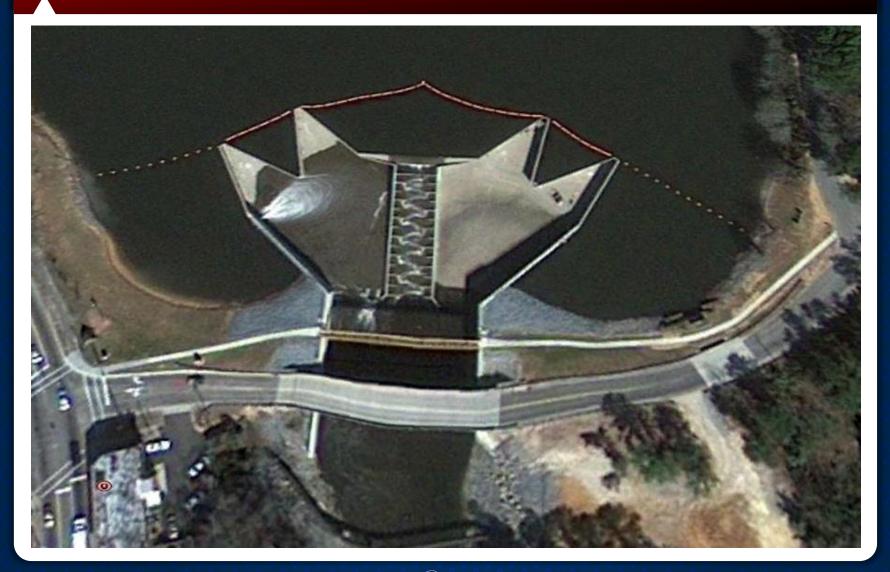
Hope Mills Dam – Prior to 2010 Failure

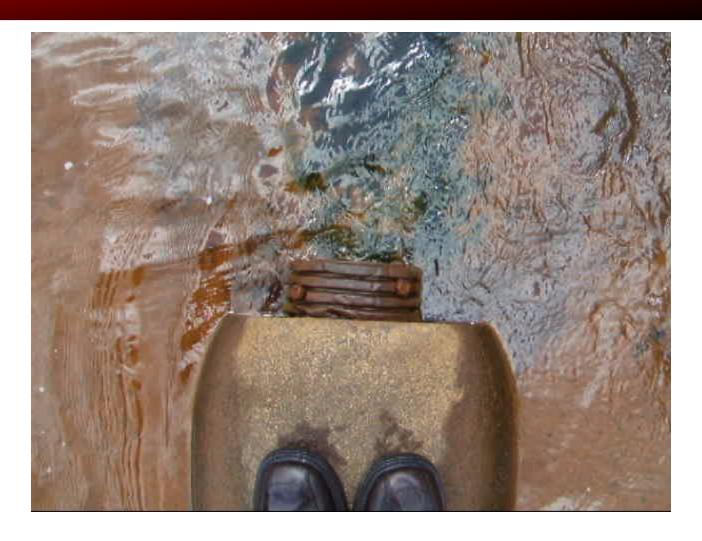
Hope Mills Dam – Drain Flow-September 2009

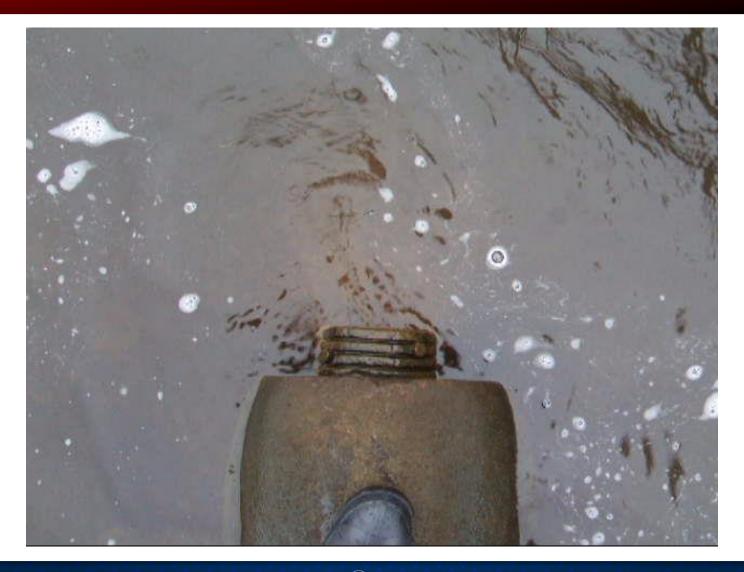
Hope Mills Dam - Drain Flow-December 2009
