Tale of Three Projects

Addressing Dam Safety Concerns within the Muskingum River Basin, OH

**AEG Annual Meeting
September 2015**

**Mike Nield, Geologist
U.S. Army Corps of Engineers
LRH Dam Safety Production Center**

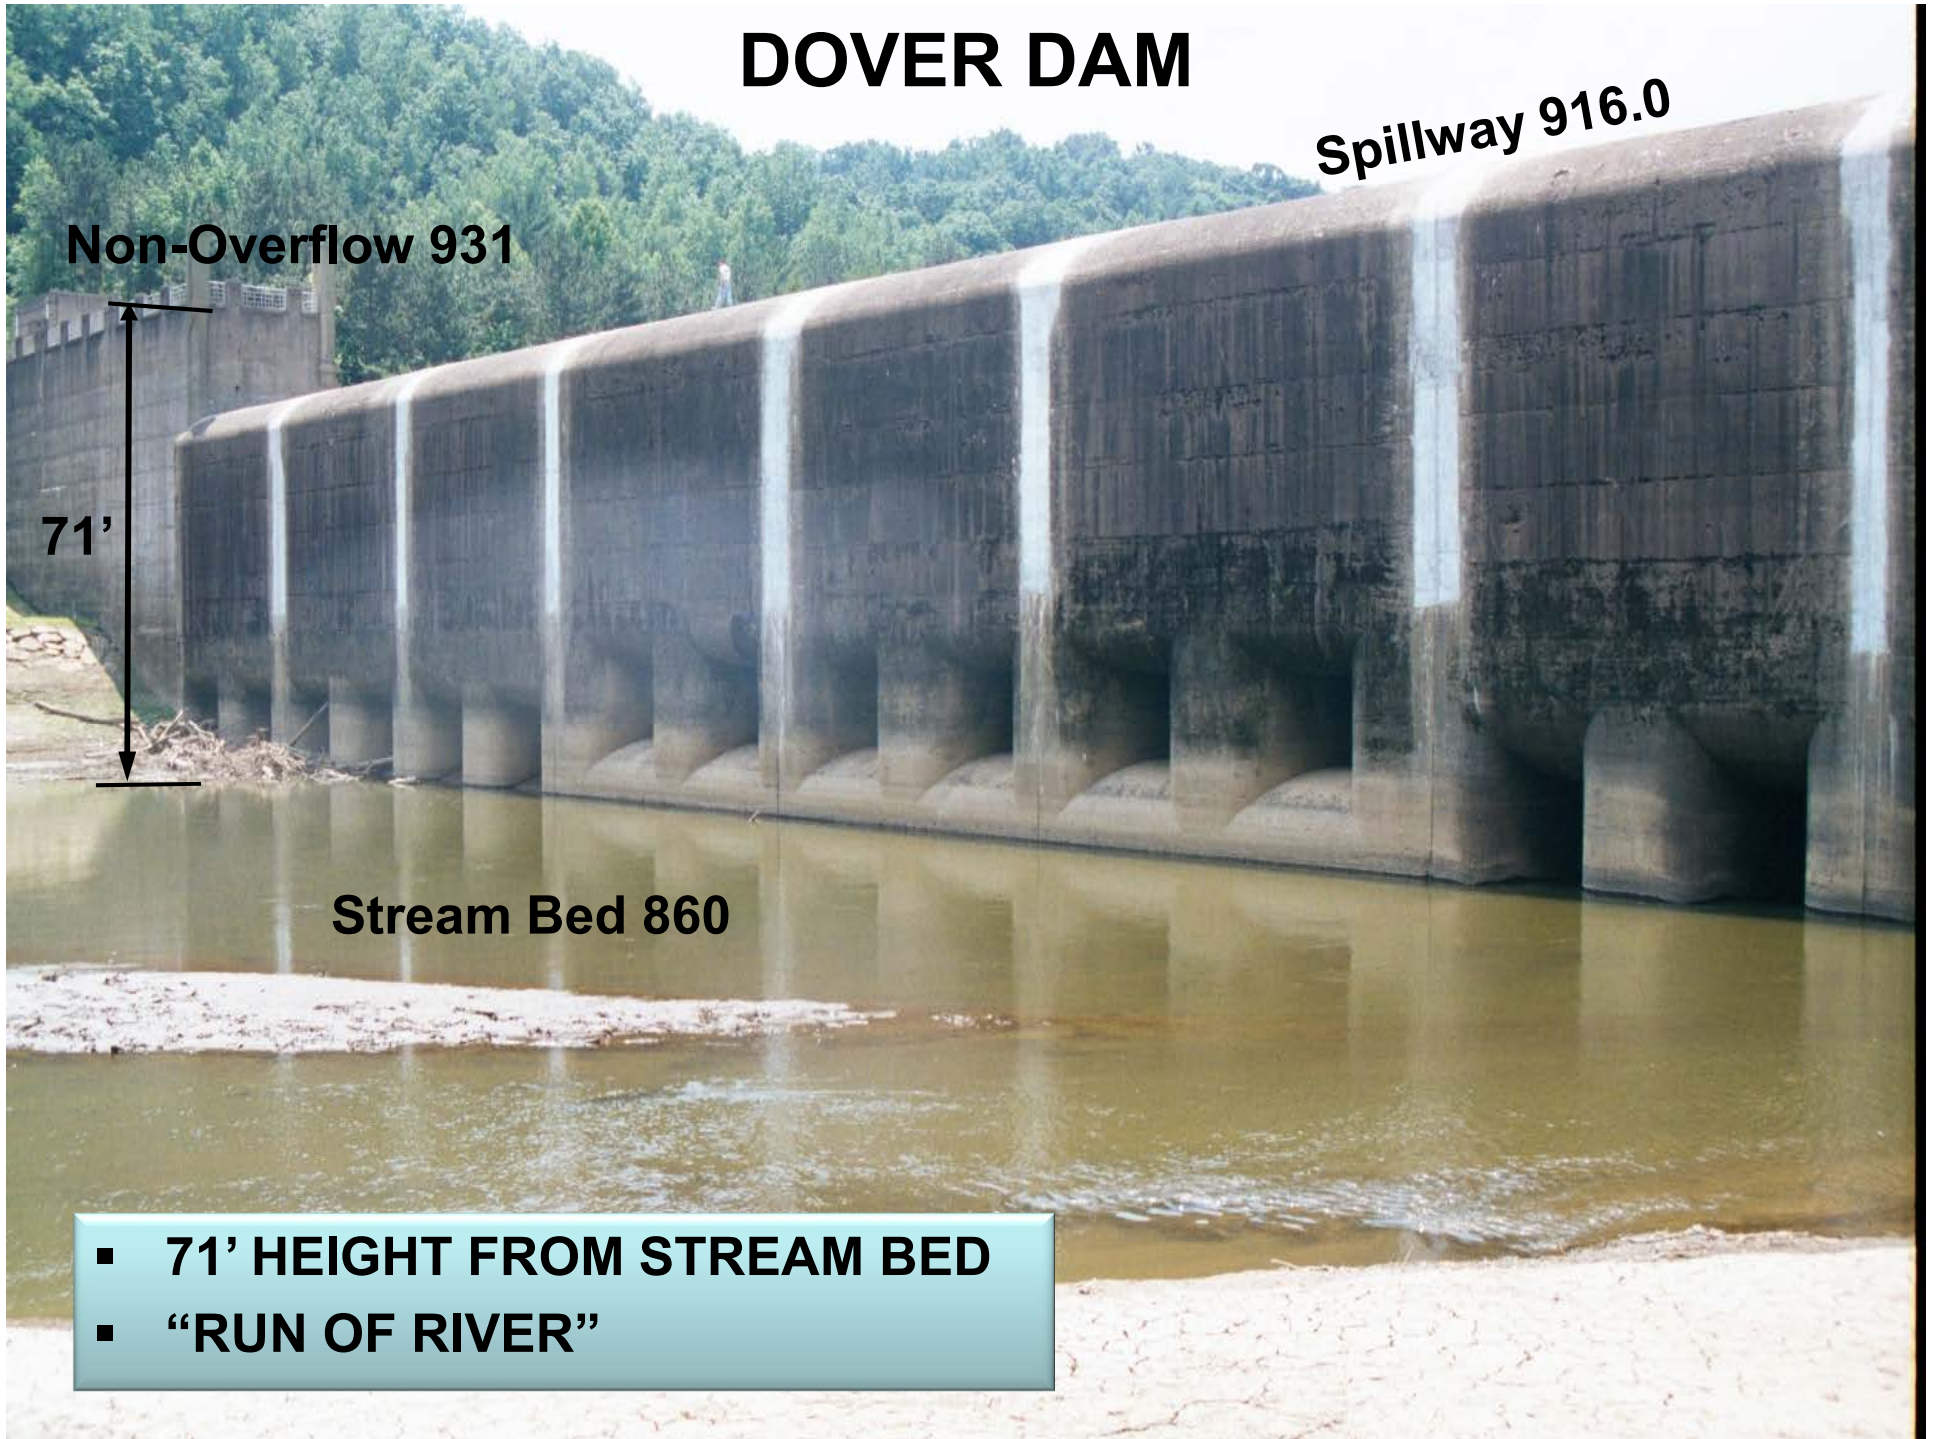
DOVER DAM – POOL OF RECORD, Jan 2005

Probable Maximum Flood el. 937

Pool el. 907.4

- Prior to spillway flow, the dam fails to provide protection against sliding
- PMF overtops dam creating downstream erosion and removal of passive wedge
- Dam Safety Action Classification II (urgent)

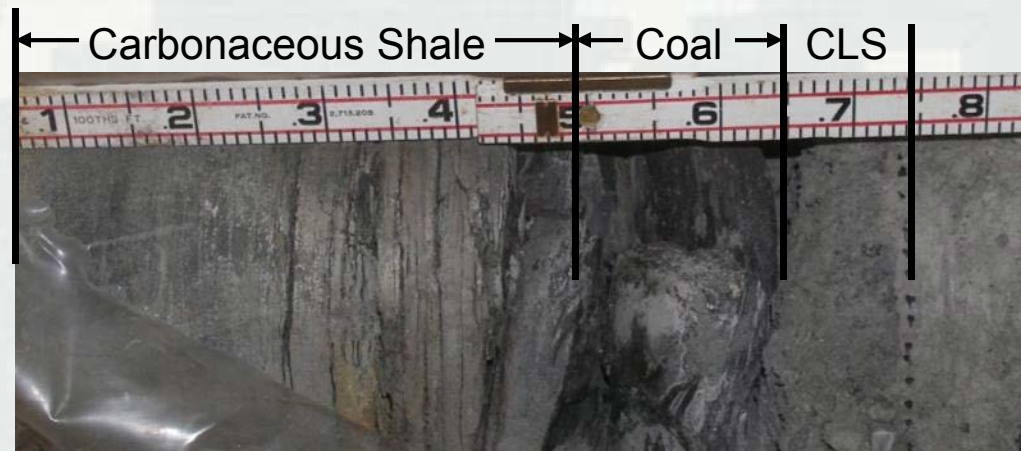
Unit #8 Carbonaceous Shale

- 3'-6' thick
- Dark gray, soft to mod. hard, carbonaceous

Unit #9 Middle Mercer Coal/Claystone

- <1' thick
- Black, blocky, occ. shaly

Potential sliding failure plane under valley monoliths

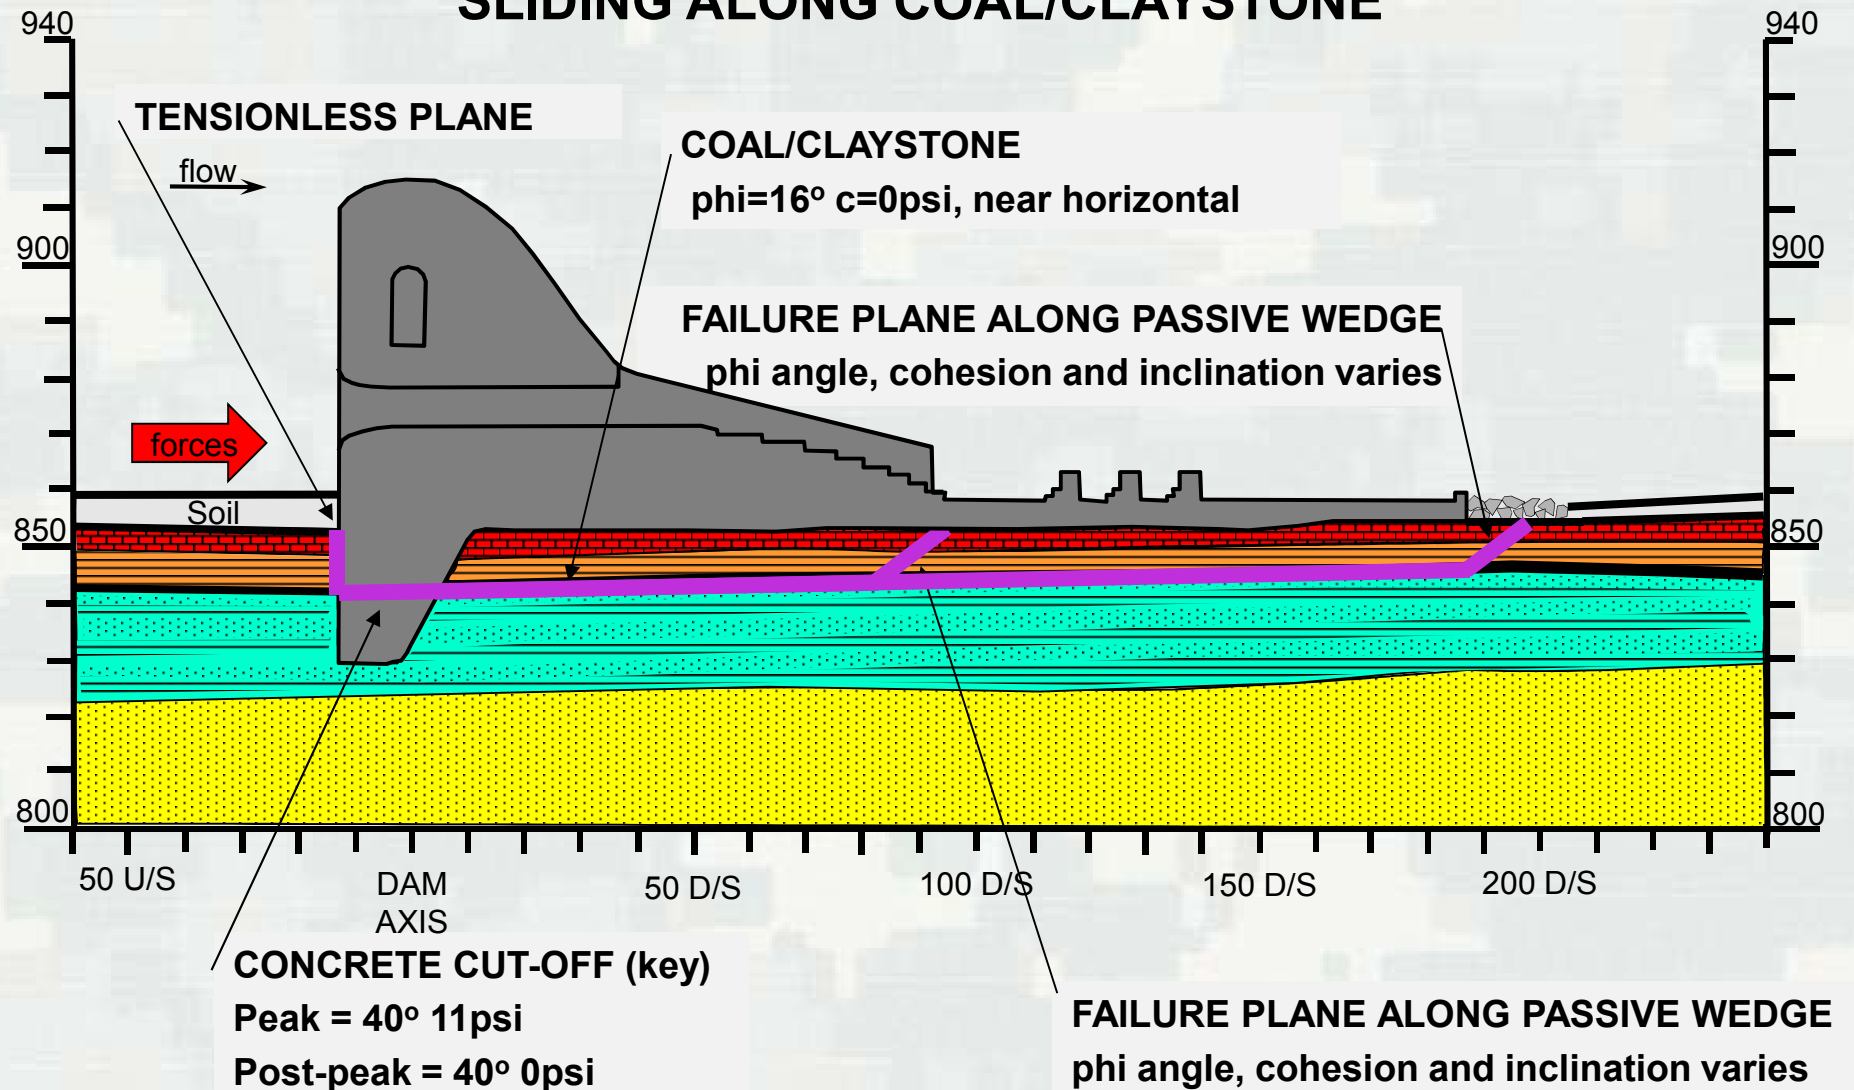
TYPICAL VALLEY MONOLITH SLIDING ALONG COAL/CLAYSTONE

POTENTIAL SLIDING FAILURE PLANES

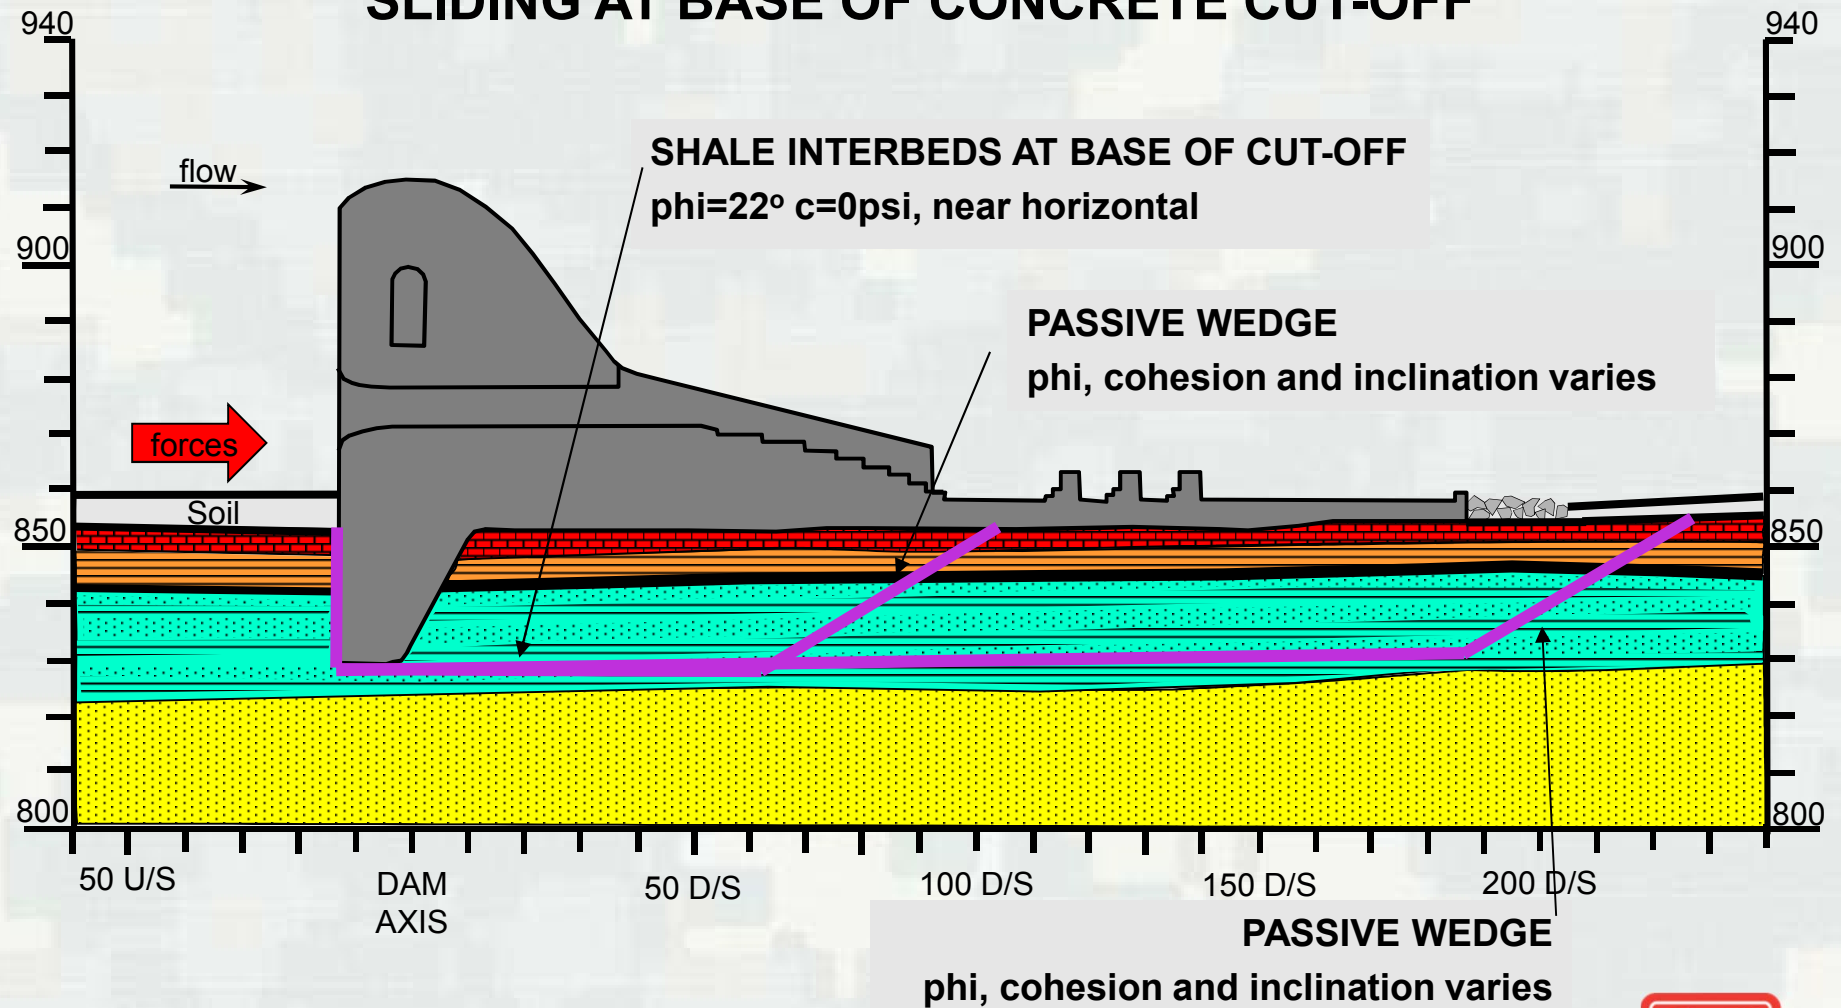
TYPICAL VALLEY MONOLITH SLIDING AT BASE OF CONCRETE CUT-OFF

POTENTIAL SLIDING FAILURE PLANES

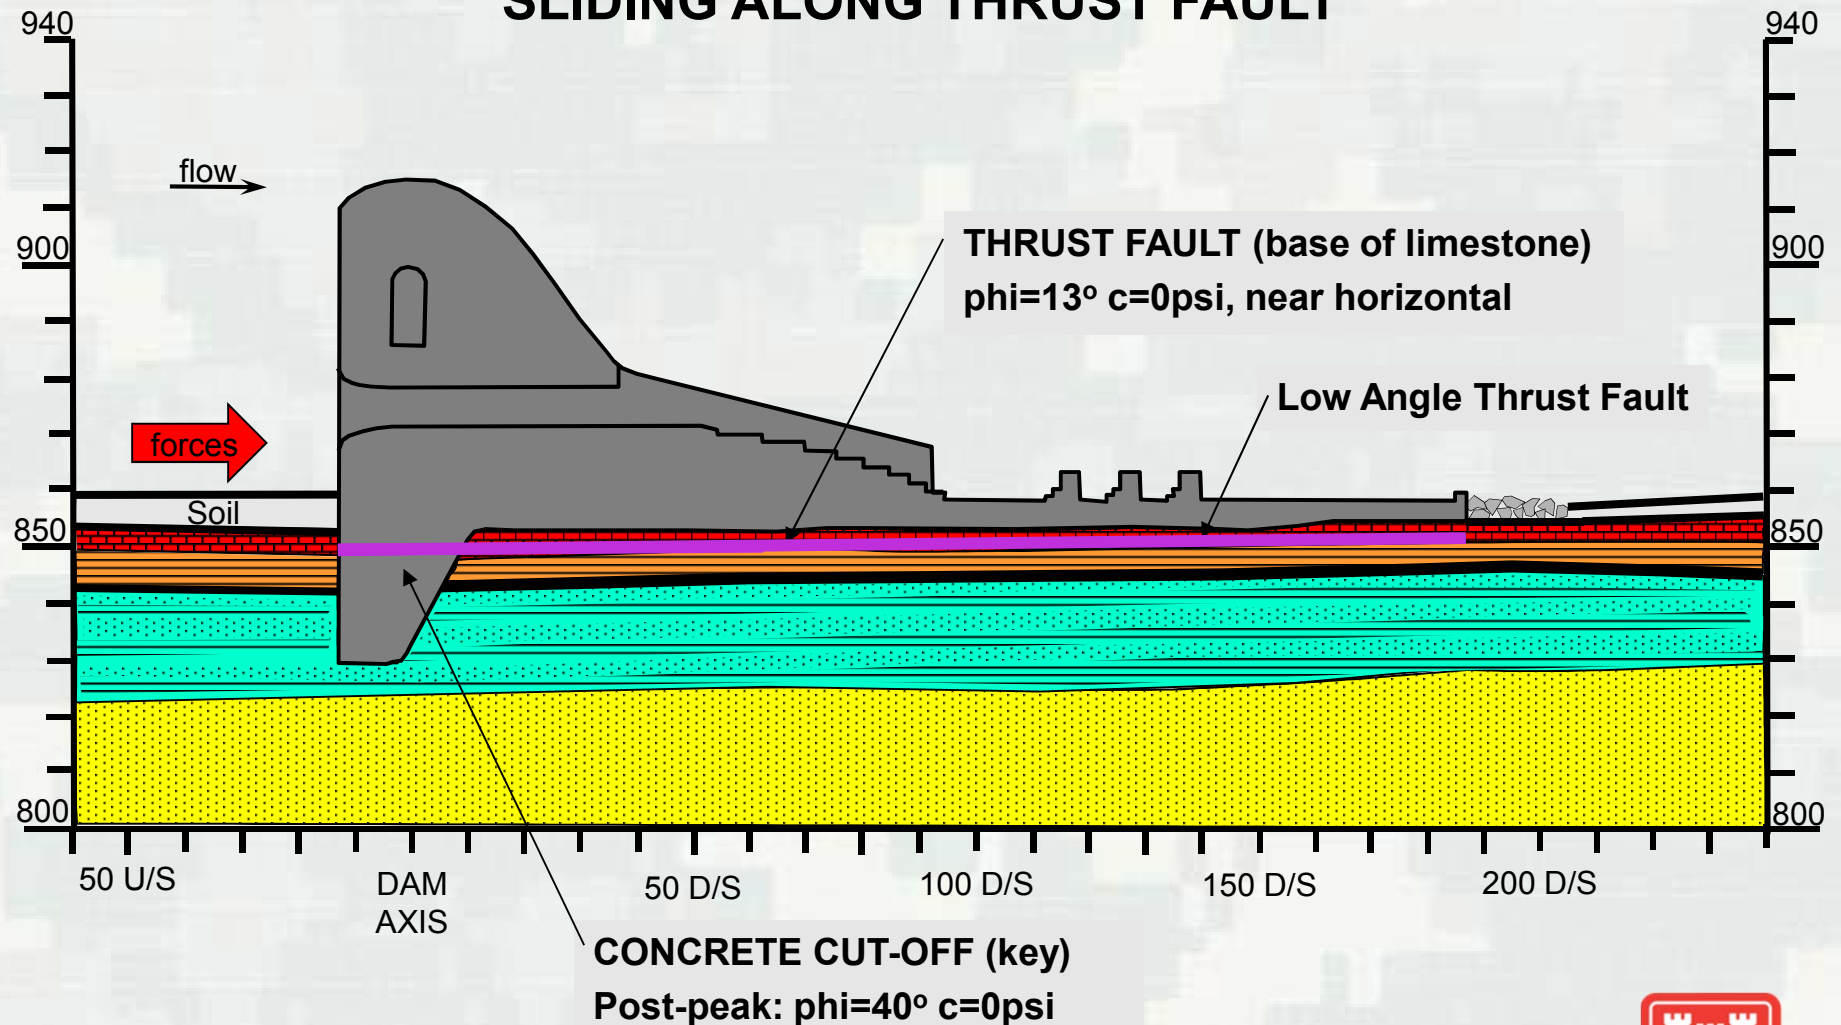
VALLEY MONOLITHS 12 & 13 SLIDING ALONG THRUST FAULT

POTENTIAL SLIDING FAILURE PLANES

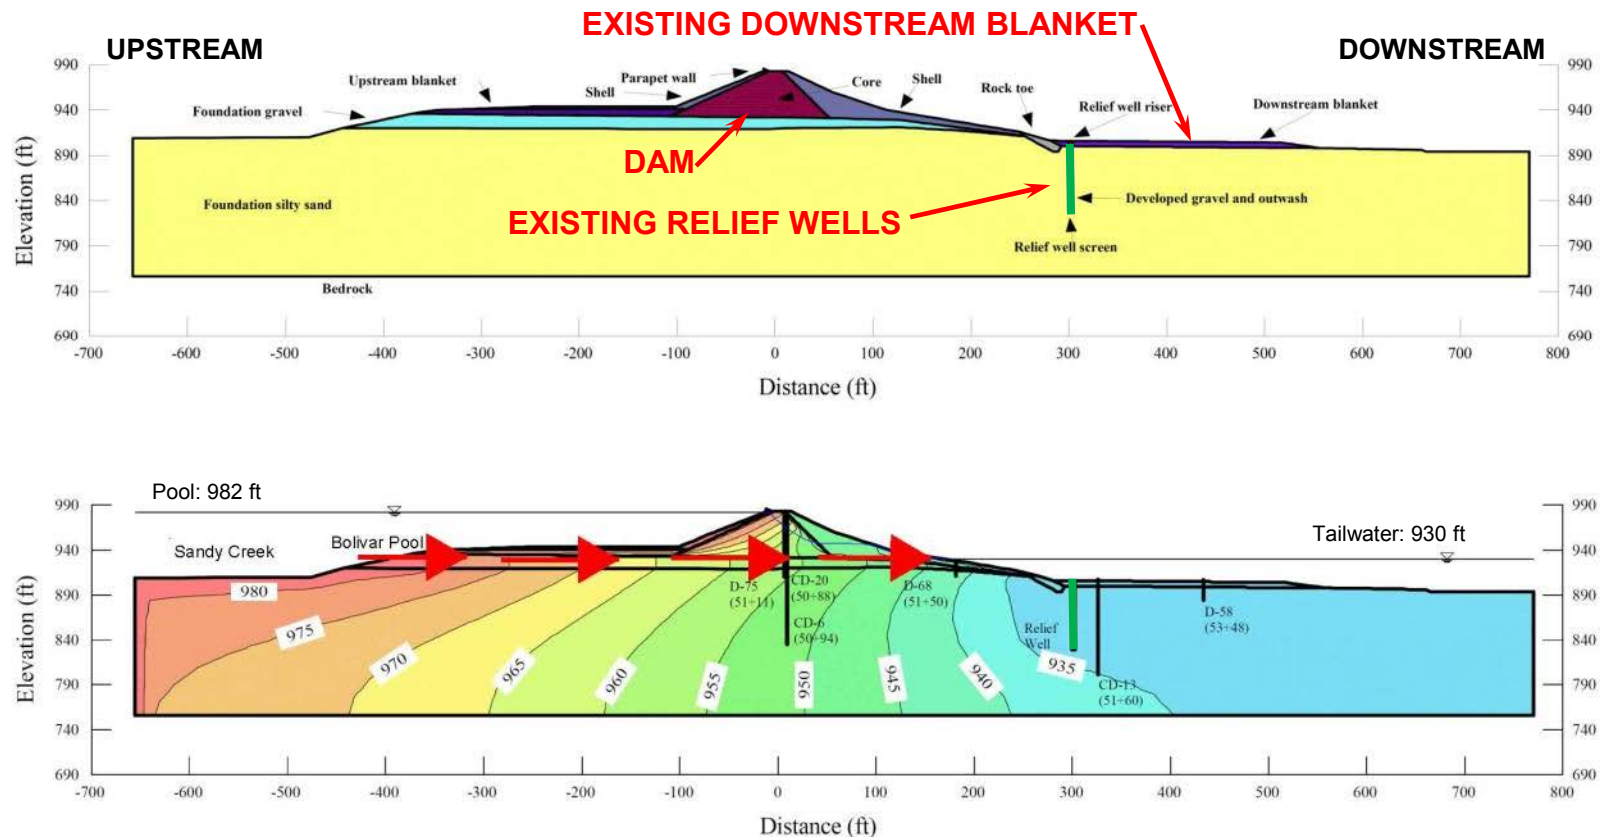
Pre Seepage Remediation

Pre Seepage Remediation: There is a direct path of seepage from Sandy Creek into the pervious foundation of the dam. The 1980's relief wells and blanket are somewhat effective in reducing head, extending the seepage path, and providing resistance to uplift but are not effective at all pool and tailwater conditions and locations below the dam.

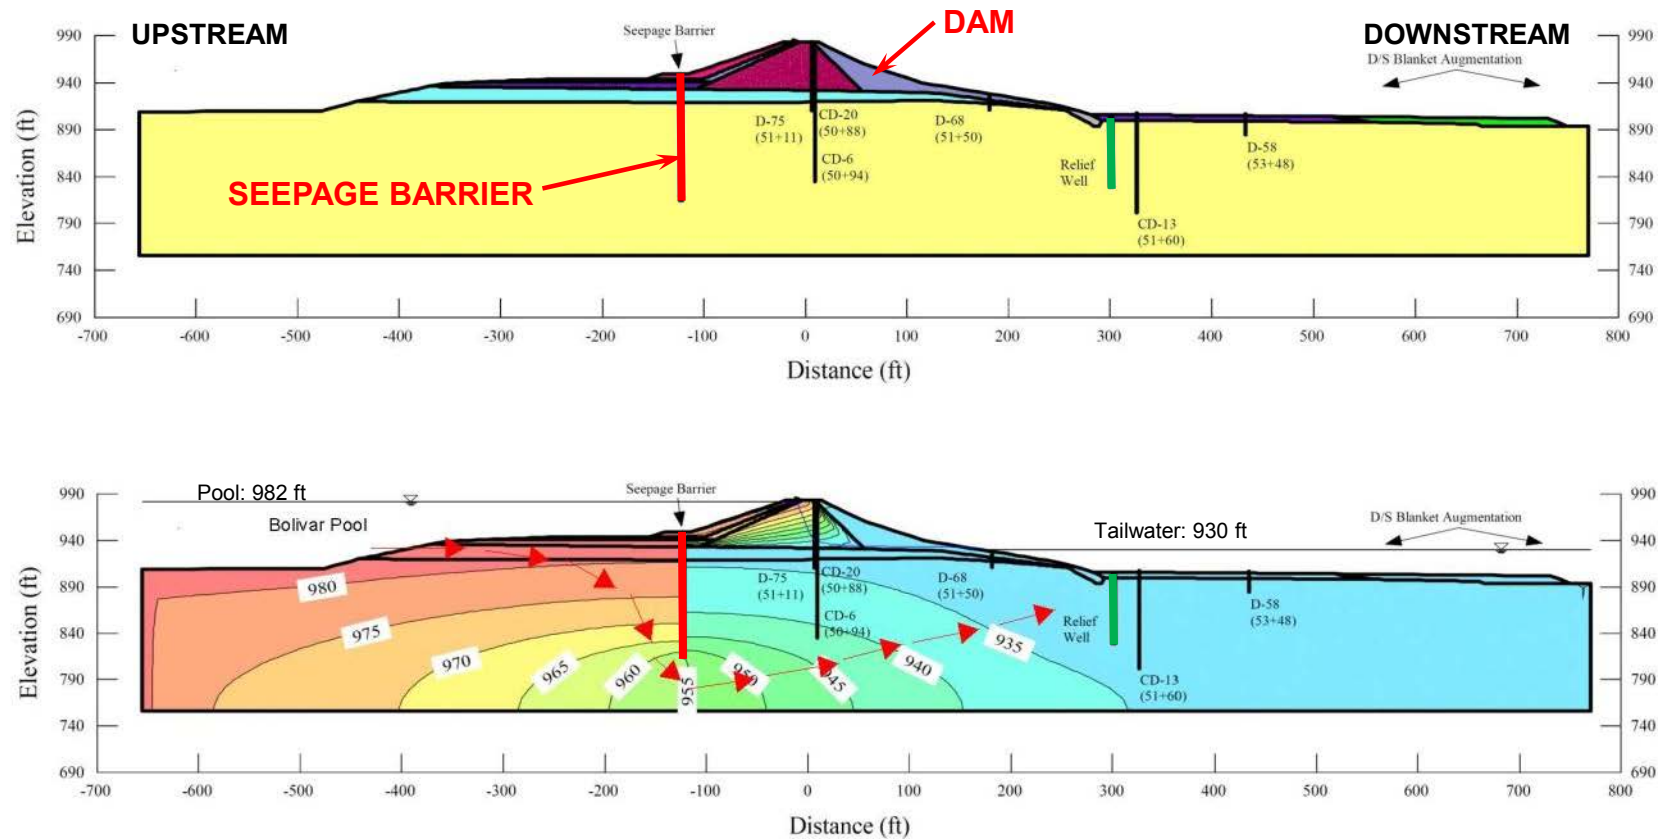
Post Seepage Remediation

Post Seepage Remediation: Seepage exit gradients are greatly reduced downstream of the dam and the potential piping pathway is cut off reducing the risk of failure of the project to an acceptable level.

(seepage barrier & filter blanket augmentation complete)

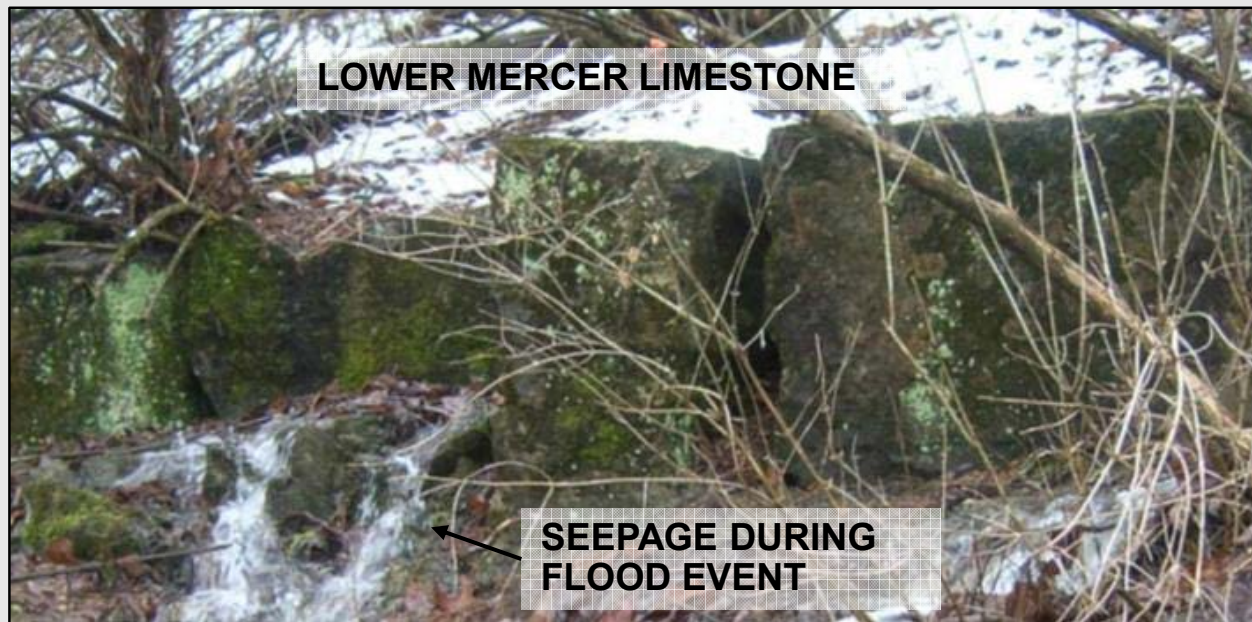
OPEN FRACTURES AT SURFACE

- Limestone Units: thin (3' to 5' thick), regionally continuous, very hard, high UCS (as high as 32,000 psi).
- Joints: high angle, solutioned, approx. 5' spacing, joint set at 90°, interconnected, avenues for groundwater flow.
- Bedding planes: low angle, open, solutioned and continuous.
- Exposed in stilling basin and spillway.

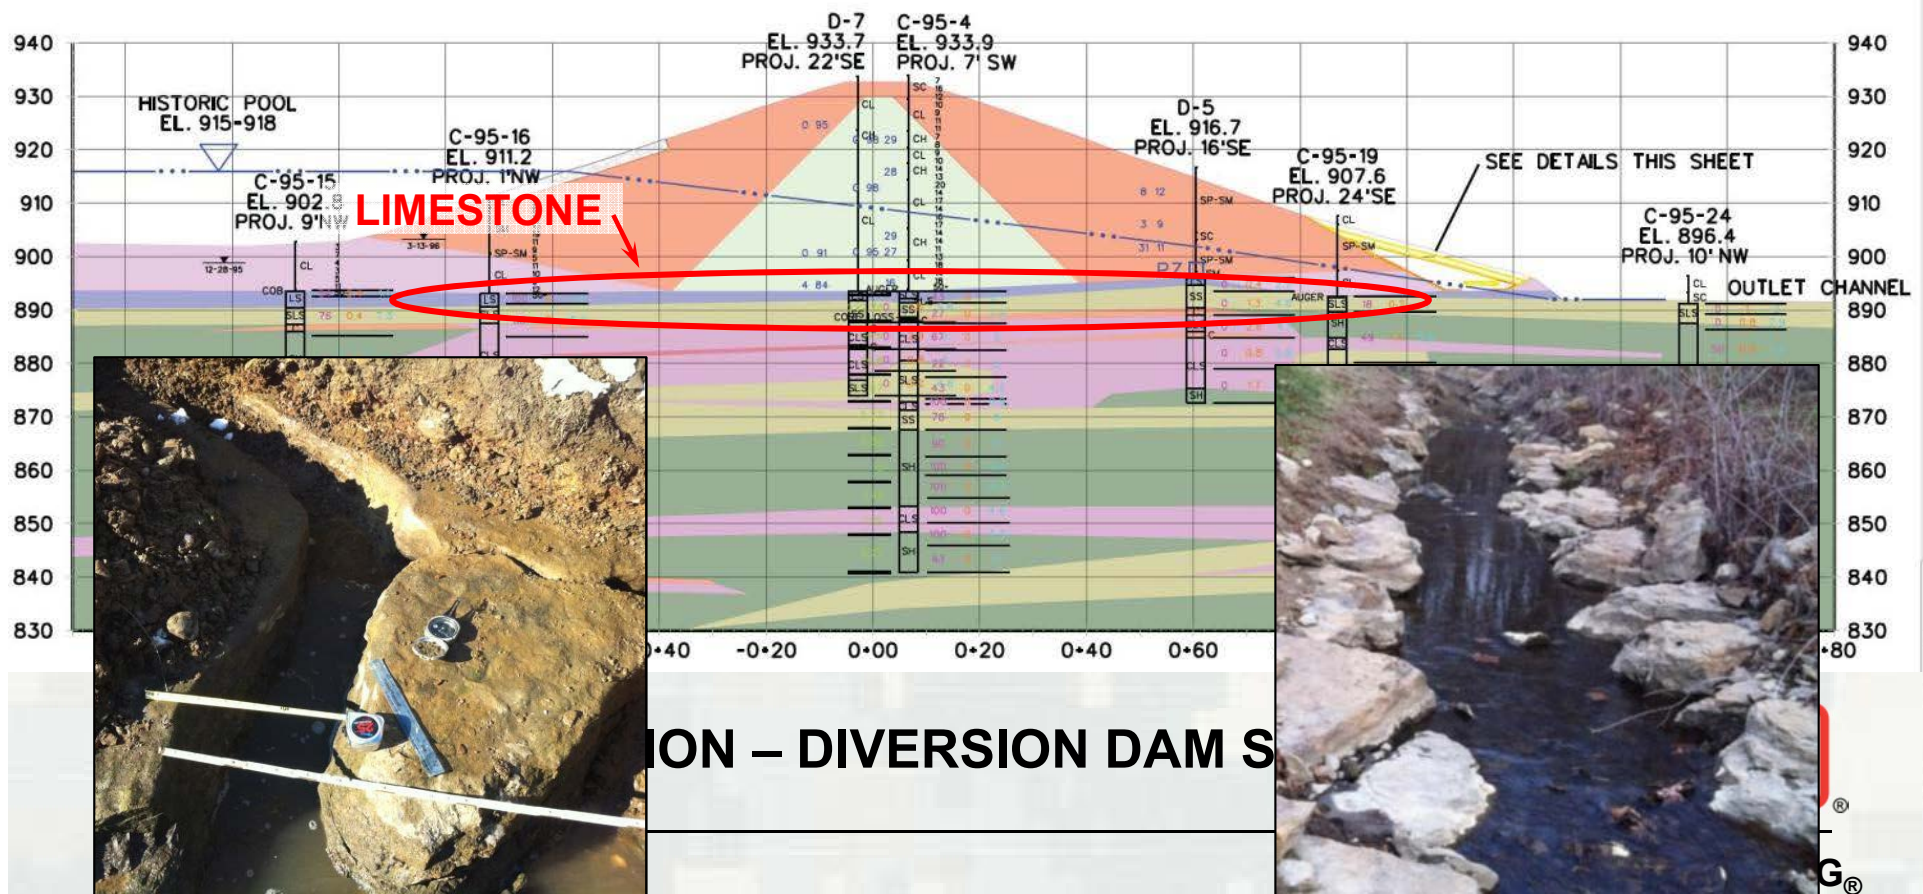
ZOAR DIVERSION DAM – GEOLOGIC PROFILE

LOWER MERCER LIMESTONE

- Thin, typically 3 to 4 foot thick
- Solutioned high angled joints and low angled bedding planes create avenues for groundwater seepage
- Limestone is missing in portions of dam footprint
