# Successful Foundation Preparations in Karst Bedrock of the Masonry Section of Wolf Creek Dam

**David M. Robison, P.G.**

Geotechnical and Dam Safety Section,  
Louisville District, U.S. Army Corps of Engineers

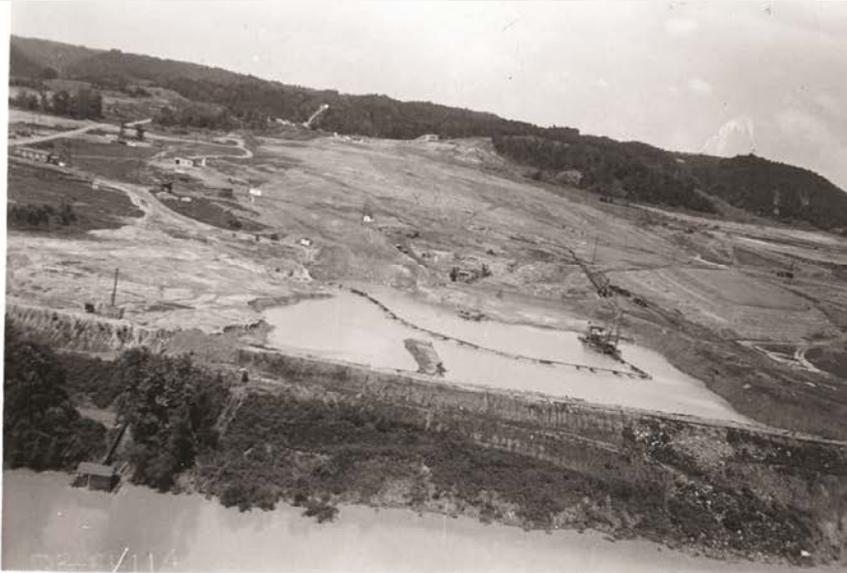
Mon. No. 20 Removal of Overburden by Dredge  
Photo No. 114

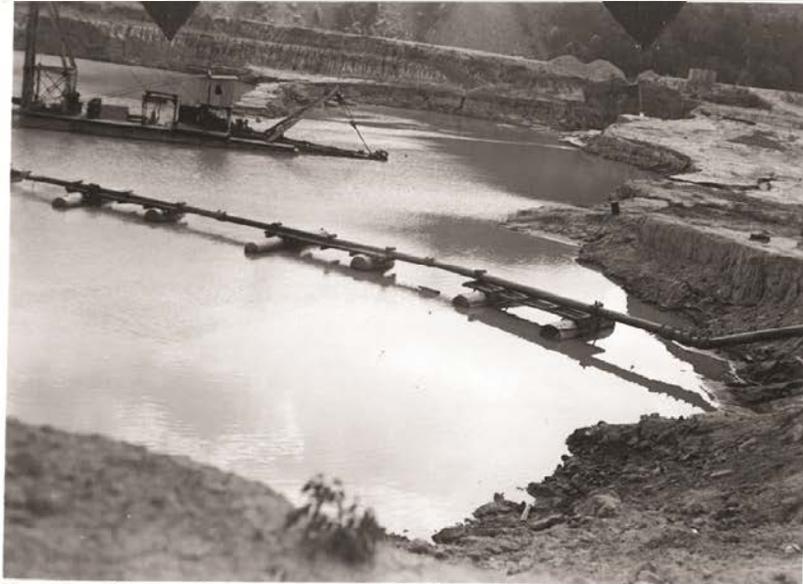
Mon. No. 20 Removal of Overburden by Dredge  
Photo No. 137

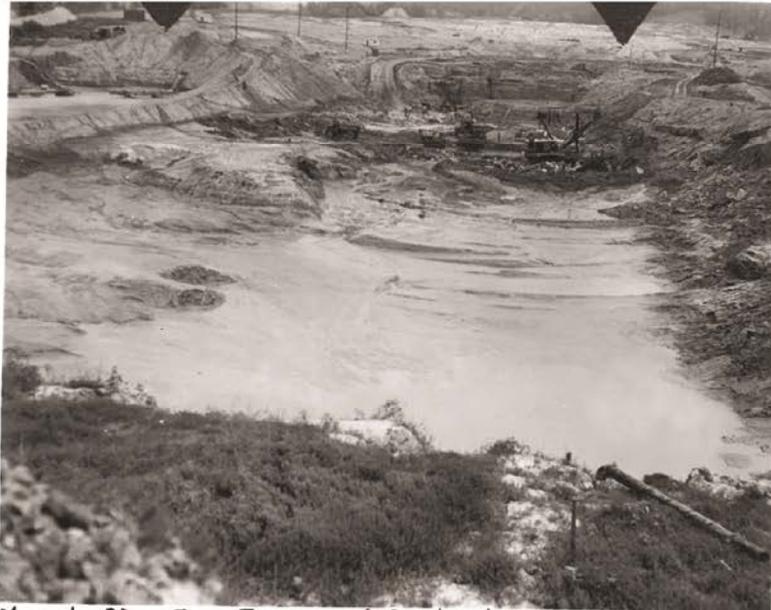
Mon. No. 20 Final Removal of Overburden by Shovel  
Photo No. 159 after Dredging Operation

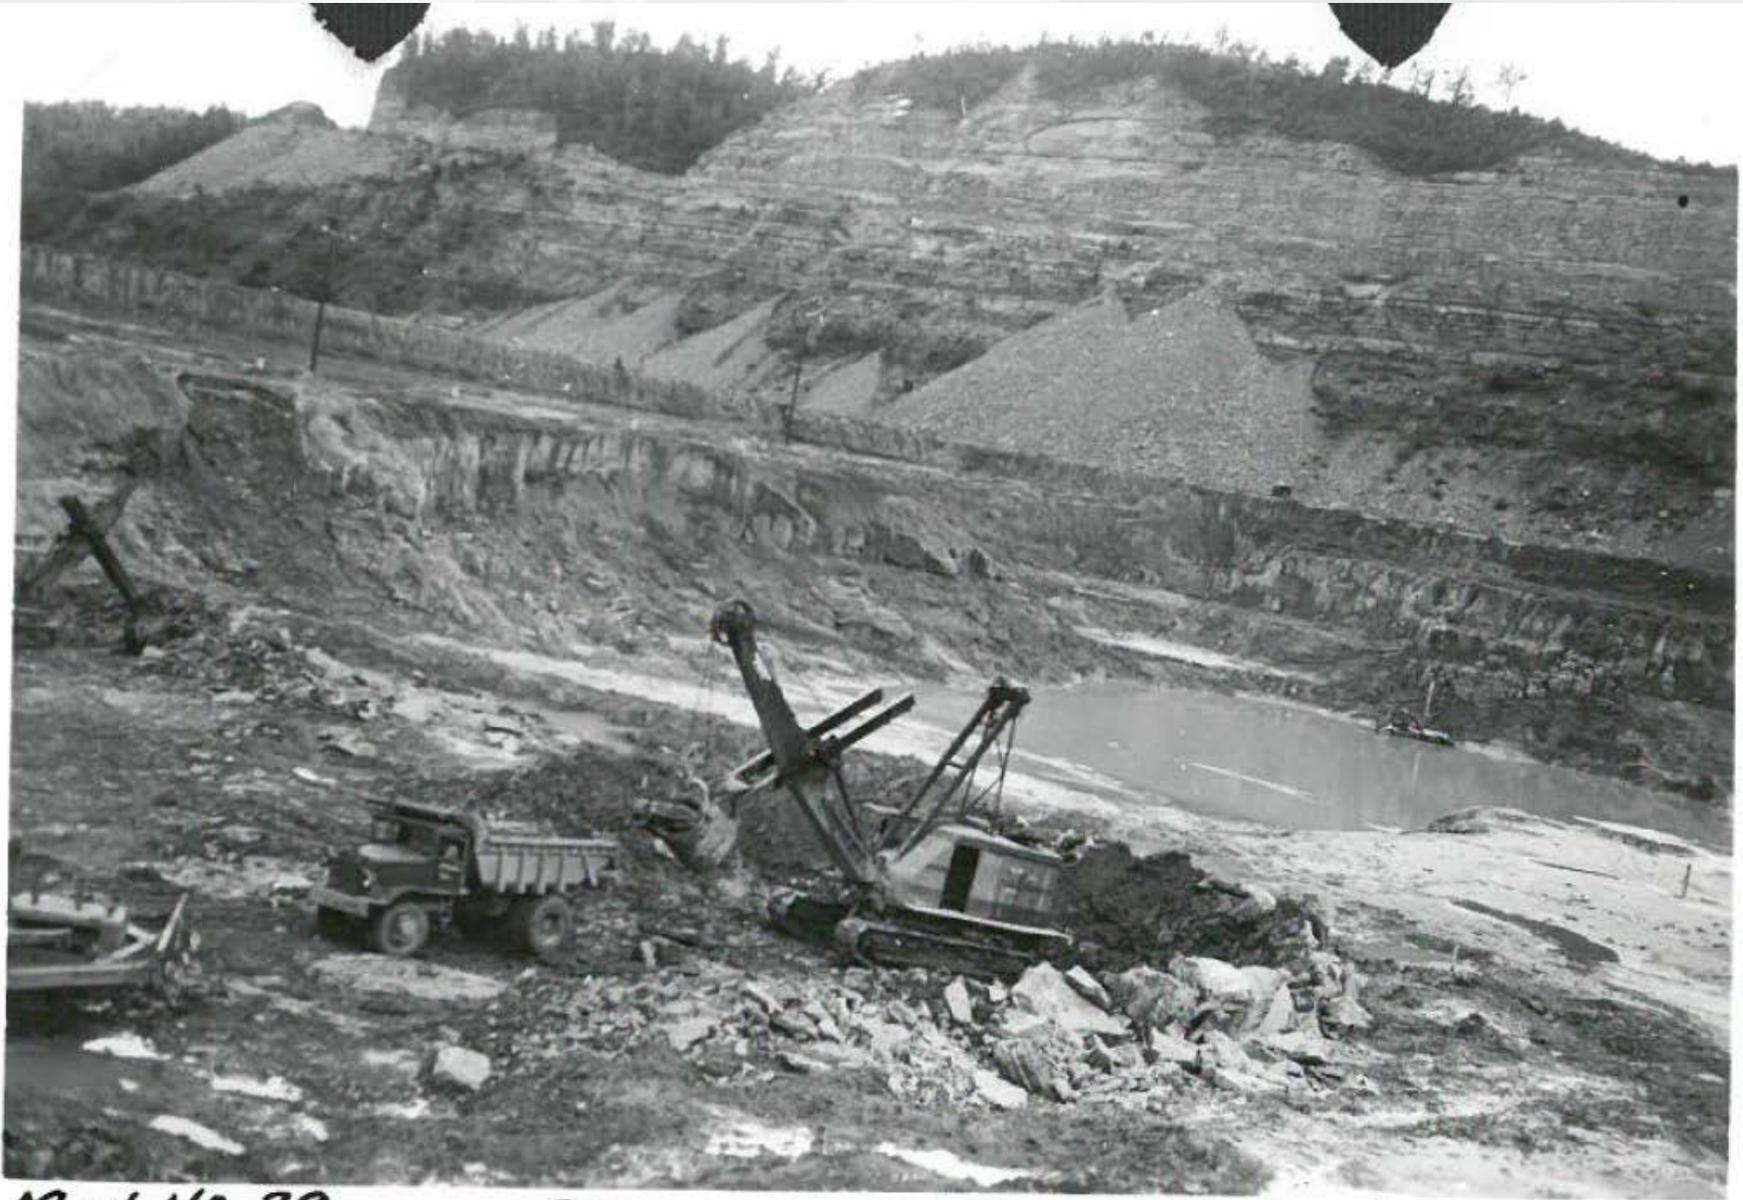
MON. No 29  
PHOTO No 153

REMOVAL OF OVERBURDEN  
BY SHOVEL

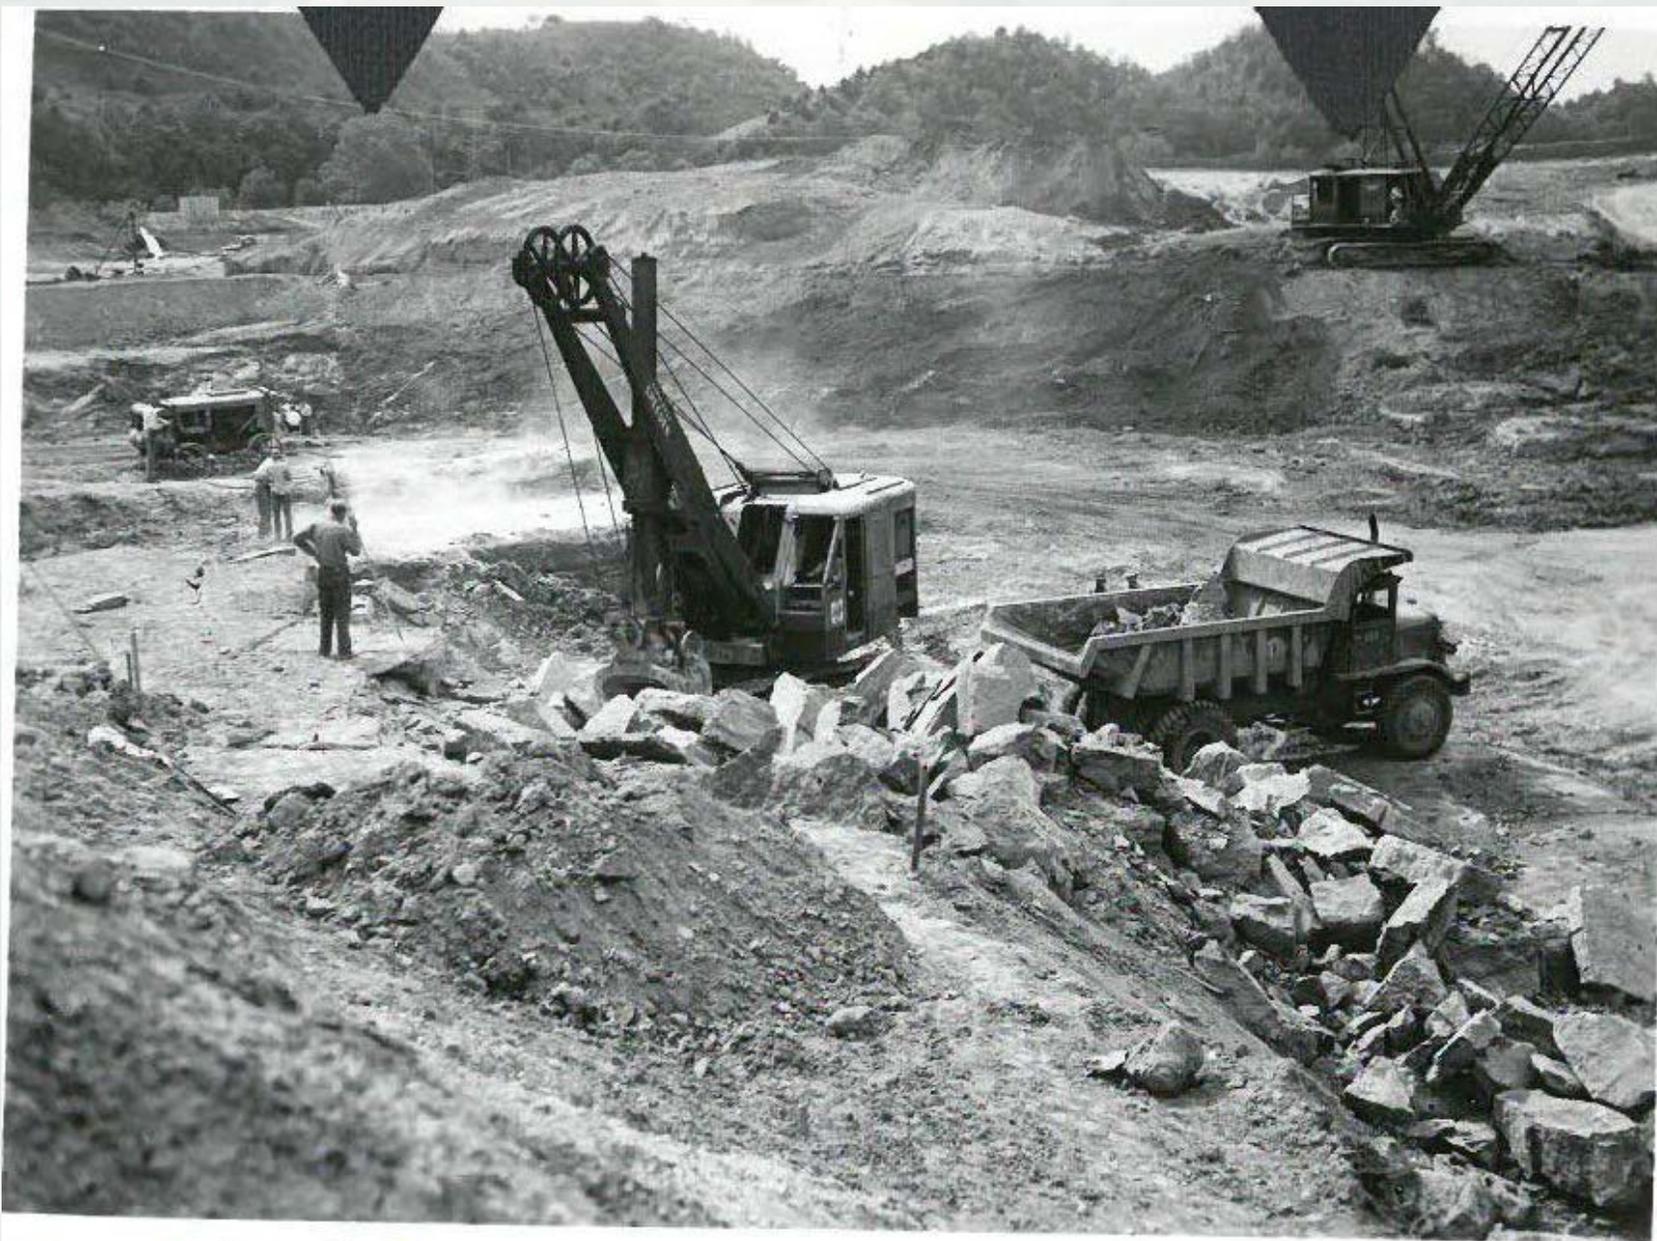
Monolith # 30      Rock Removal by Shovel      Elev. 662  
PHOTO N° 52

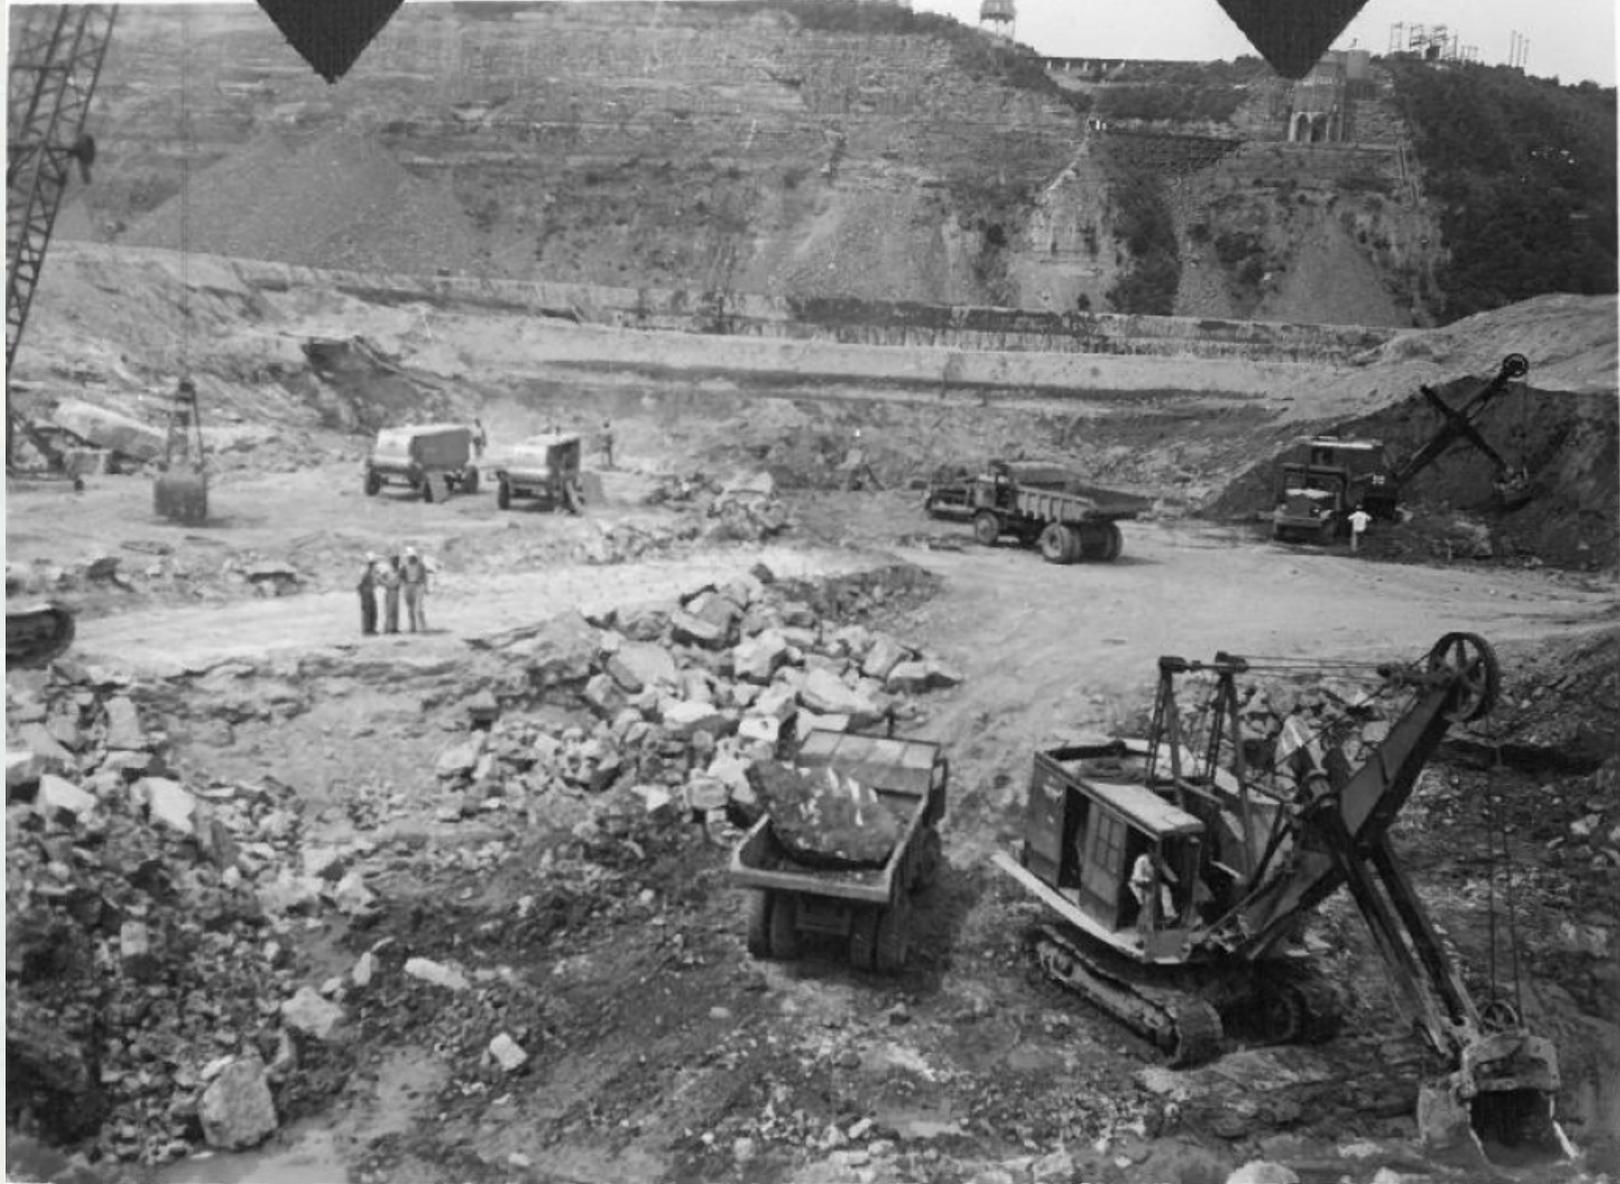
Photo No.89

Mon.No.32  
Cleaning Out Solution Channel

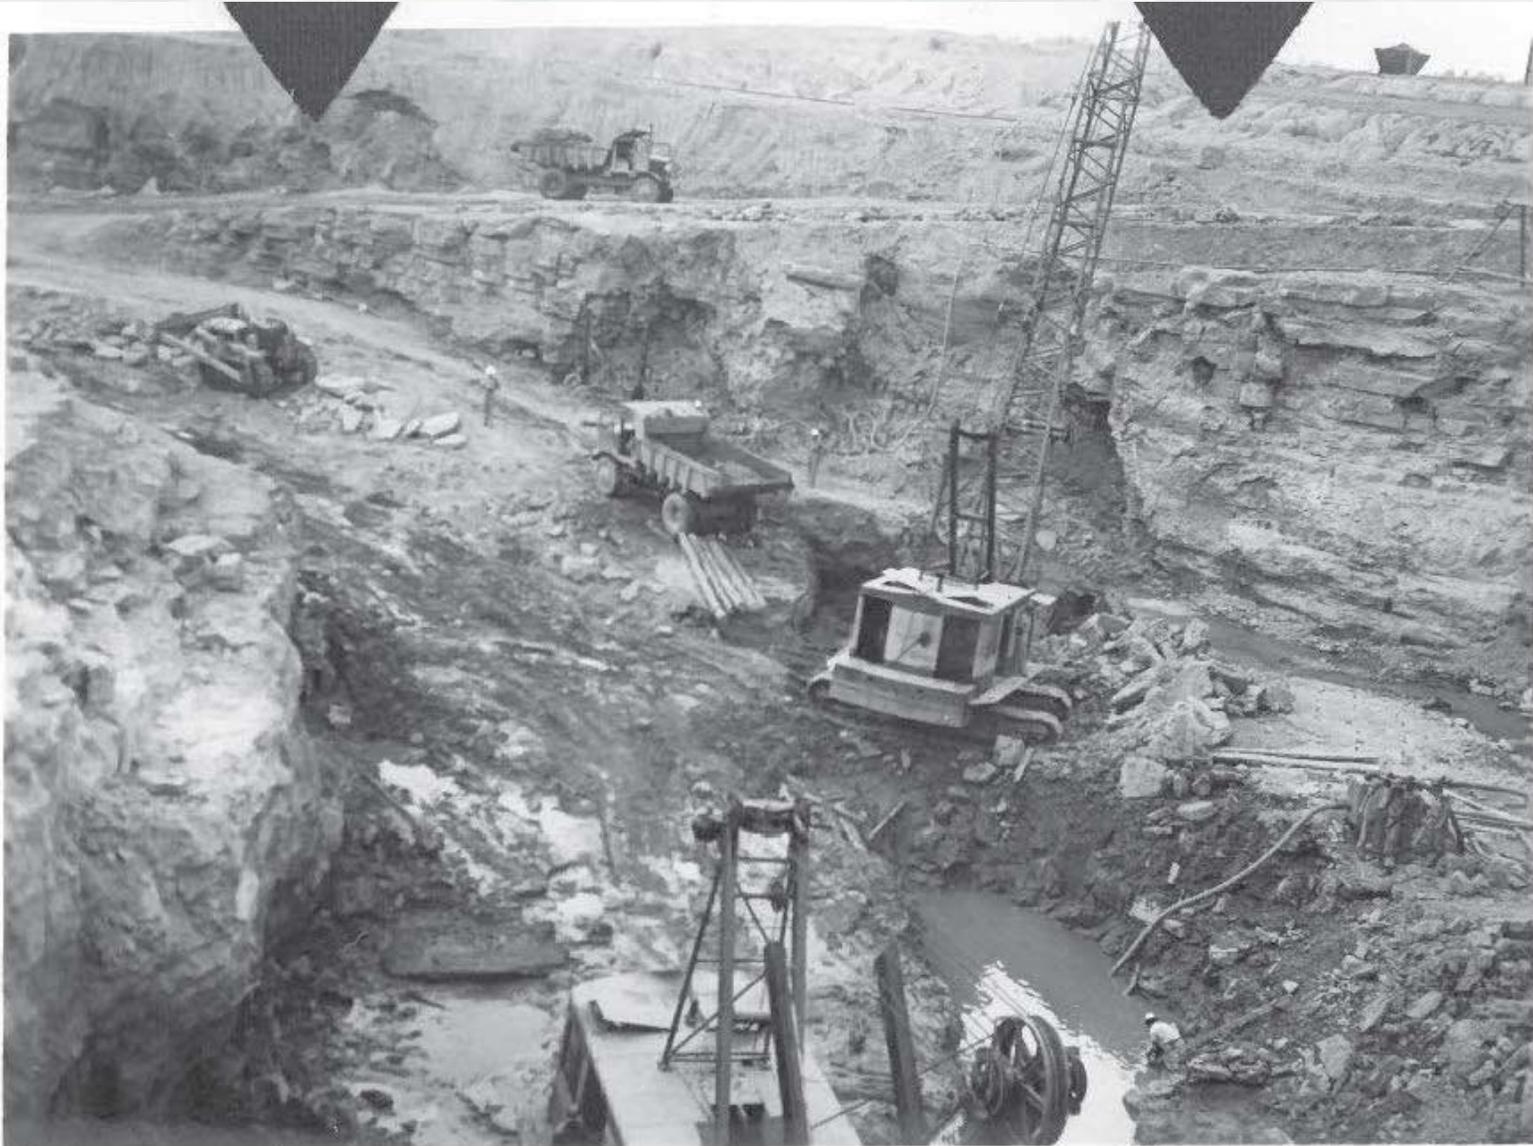
Photo No. 139

Widening & Exploring Solution Channel

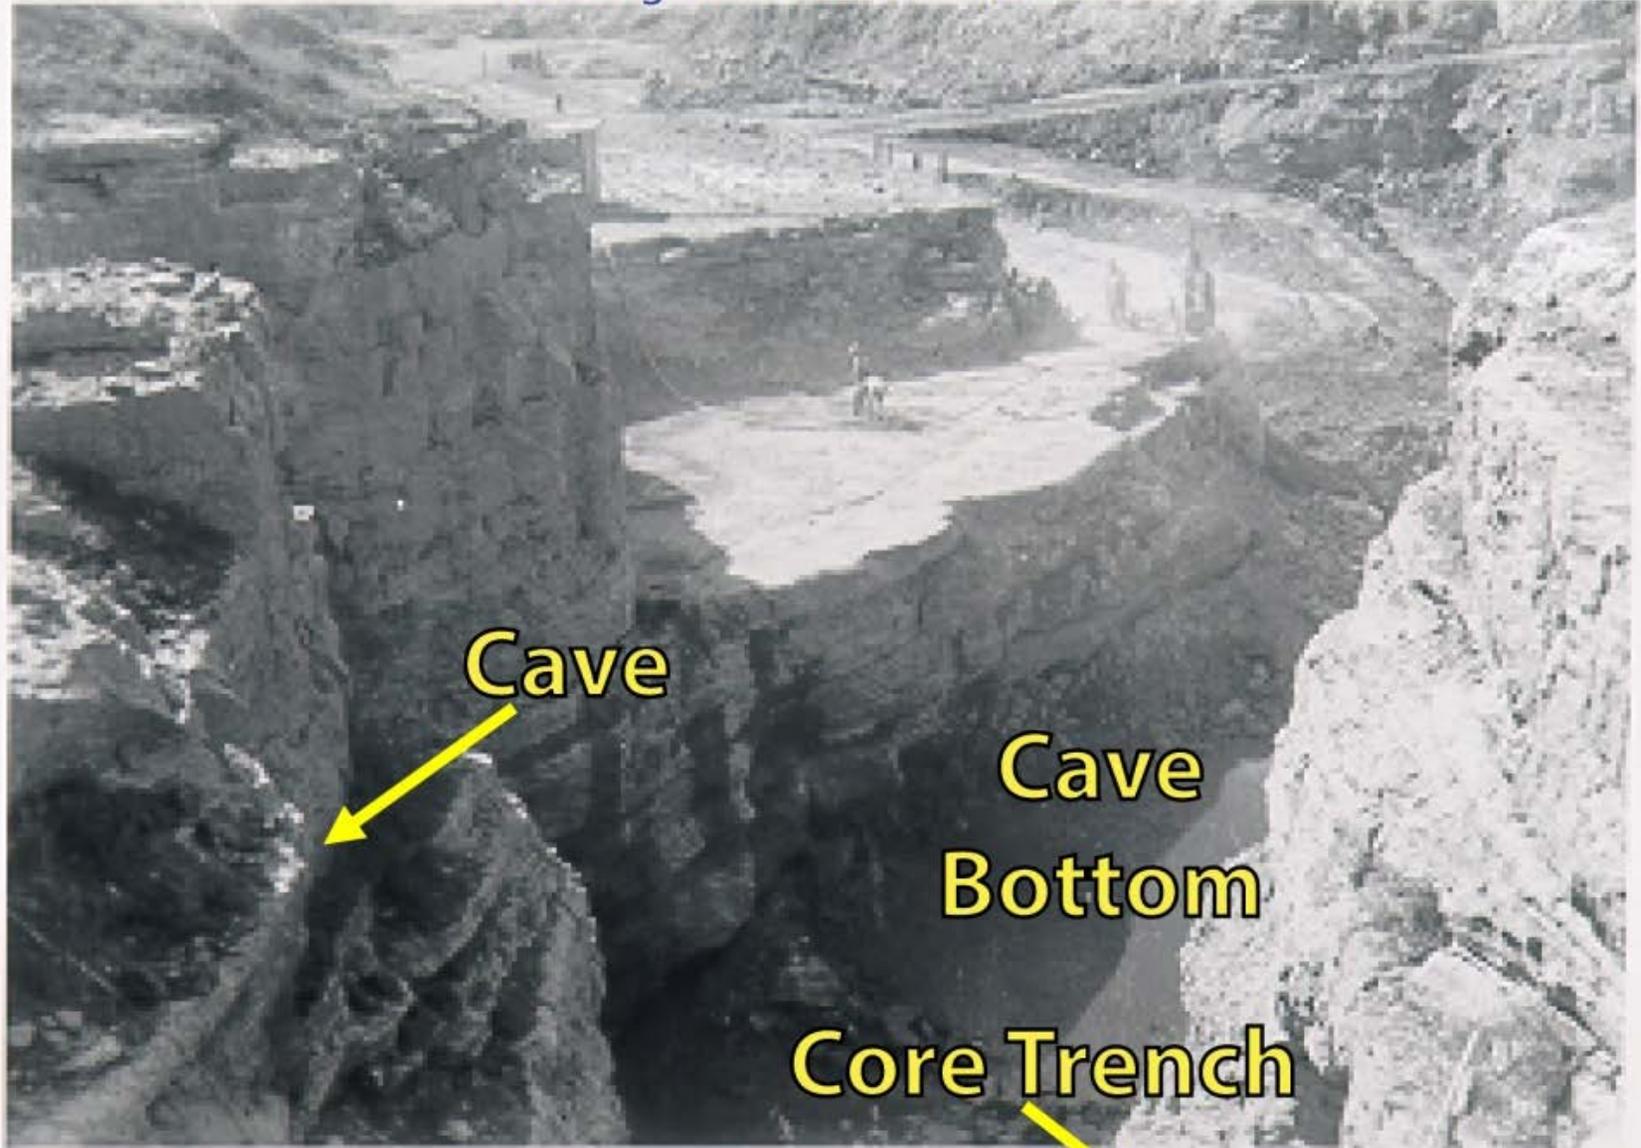
# Large Solution Channel Excavated

Looking Downstream Mon. 37

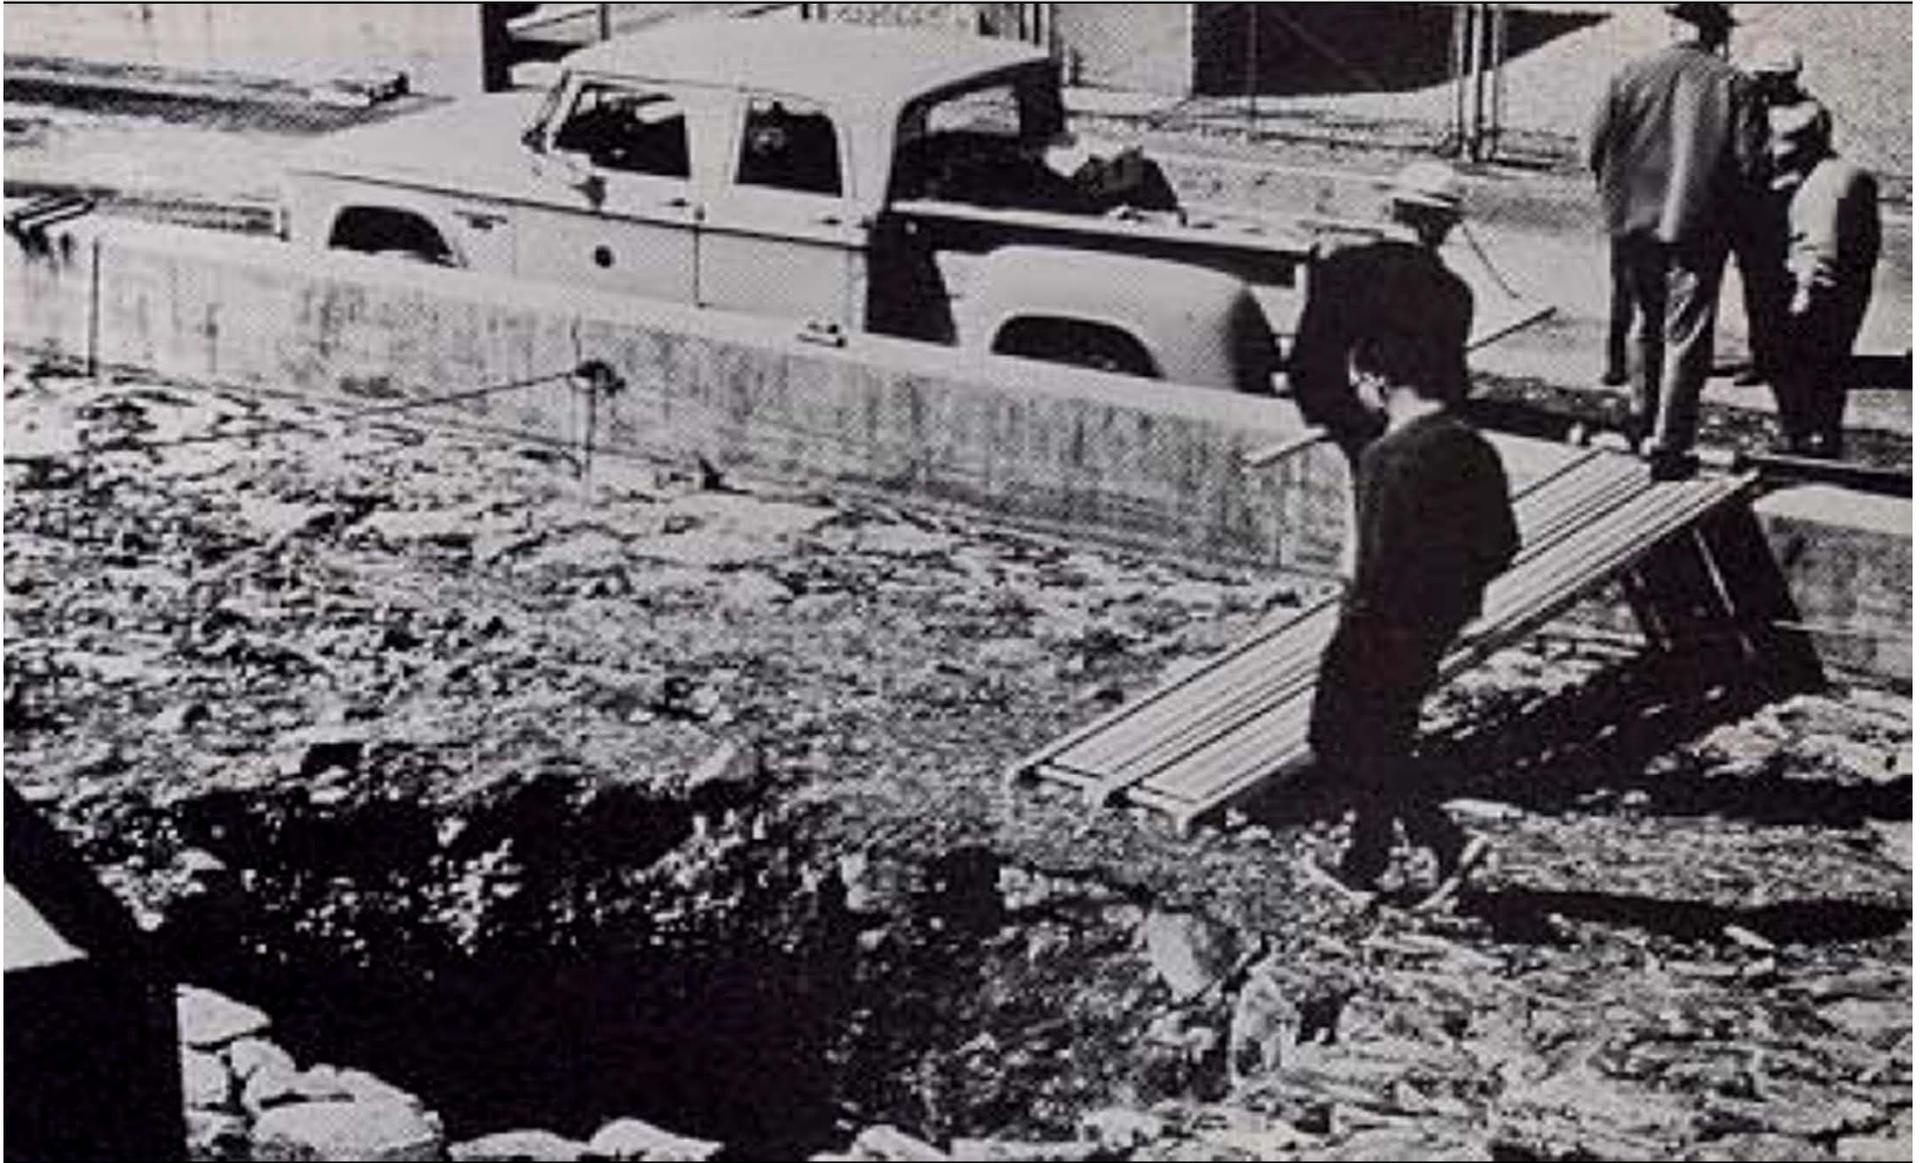
## Sinkhole Observed near Switchyard in 1968

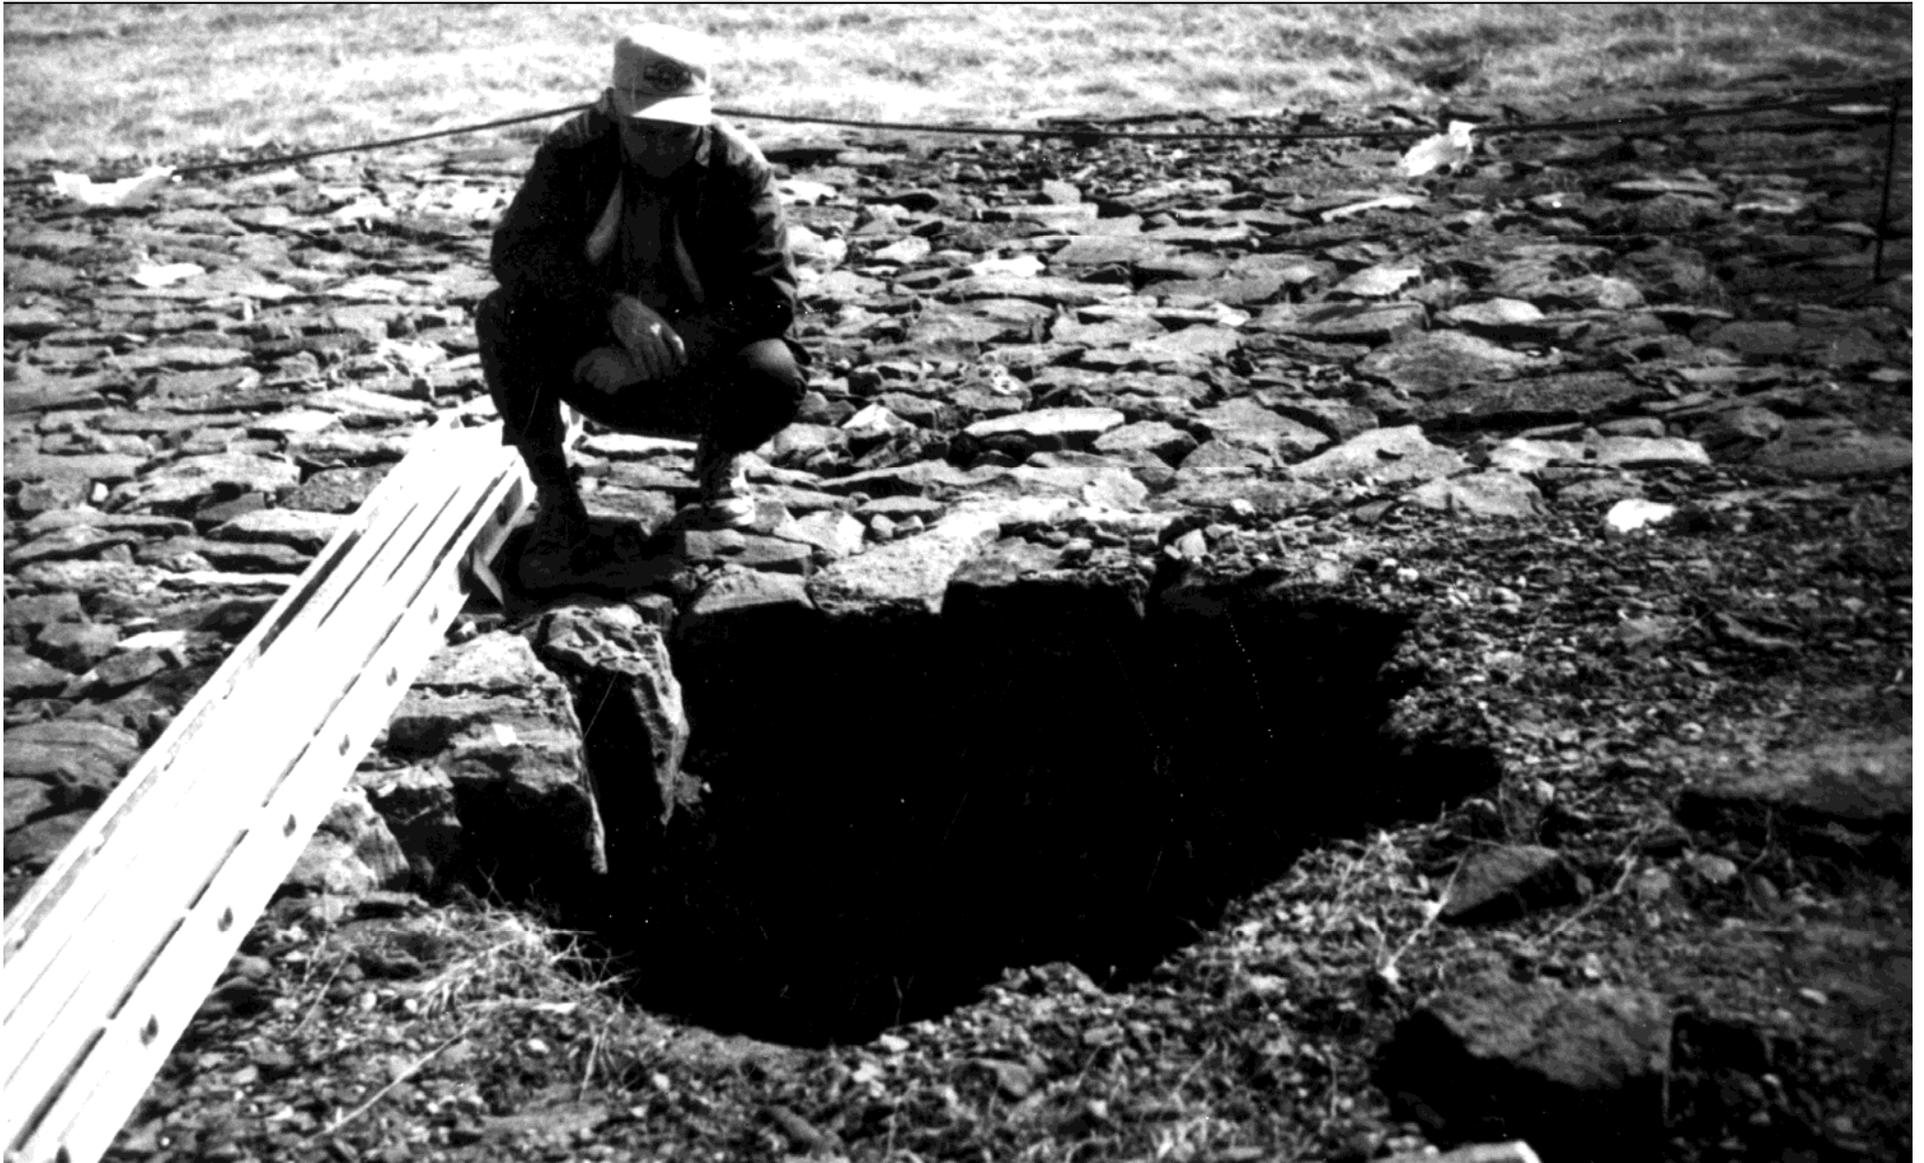
## Sinkhole Observed near Switchyard in 1968

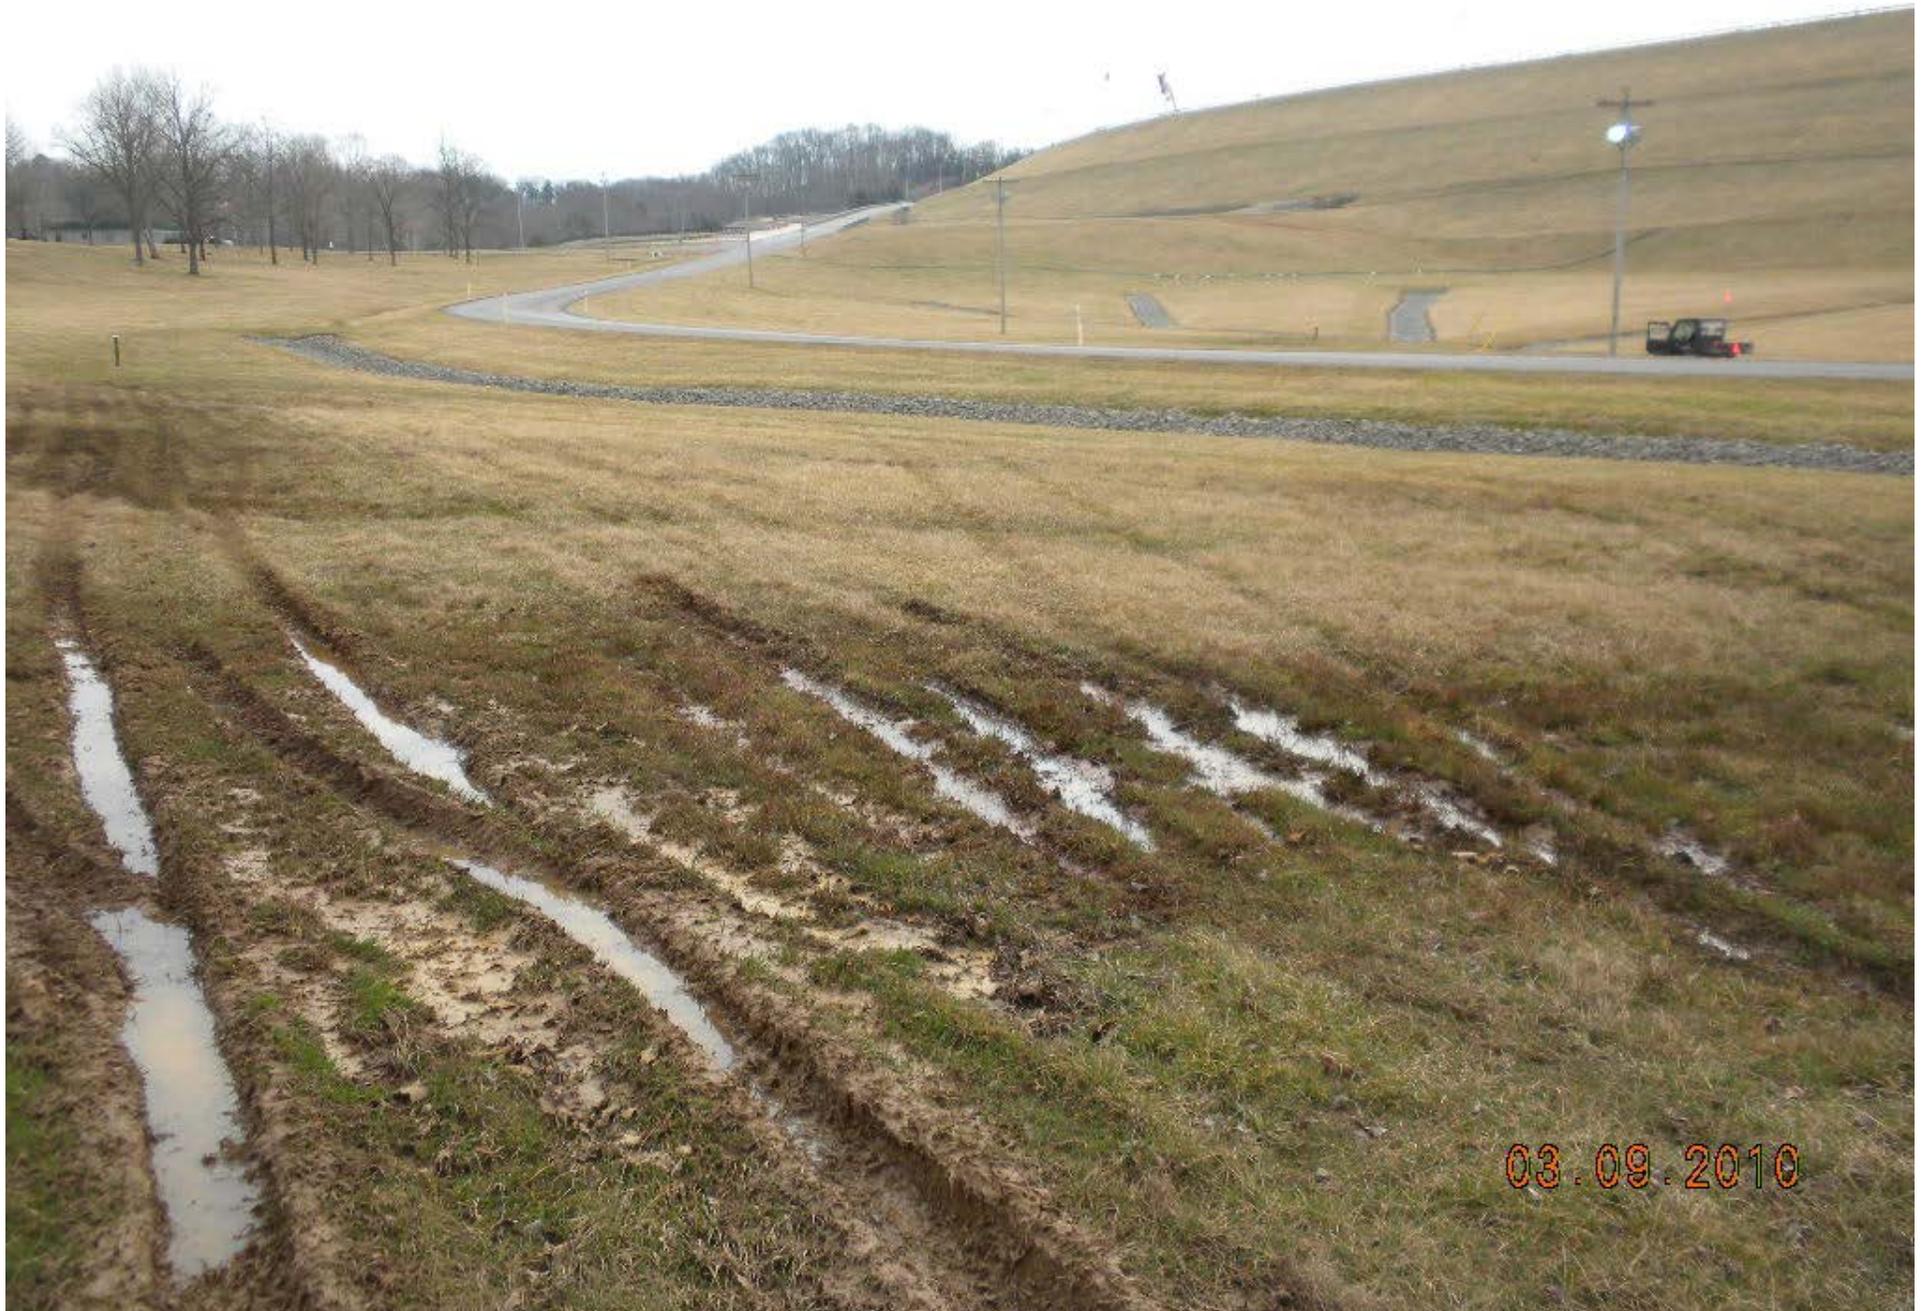
# Downstream Wet Areas

March 09, 2010

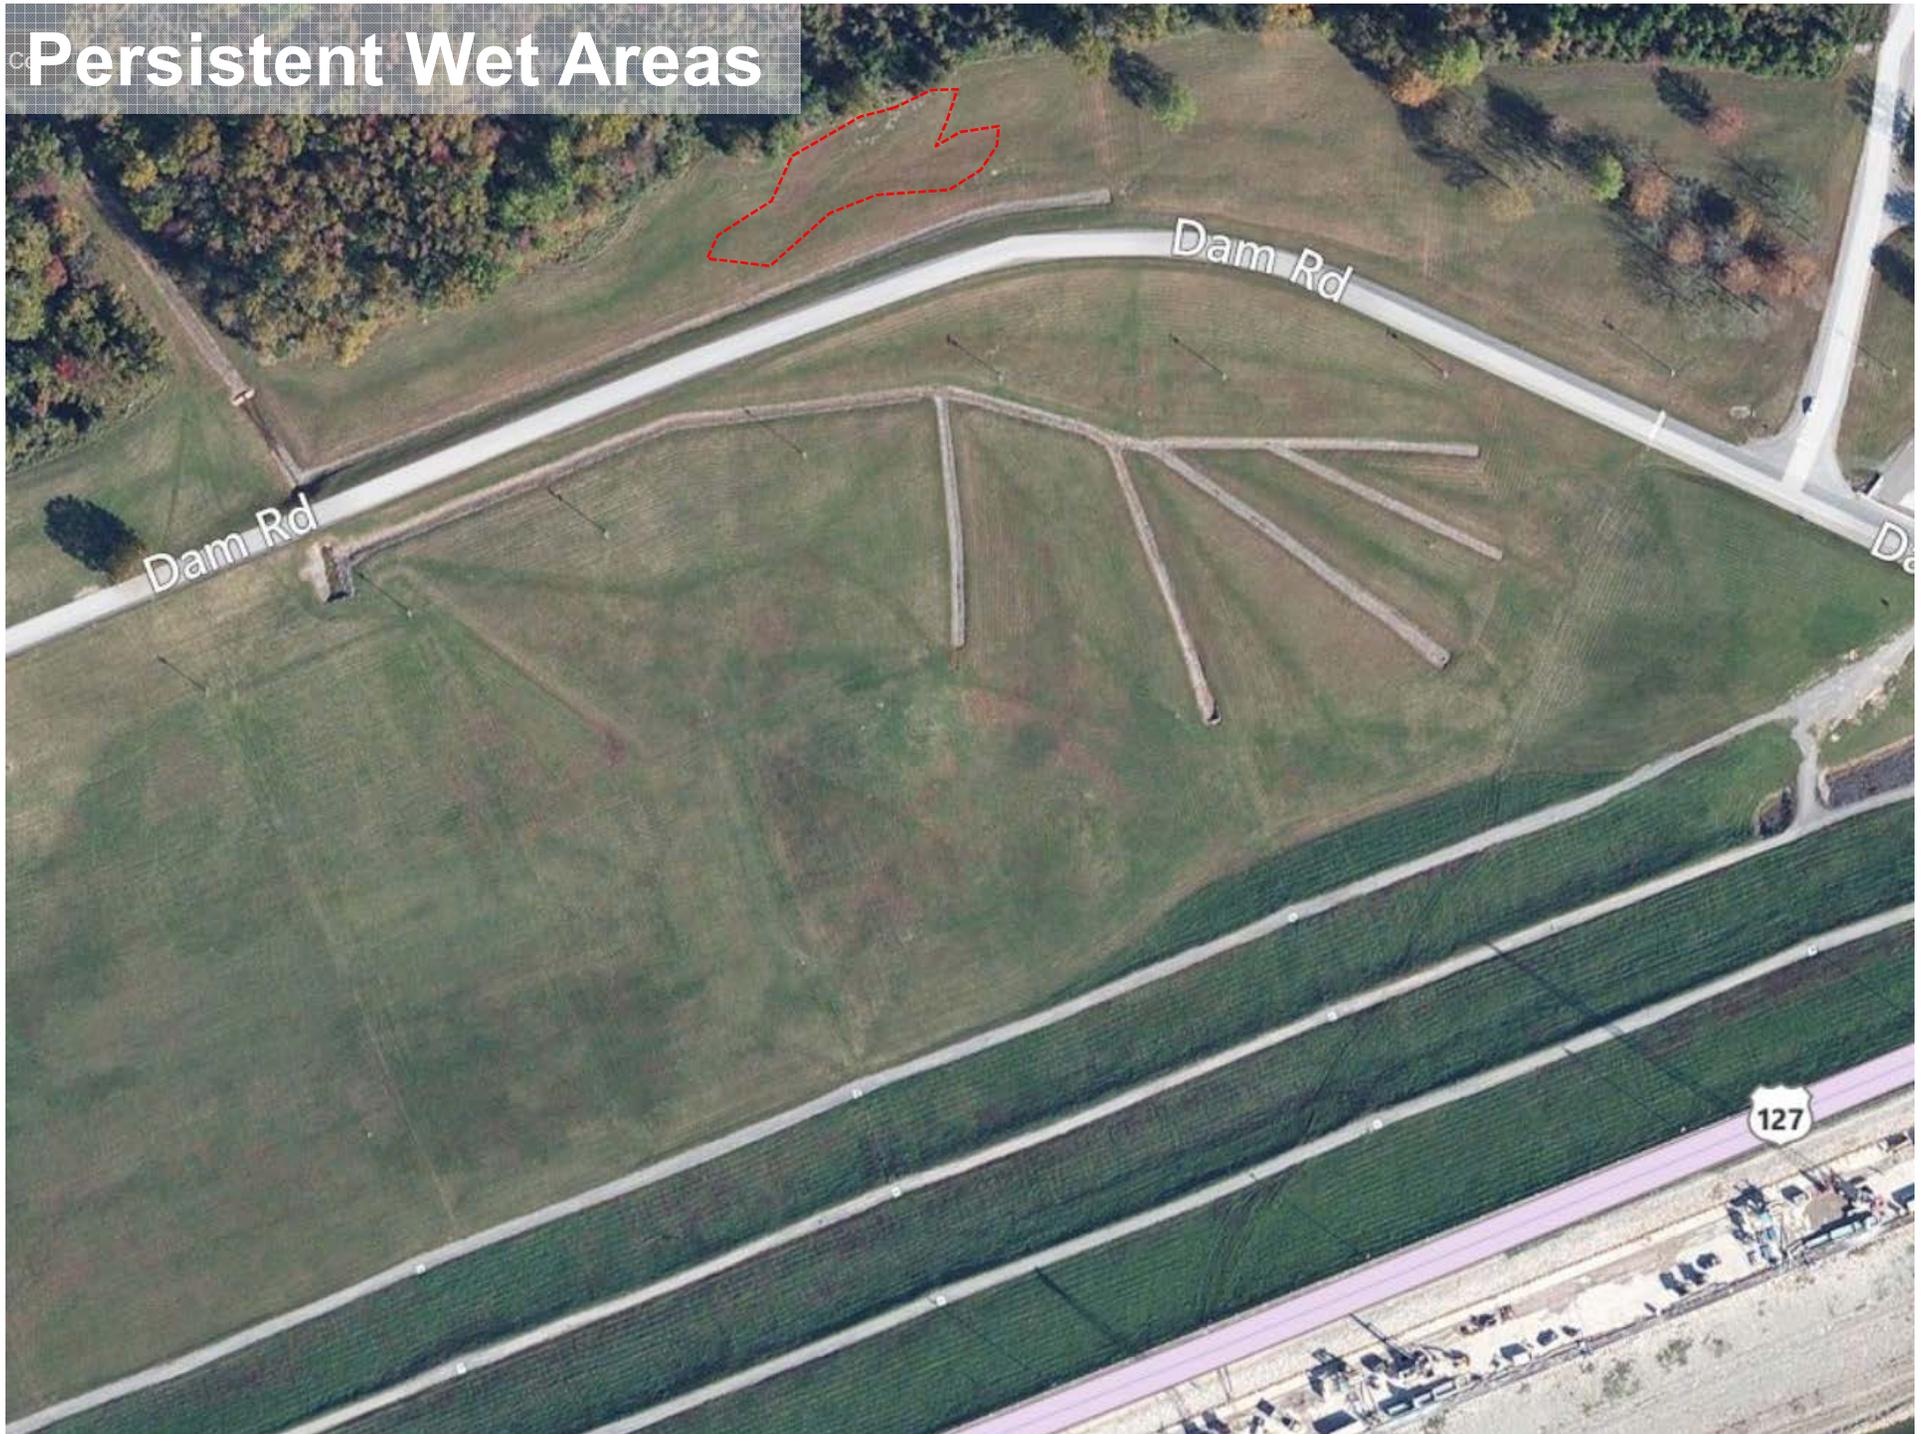
# Persistent Wet Areas
