# Investigations of the Pedro Miguel Fault during Borinquen Dam 1E Construction Panama Canal Expansion

David Schug, Paul Salter, Dan Meier,  
Robert Urban, Chris Goetz, AECOM

AEG September 22, 2016

## FAULT INVESTIGATIONS DURING BORINQUEN DAM 1E CONSTRUCTION PANAMA CANAL EXPANSION

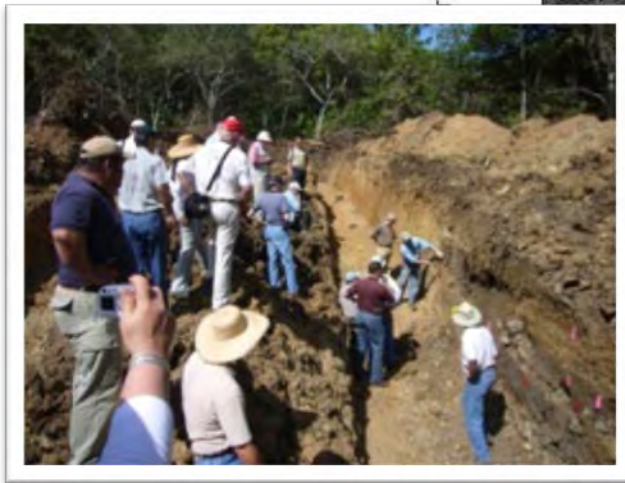
Two or three late Holocene events

Potential 3 m rupture should be considered for design

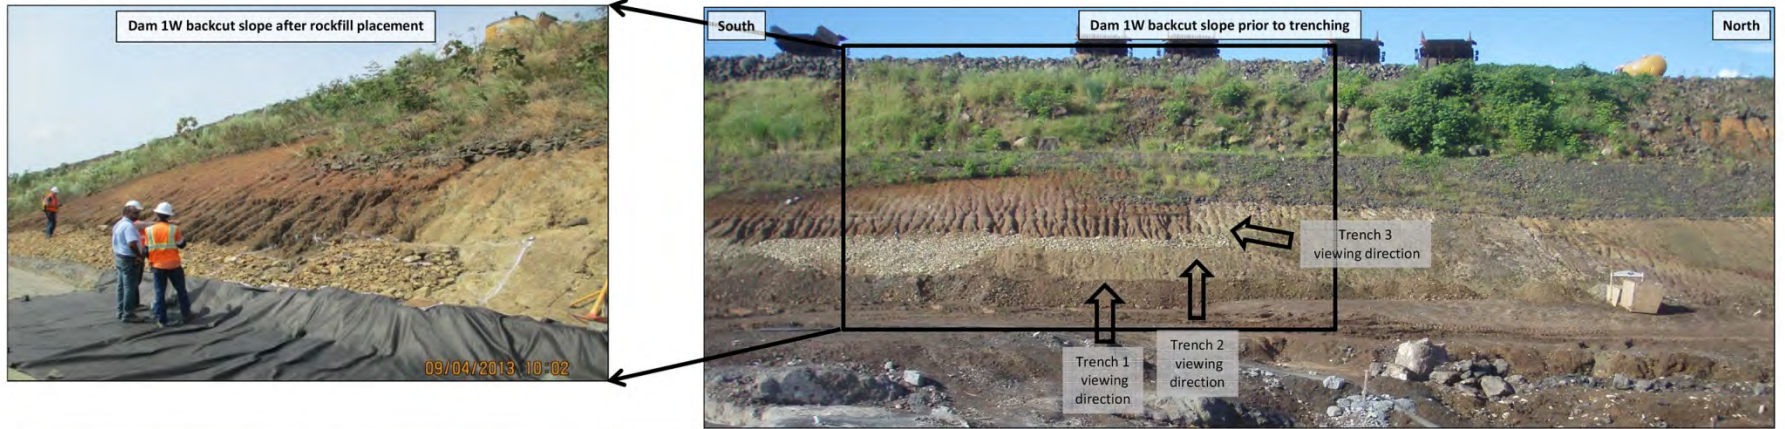
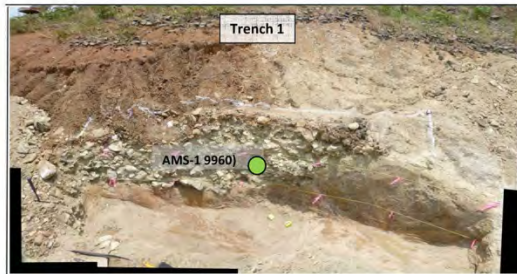
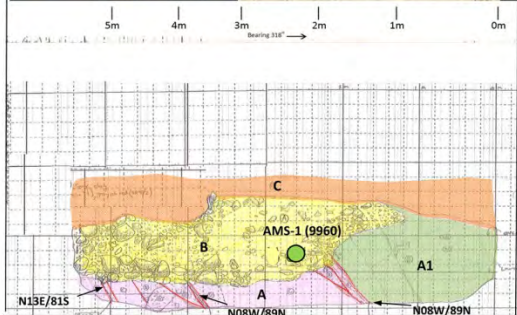
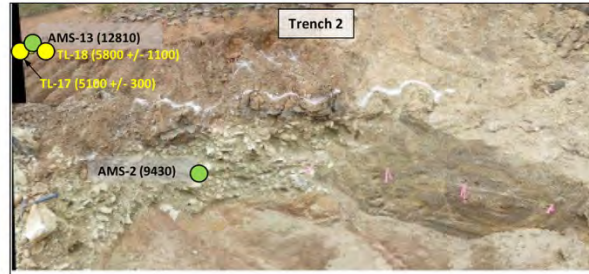
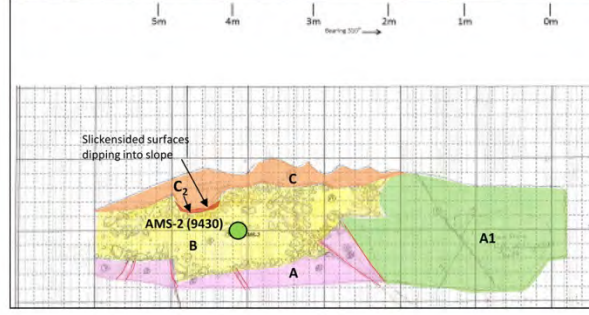
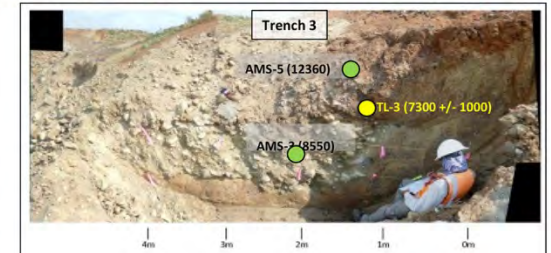
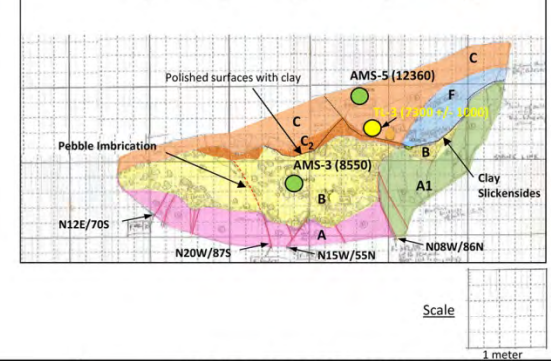
## Geologic Log of Trench Exposures Southeast Strand Fault at Dam 1W

**The “Southeast Strand” of the Pedro Miguel fault has produced minor displacement of early Holocene alluvium at Dam 1W**

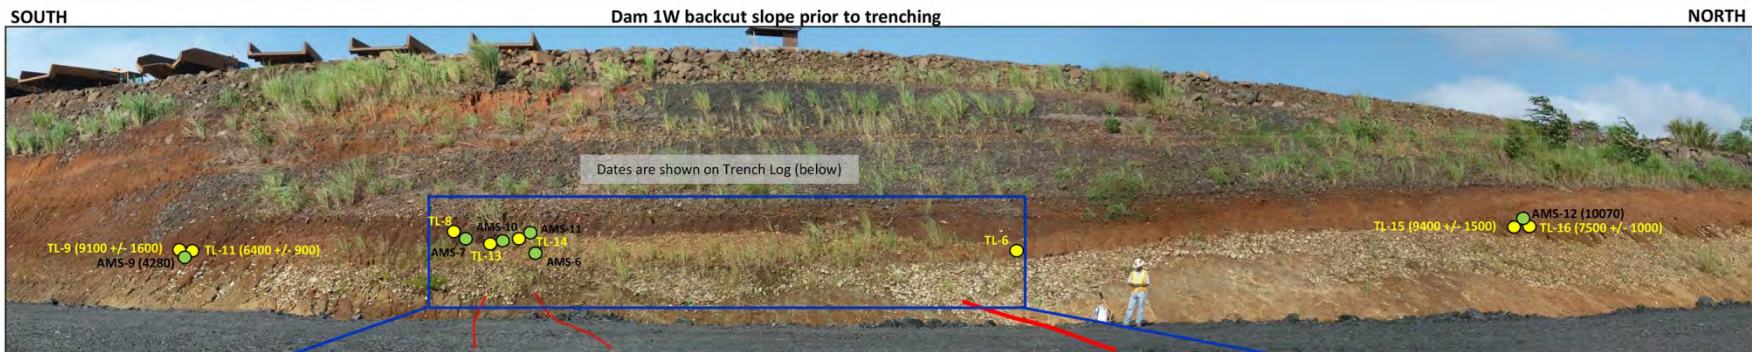
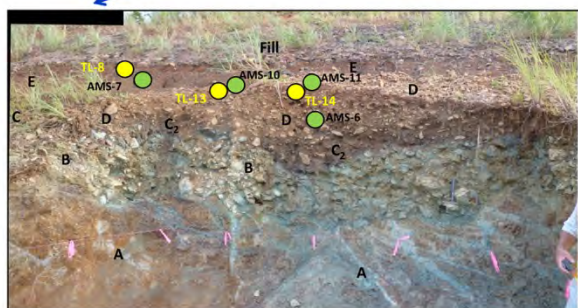
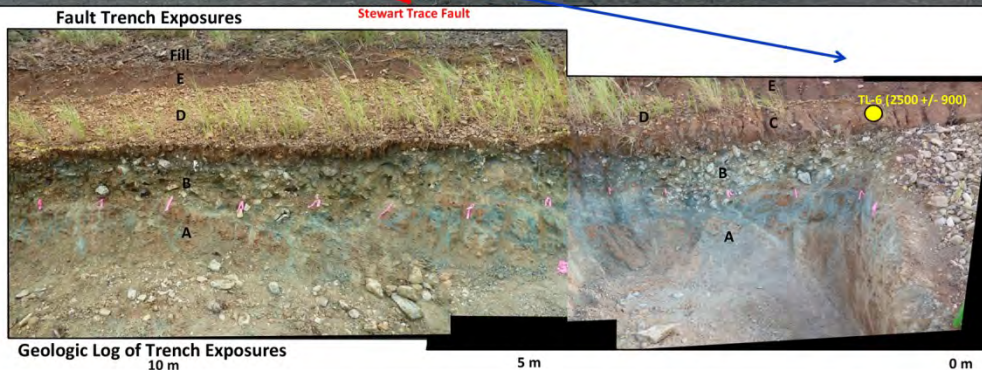
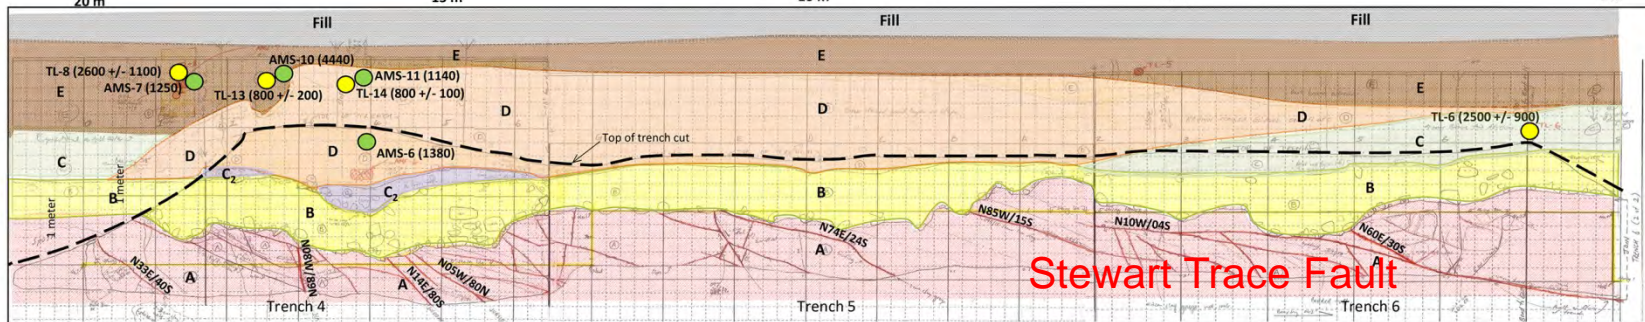
### Geologic Log of Trench Exposures Stewart Trace Fault At Dam 1W

**The Pedro Miguel “Stewart Trace” fault does not displace Holocene alluvial gravels at Borinquen Dam 1W**
