# SLIDING FAILURES AT FIVE LOCK AND DAM PROJECTS

## Dam and Cofferdam Failures within the Ohio River Basin

AEG 62<sup>nd</sup> Annual Meeting  
September, 2019

Mike Nield, Senior Engineering Geologist  
U.S. Army Corps of Engineers, Huntington WV  
LRD Dam Safety Production Center  
Dam Safety Modification Mandatory Center of Expertise

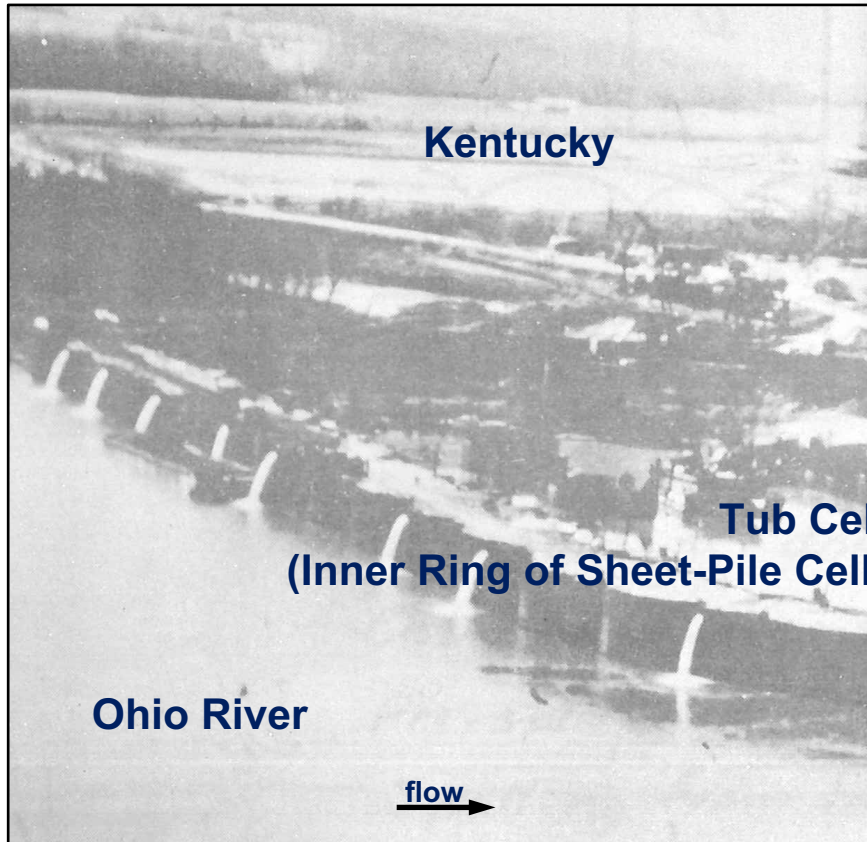
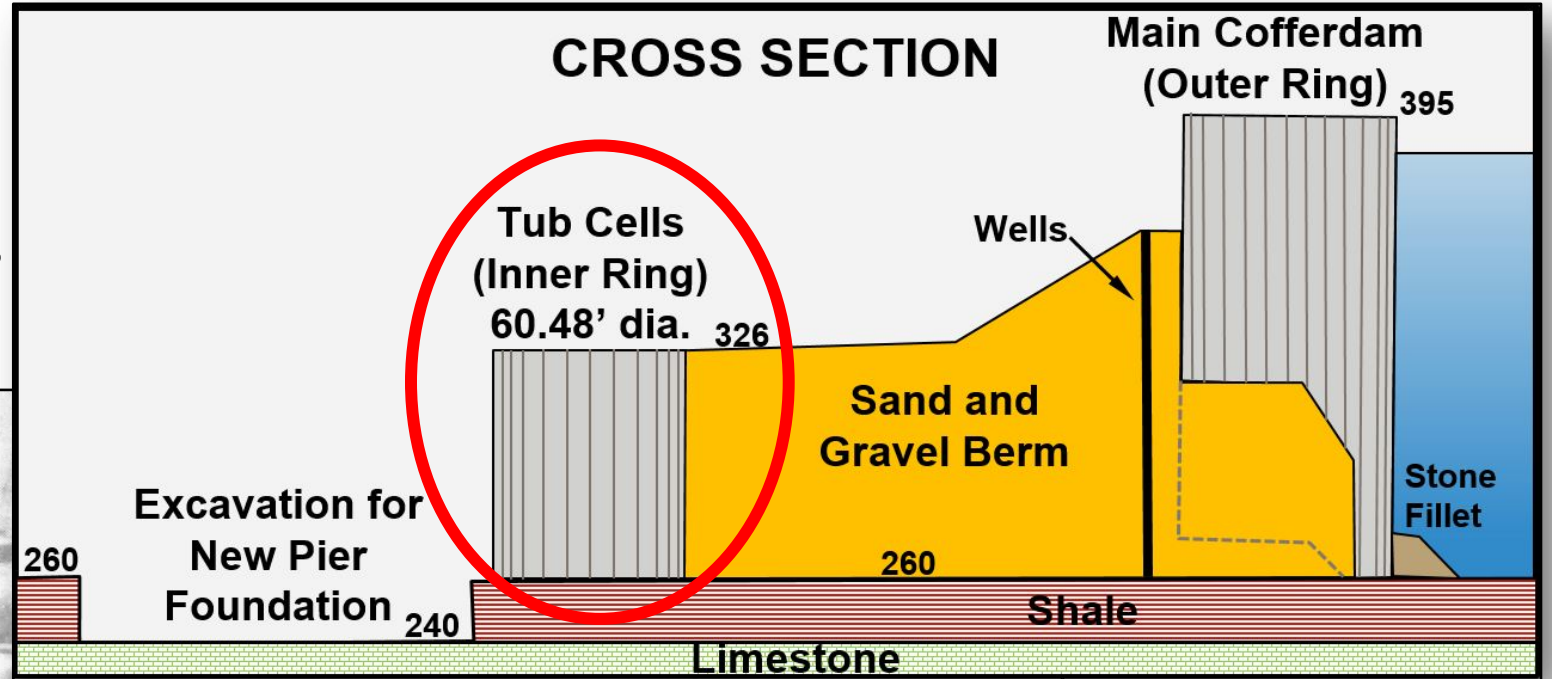
- Double-ringed sheet-pile cell cofferdam
- Inner ring of cofferdam cells founded on top of rock

Mississippian-age  
Waltersburg Shale

Tub Cells  
(Inner Ring of Sheet-Pile Cells)

Sand Berm

Main Cofferdam  
(Outer Ring of Sheet-Pile Cells)

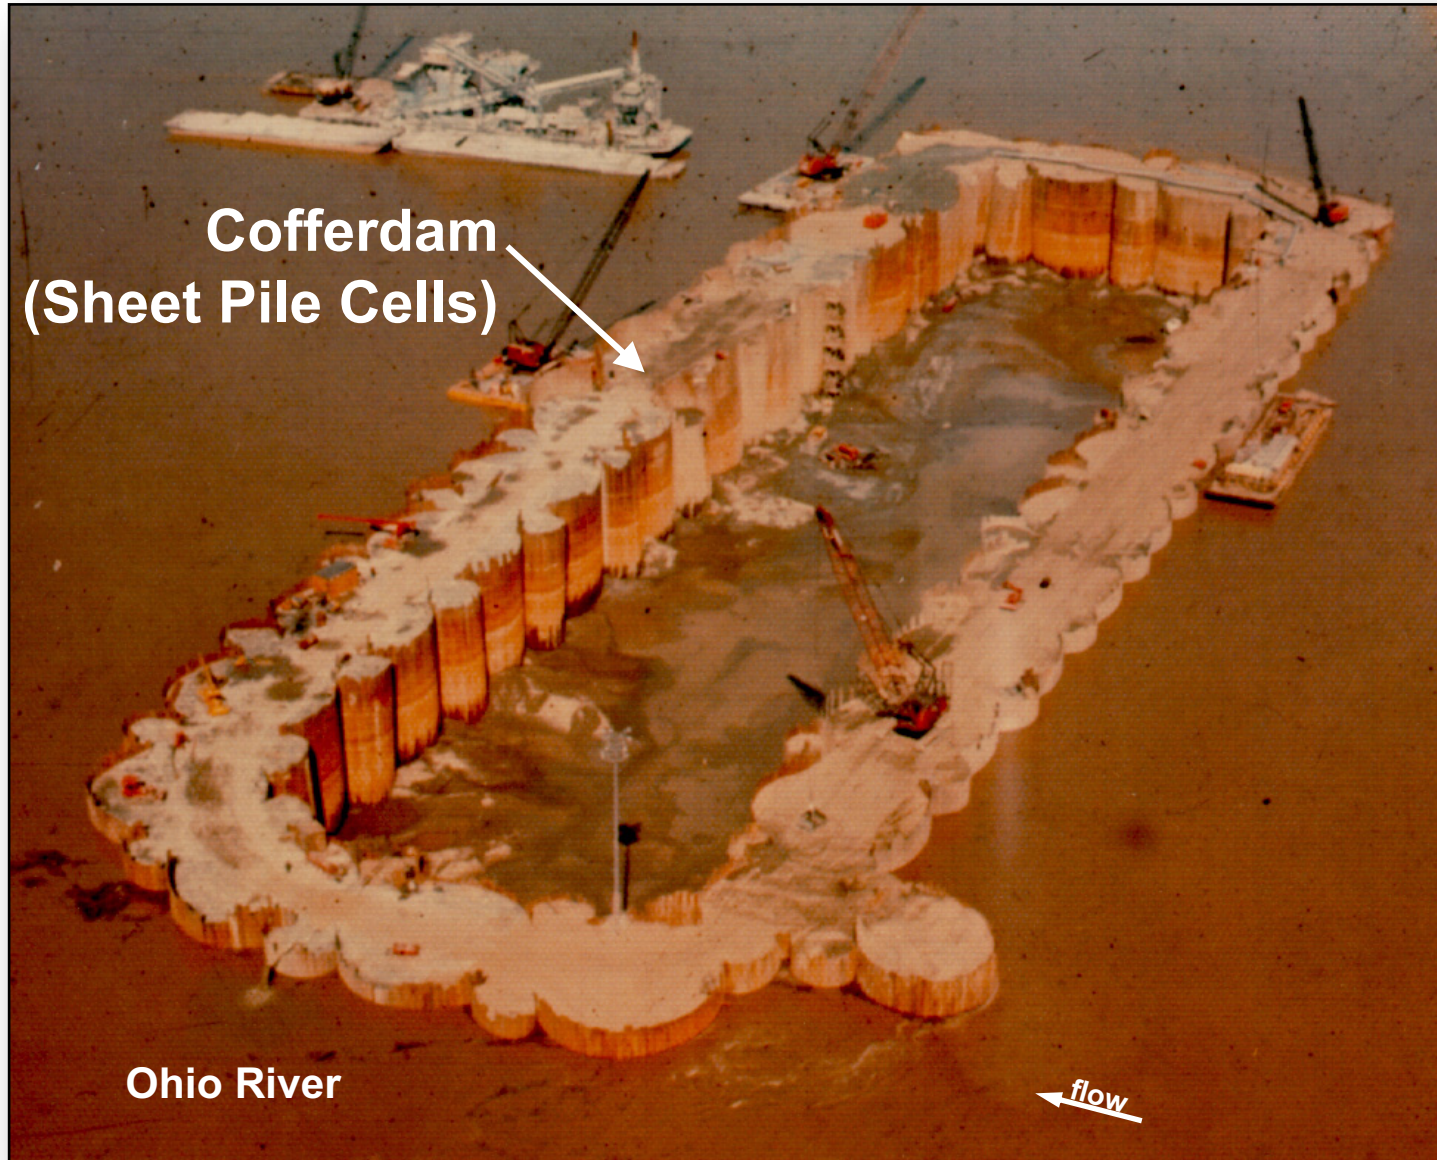
Aerial Photo – Cofferdam - Prior to Failure

- Cofferdam sliding failure on Feb 26, 1971 during a period of high water, 10 days after dewatering.
- Started at 9:45am, movement over a period of <10 minutes
- 52 personnel were in the work area, all escaped harm.
