# Investigations of the Pedro Miguel Fault during Borinquen Dam 1E Construction Panama Canal Expansion

David Schug, Paul Salter, Dan Meier,  
Robert Urban, Chris Goetz, AECOM

AEG September 22, 2016

## FAULT INVESTIGATIONS DURING BORINQUEN DAM 1E CONSTRUCTION PANAMA CANAL EXPANSION

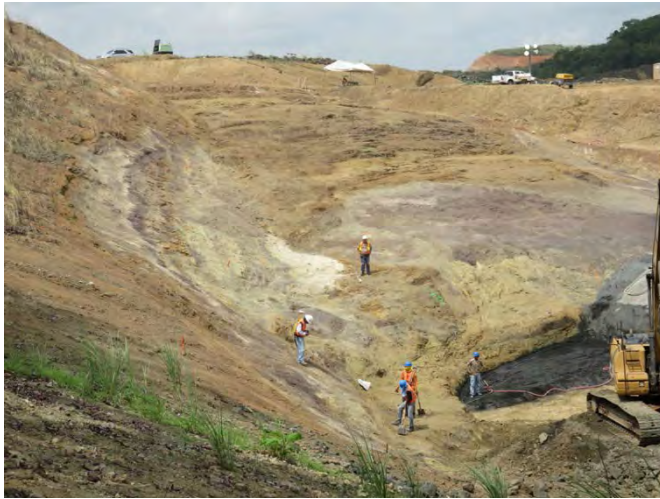
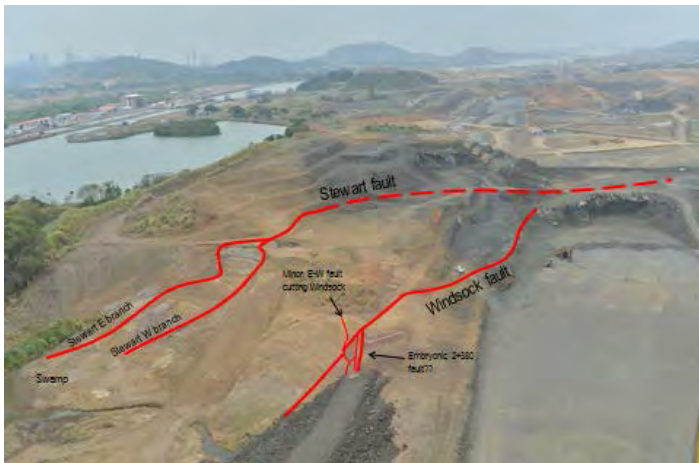
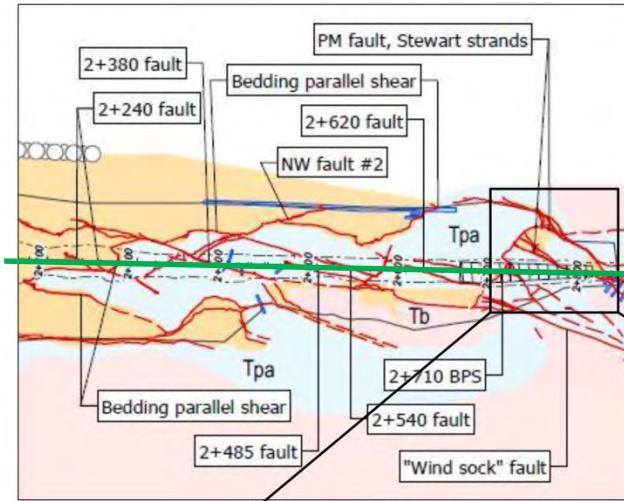
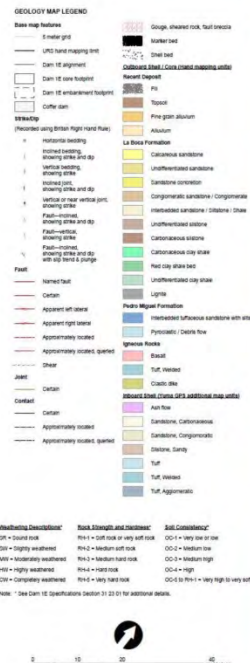
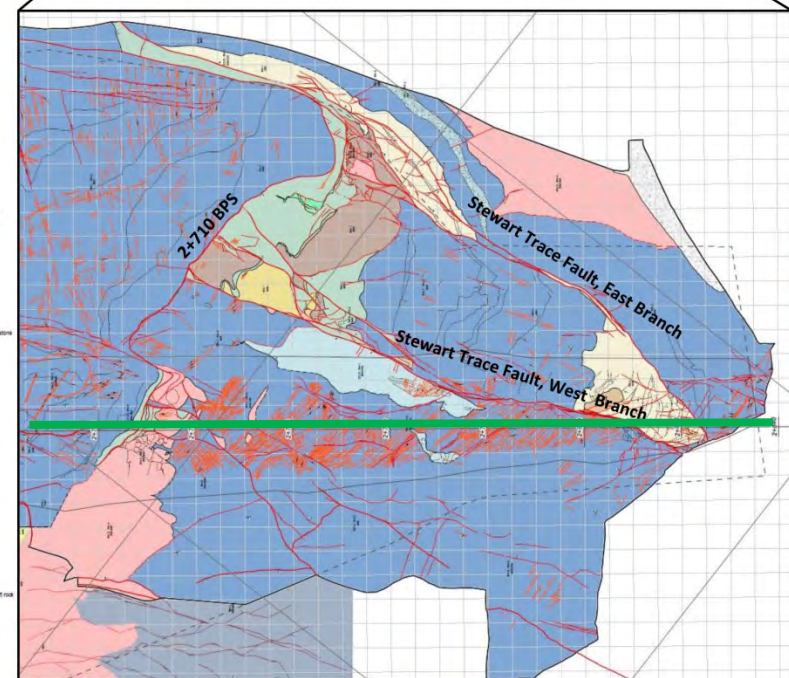
# Pedro Miguel Fault South Abutment Dam 1E

Figure 6: Pedro Miguel Stewart Strands Geology

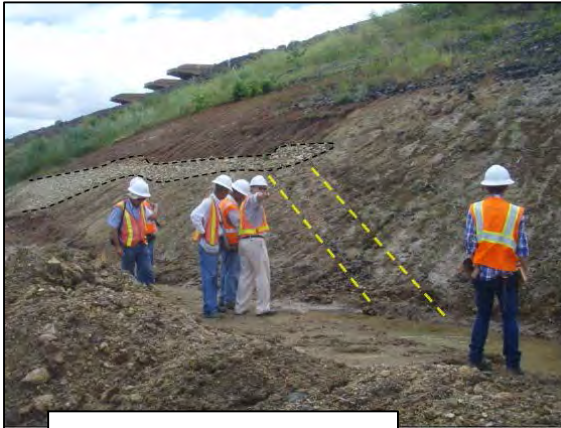
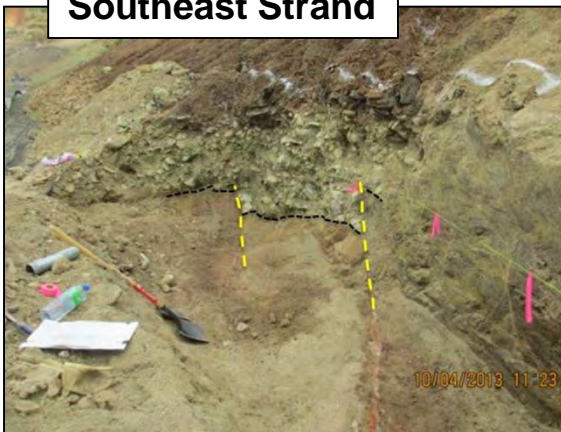
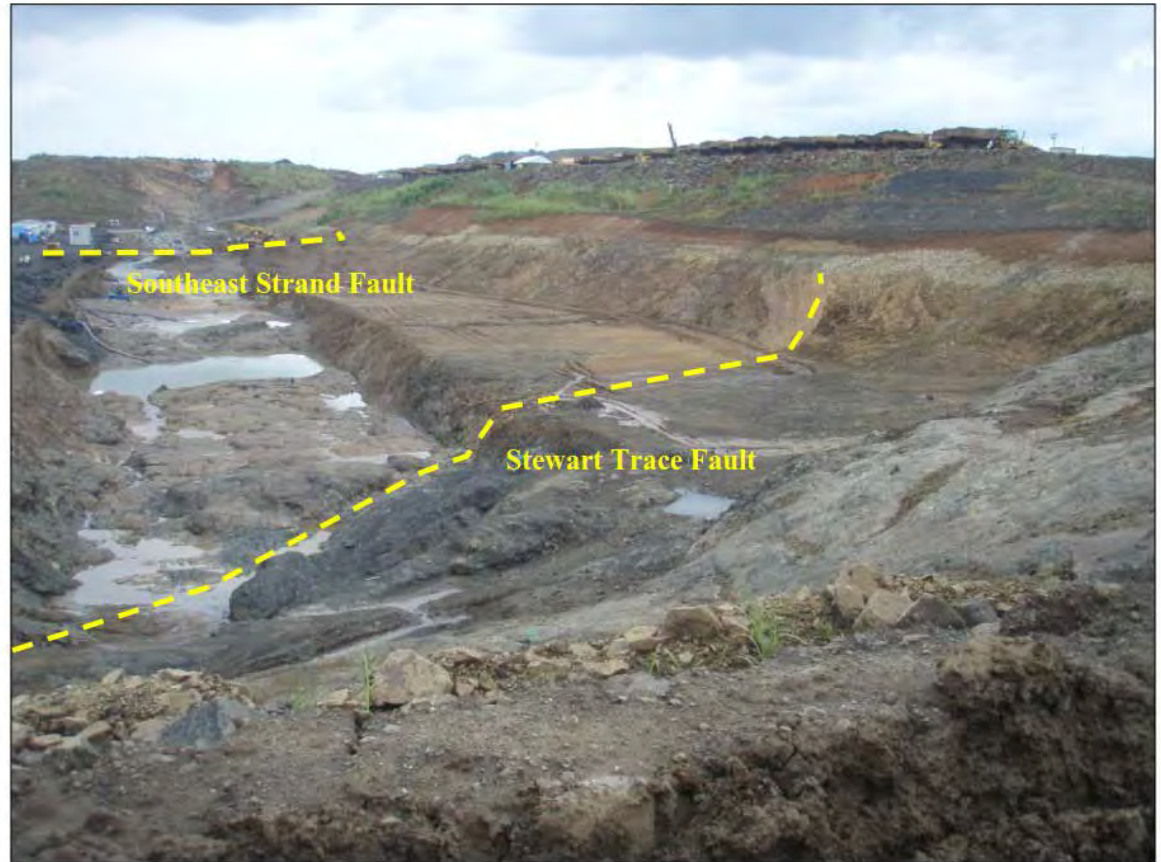
# Pedro Miguel Fault Dam 1W Foundation

**Southeast Strand**

**The “Southeast Strand” of the Pedro Miguel fault has produced minor displacement of early Holocene alluvium at Dam 1W**

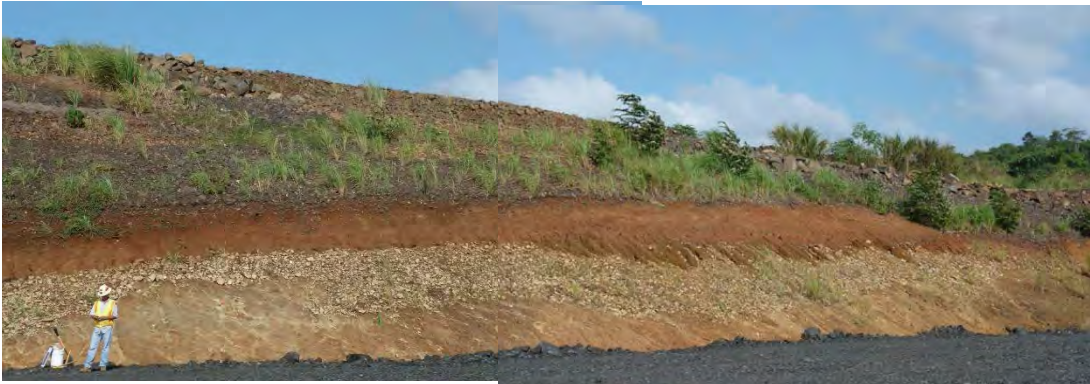
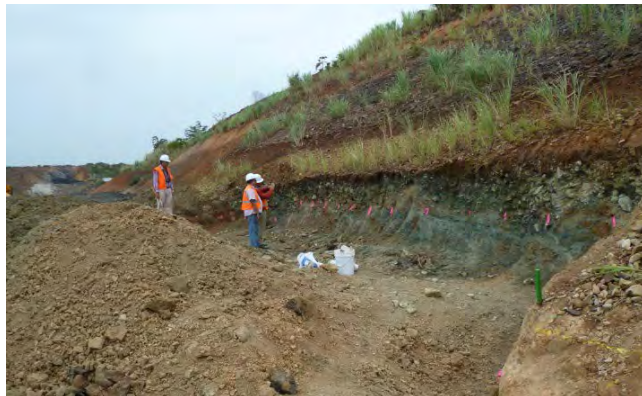
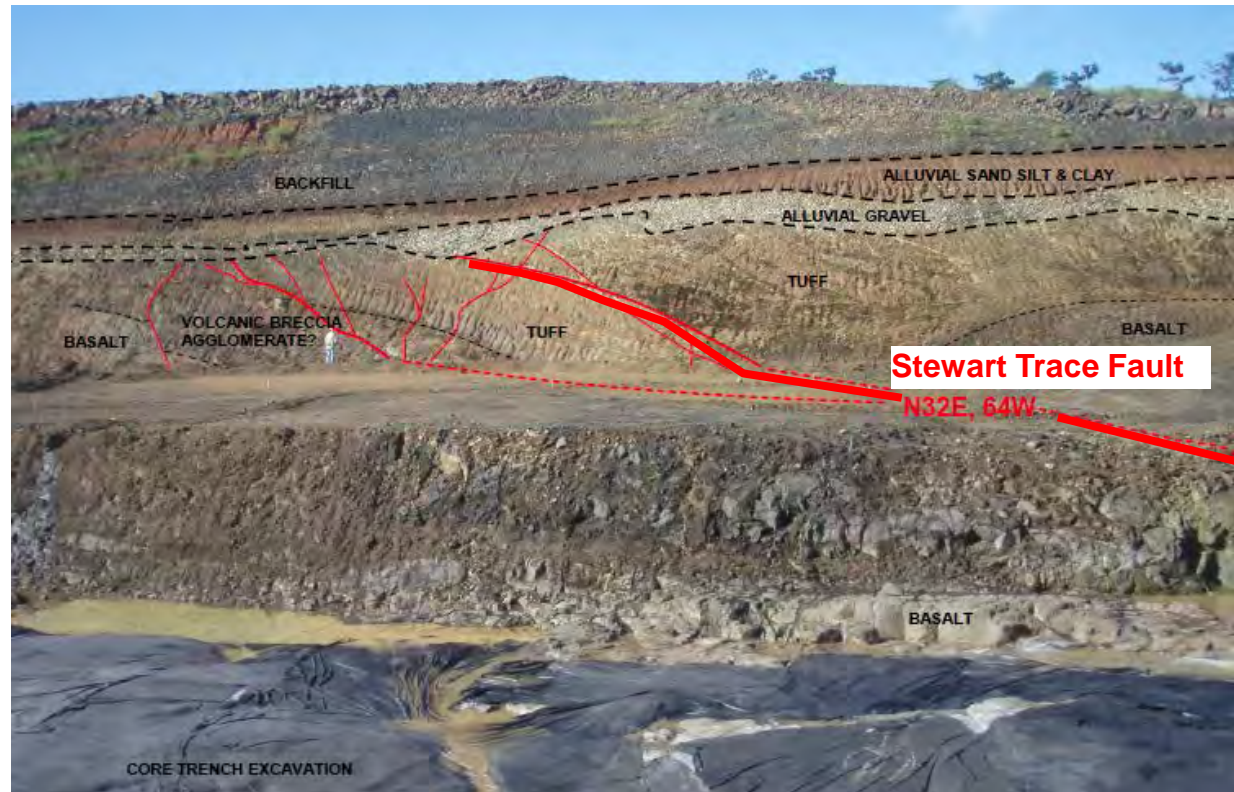
# Pedro Miguel Fault at Dam 1W

**The Pedro Miguel “Stewart Trace” fault does not displace Holocene alluvial gravels at Borinquen Dam 1W**

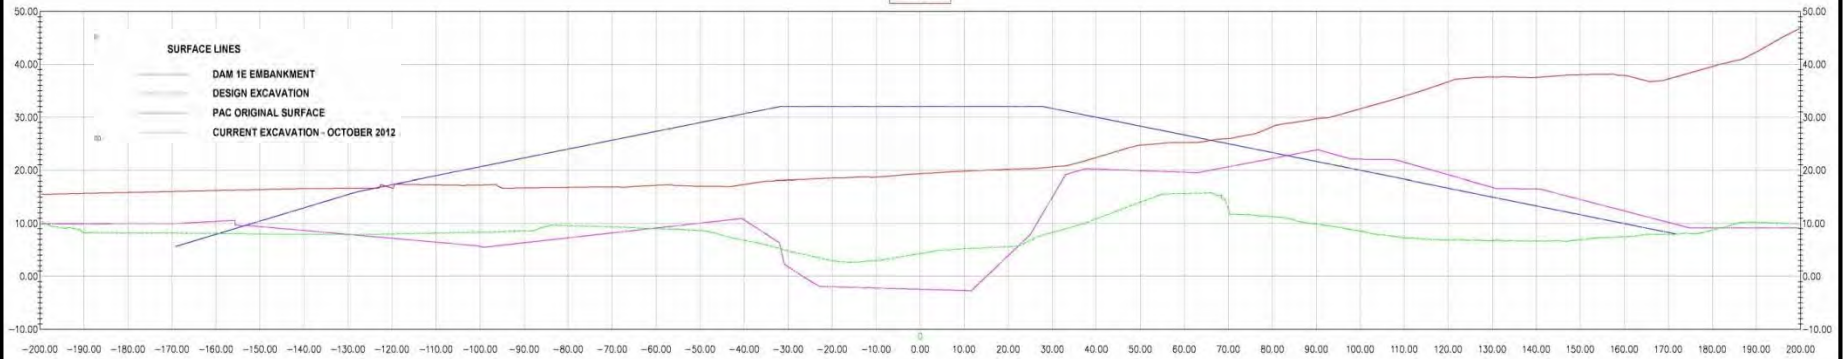
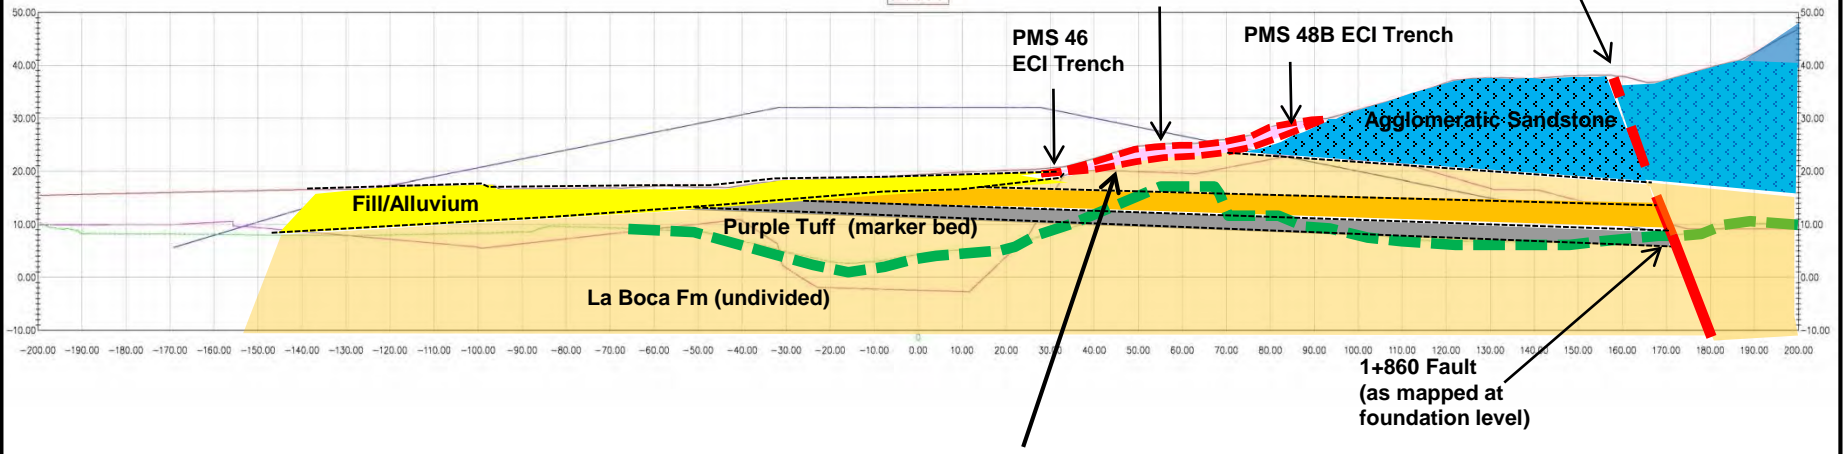
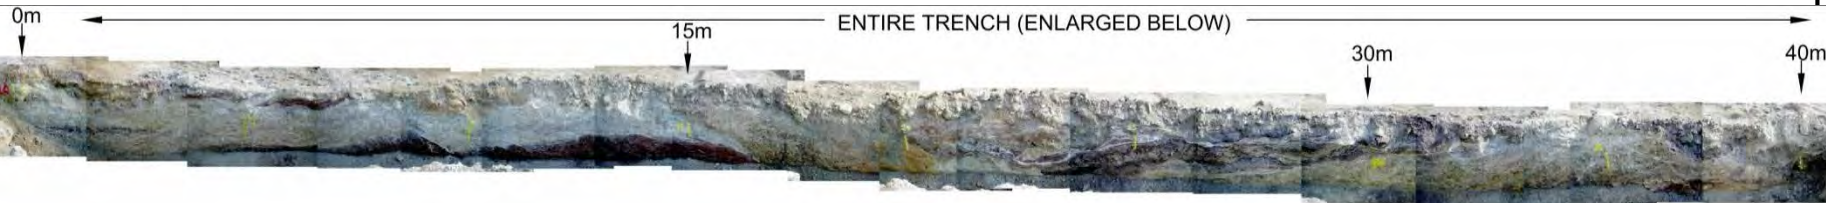
# Section at 1+860 Fault (Deepened PAC Redesign)

Apparent bedding dip = 5 degrees
