PORTUGUES DAM: CHALLENGES AND SUCCESS IN FOUNDATION DOCUMENTATION AND TREATMENT

John Conway Project Geologist

September 24, 2015

Portugues Dam

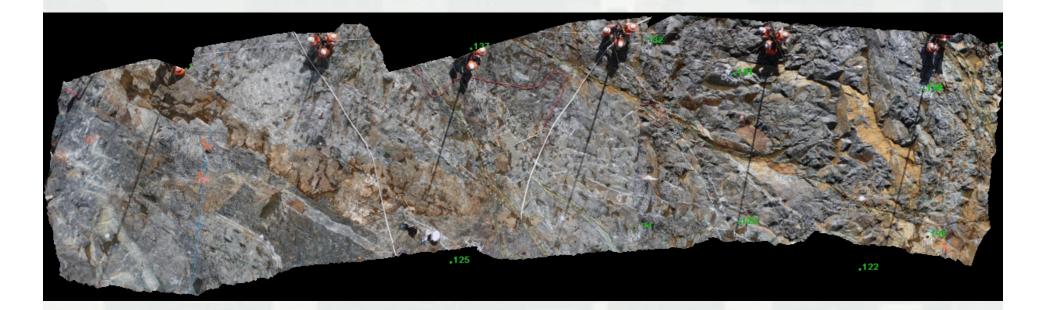
Strip of Photos

- Field mapping base
- Features described from field labeling

~7 photos per strip, one hour on this foundation

- Immediately print photos for mapping
- Field descriptions directly on the photos
- QC software measurements dip/dip direction

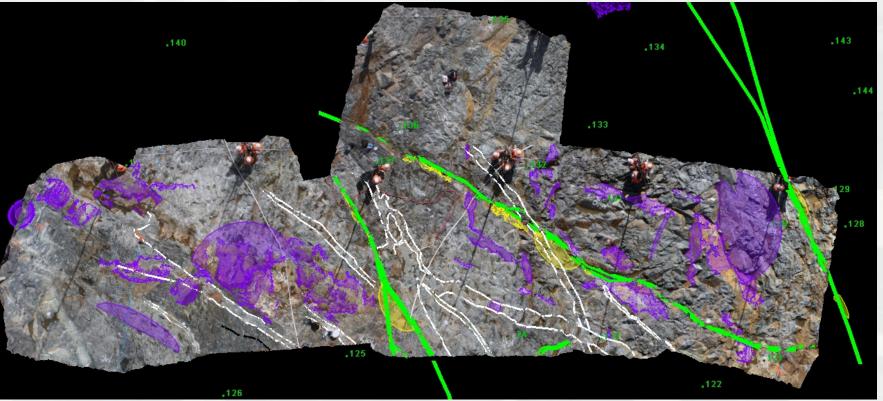
Photo Analysis

- Fracture length/continuity/orientation
- Digitize features
- Contours/Sections/Volumes
- Document treatment areas

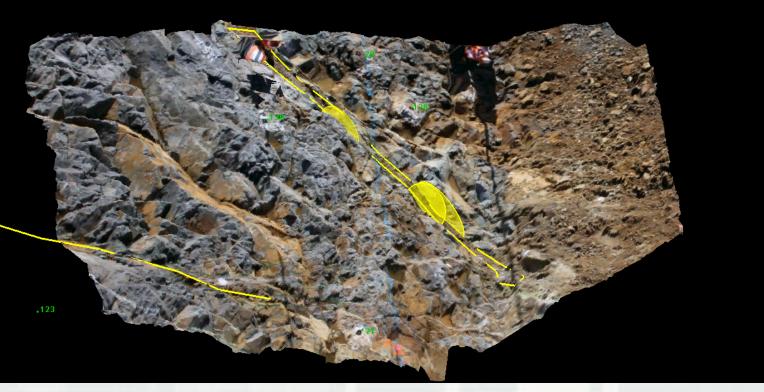
Processed photo pair

3D Processing and Analysis

- Software processing photos
- Analysis varies with purpose

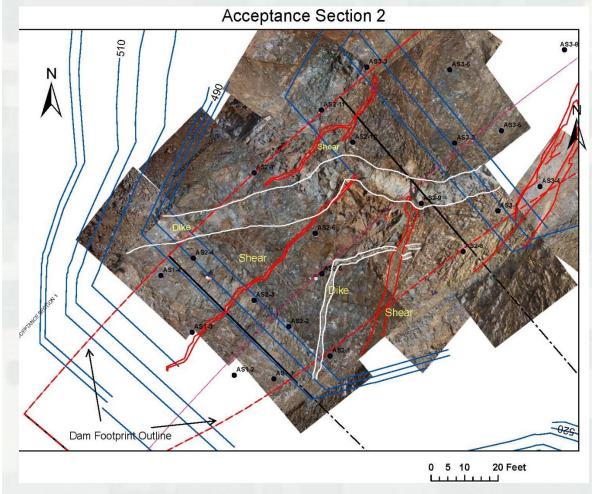
Data Presentation

- GIS with numerous presentation possibilities.
- Cross sections projecting shears to boreholes using orientation data.

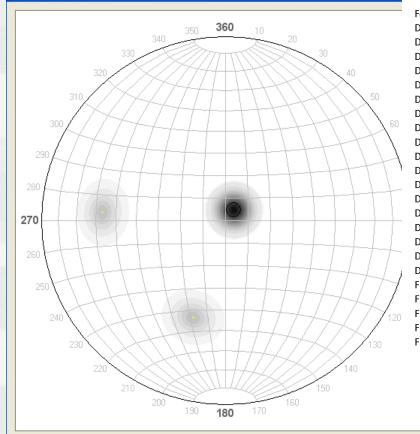
Discontinuity Analysis

Stereonet of measured orientations
