**The highest dam of the world
in a challenging geological environment**

The proposed Rogun 335m high dam, Tajikistan

Paul G. Marinos, Independent consultant

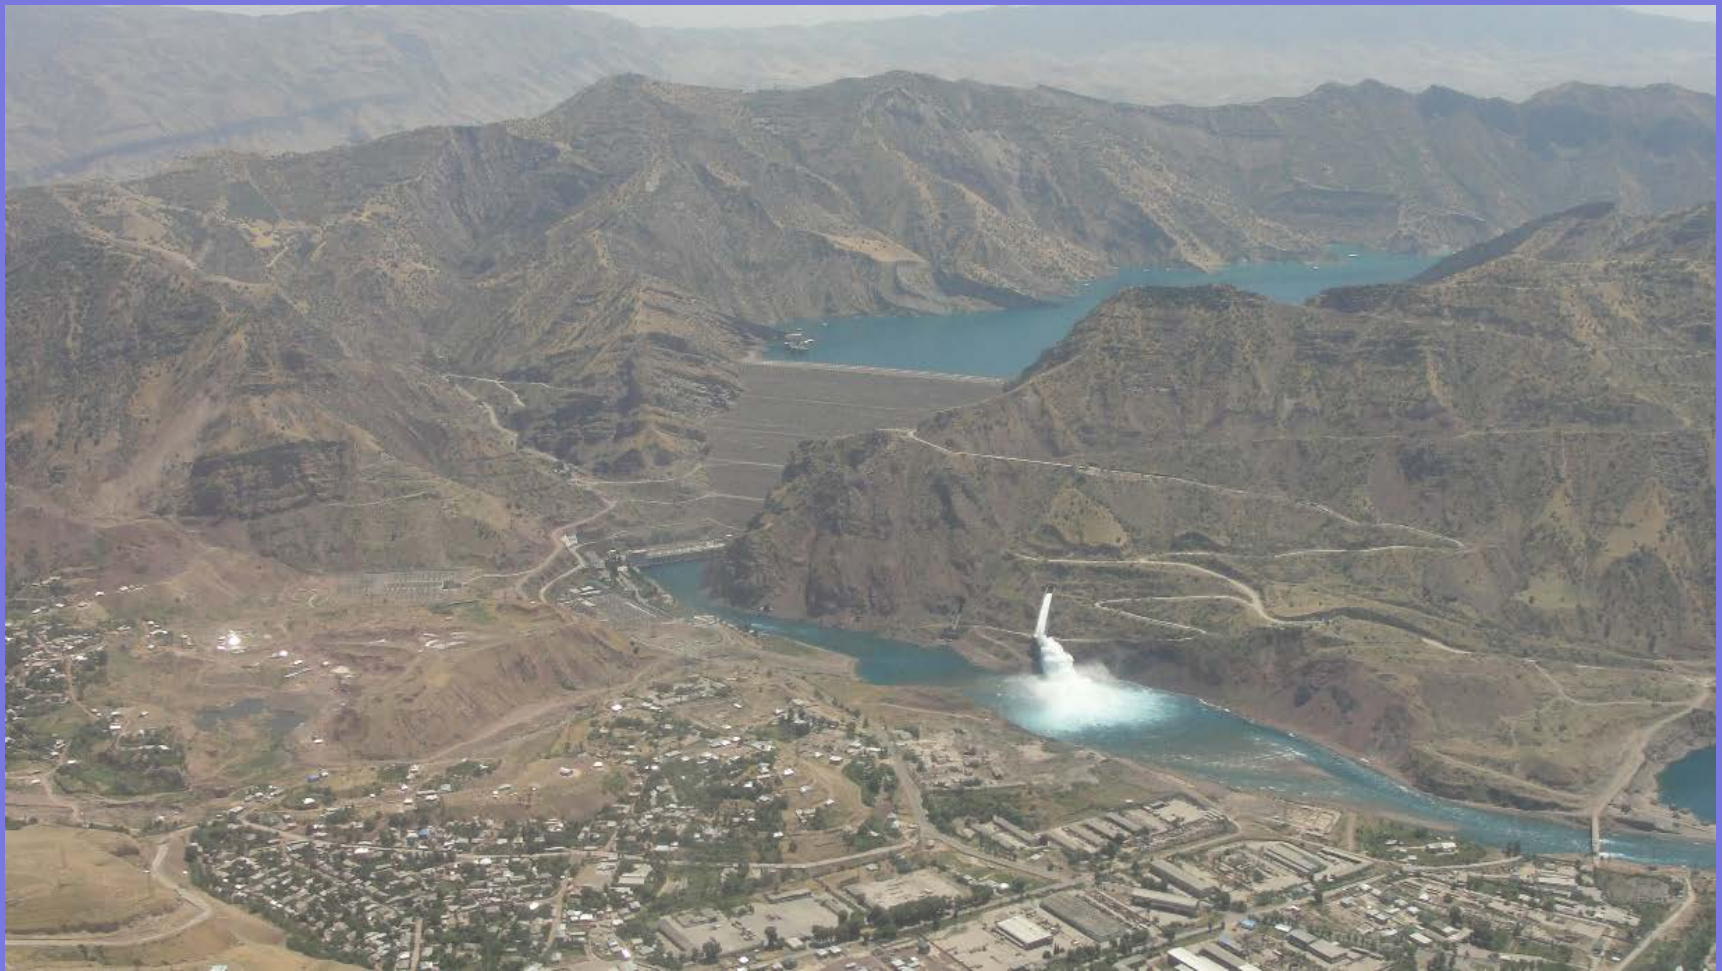
NUREK DAM, 300m high, downstream of ROGUN

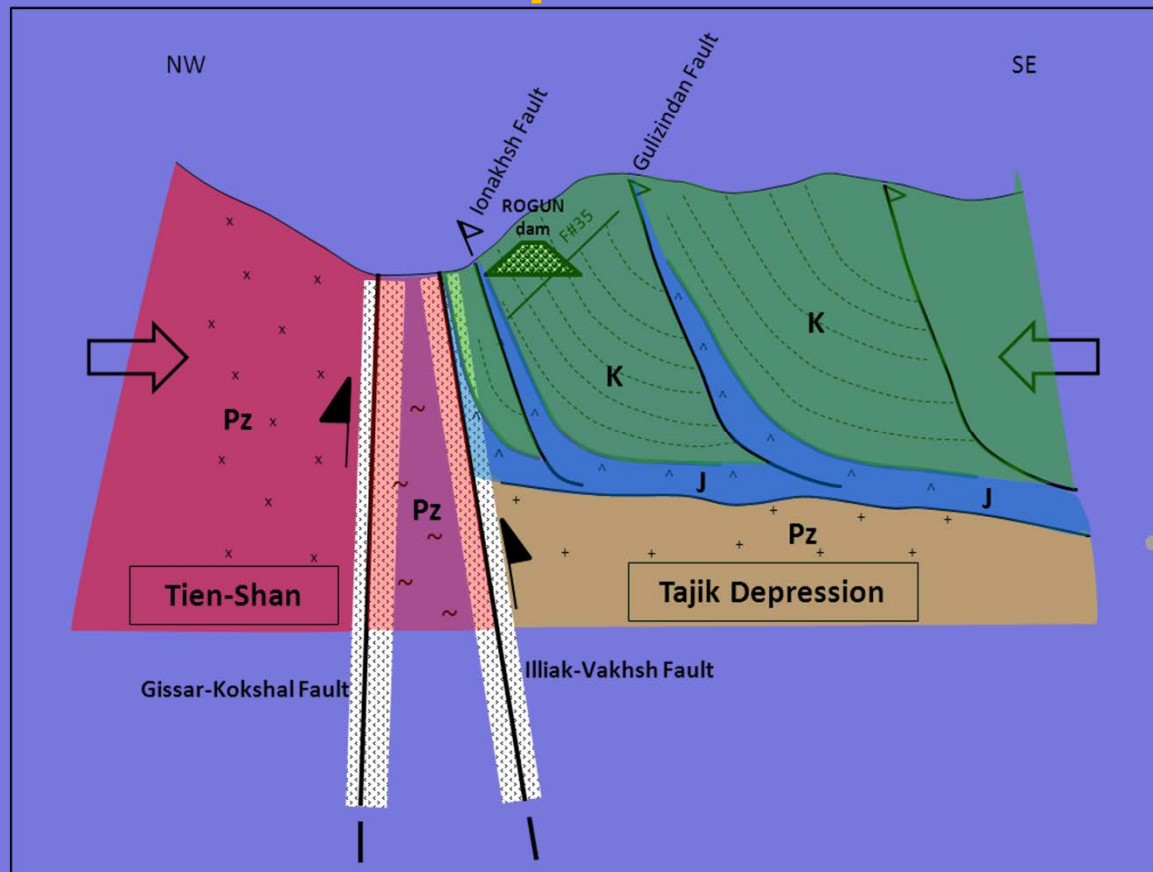
Principal faults

From TEAS consultant reports

- 1. Crustal faults
 - >500 km long, 50 km deep
 - Guissar-Kokshal fault,
 - Illiak-Vakhsh fault,
N boundary of the Tajik Depression
- 2. Regional faults in the TD
 - ~100 km long, rooted in Jurassic salt layer
 - Ionaksh fault in dam foundation
 - Gulizindan fault
- 3. Local faults
 - <5 km long
 - Fault no.35, in dam foundation

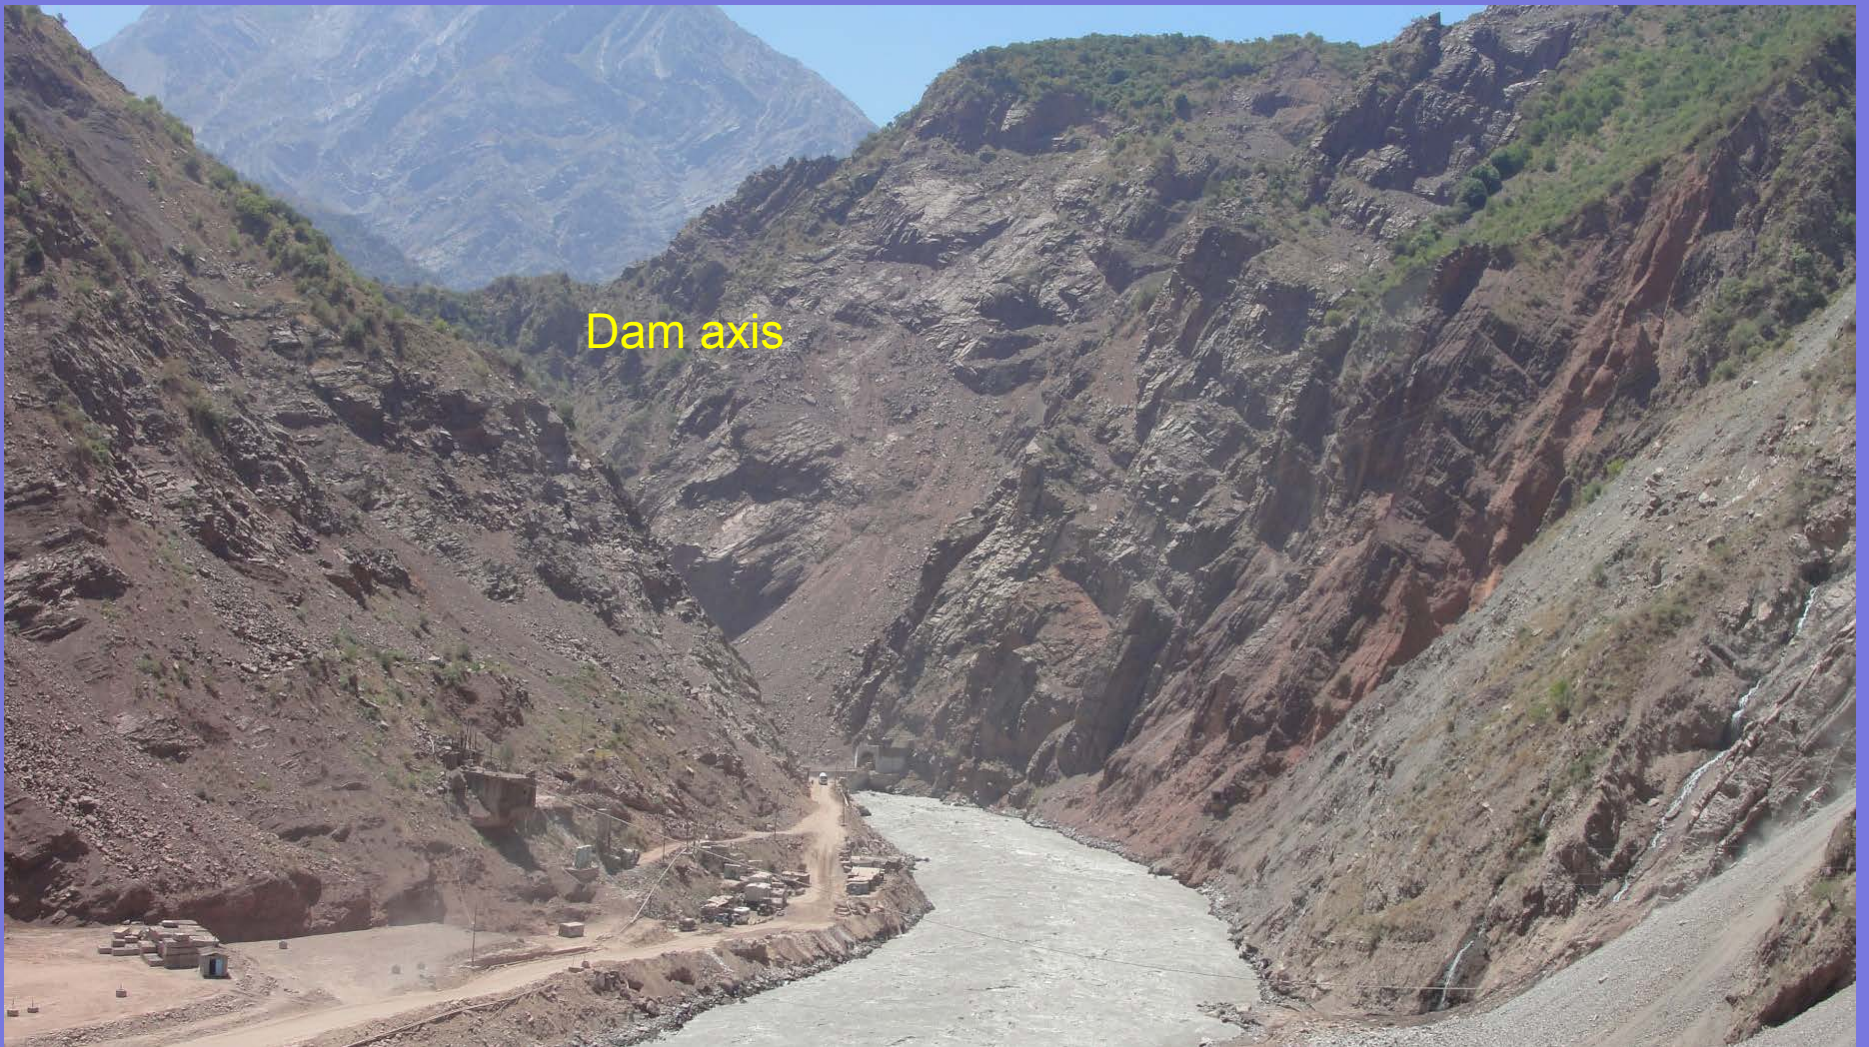
Rogun dam Site Geology

Alternations of sandstones
and siltstones

In blue the stage I construction
for early power production

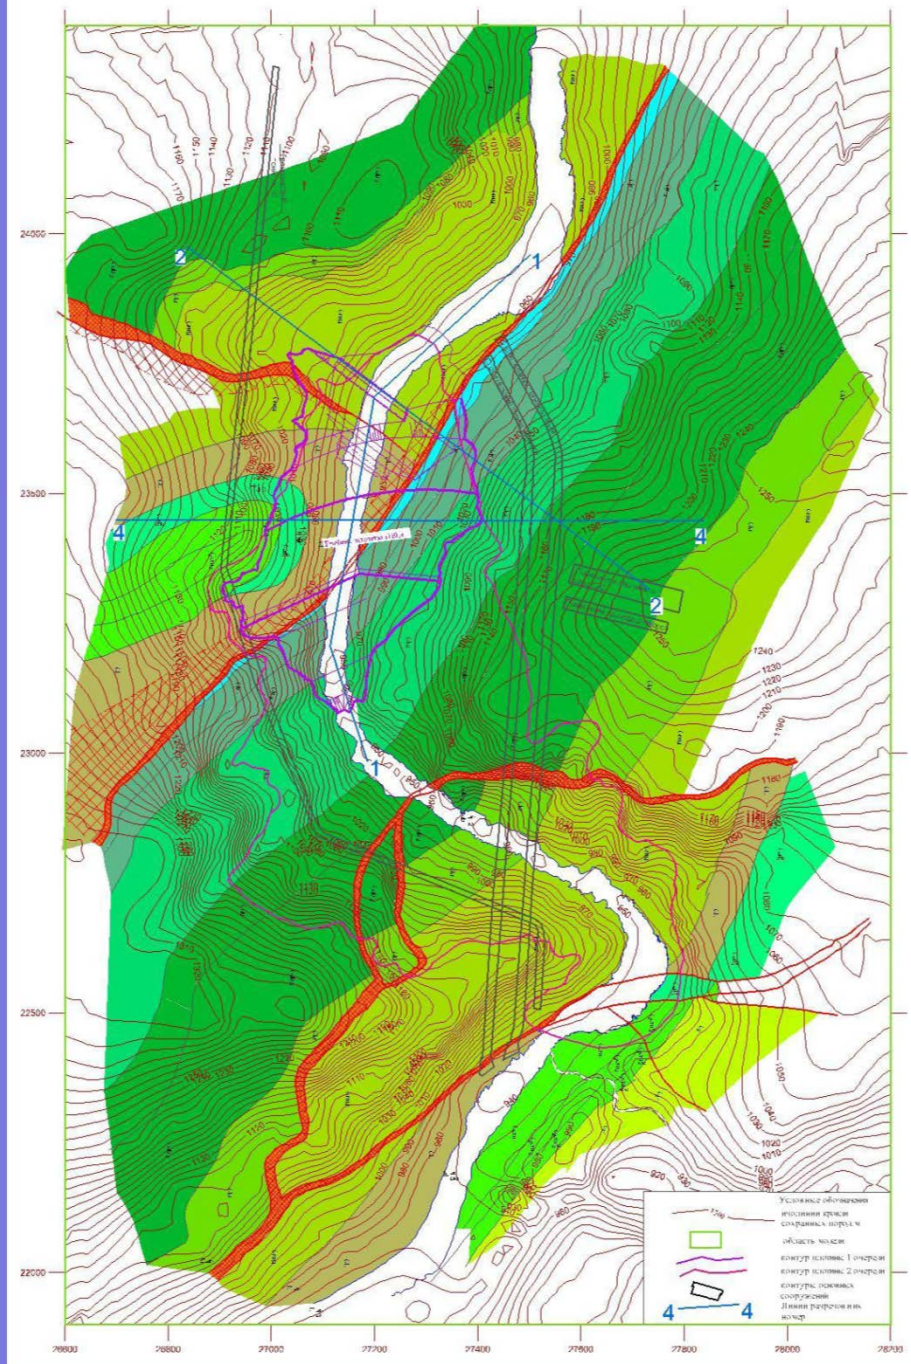
Site geology – Lithology

- Upper Jurassic evaporites: halite, gypsum, anhydrite, 400 m thick; 20 m reddish mudstone cap
- Lower Cretaceous continental series: alternating sandstone, siltstone, mudstone (shales), 1100 m thick
- Marine sedimentary series: siltstone, shales, gypsum, dolomite, limestone; often fossiliferous; 550 m thick

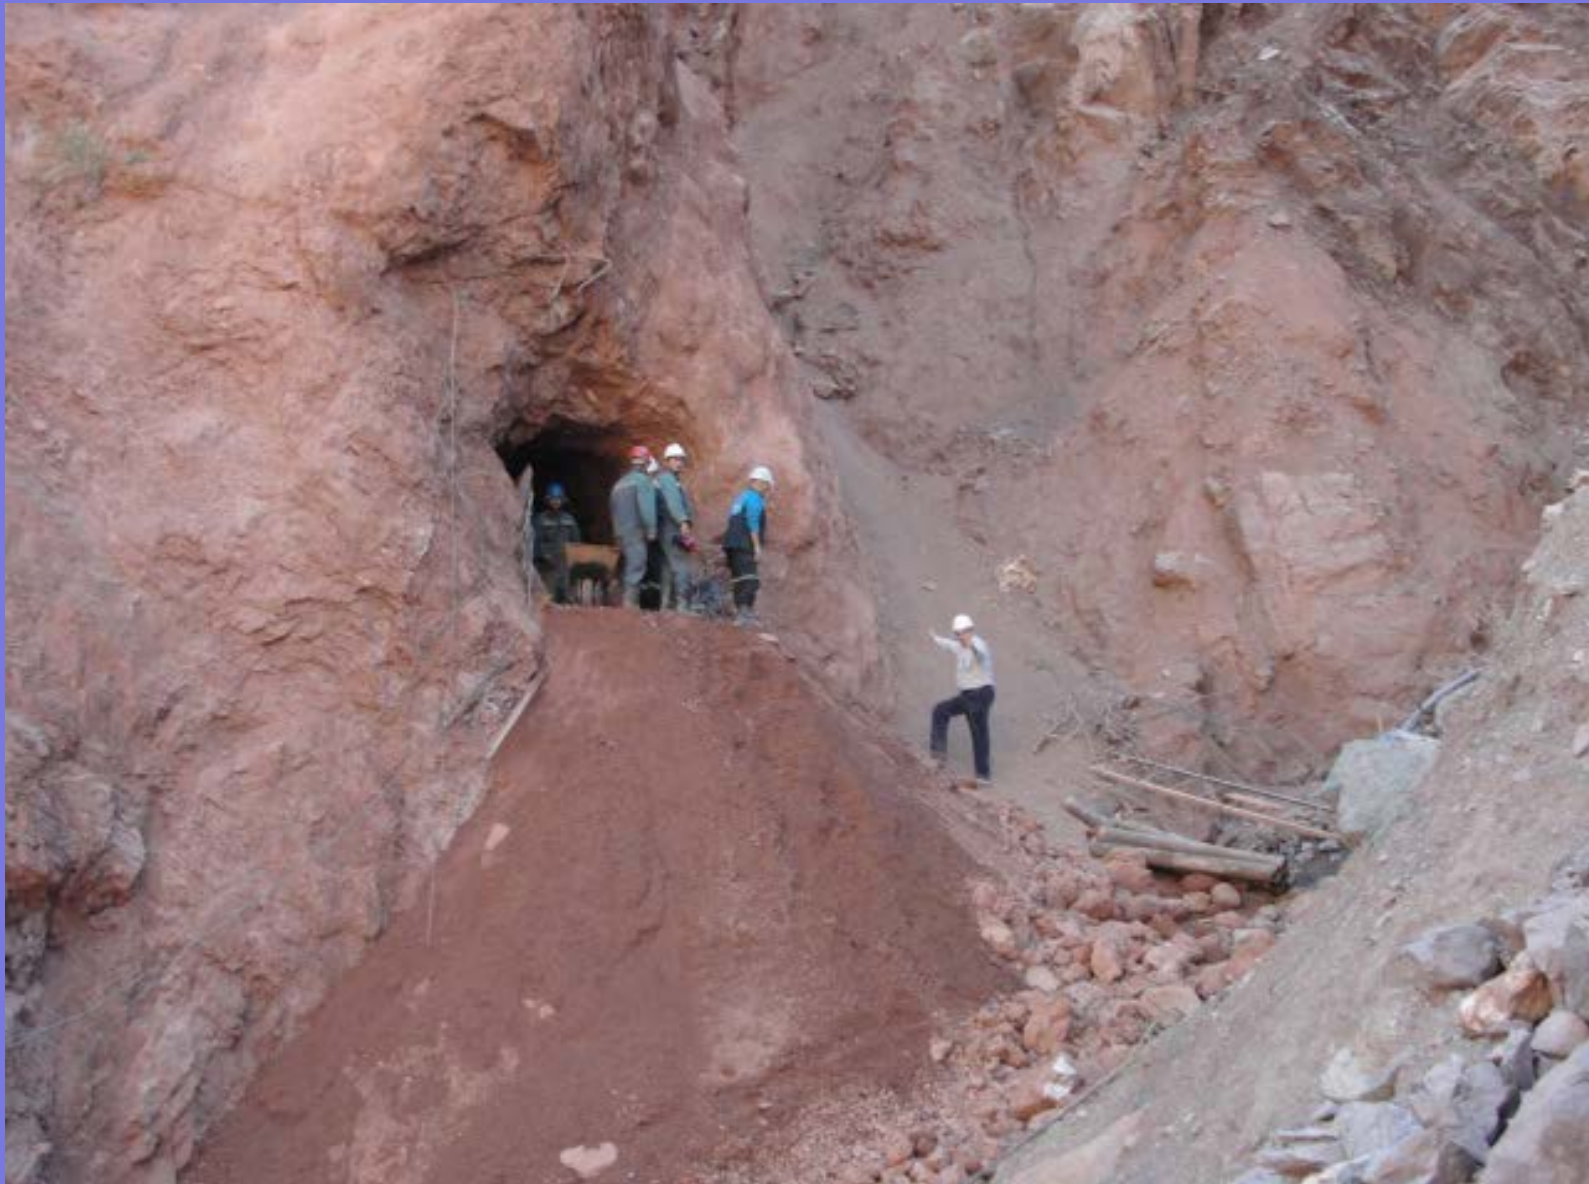
Exploring the Ionakhsh fault

- The site is tight and there are several constraints, namely:

- The Ionakhsh creeping fault and potential seismic movements
- Salt wedge in the foundations
- Fault No. 35 and potential seismic movements
- Location of intake portal for existing diversion tunnels

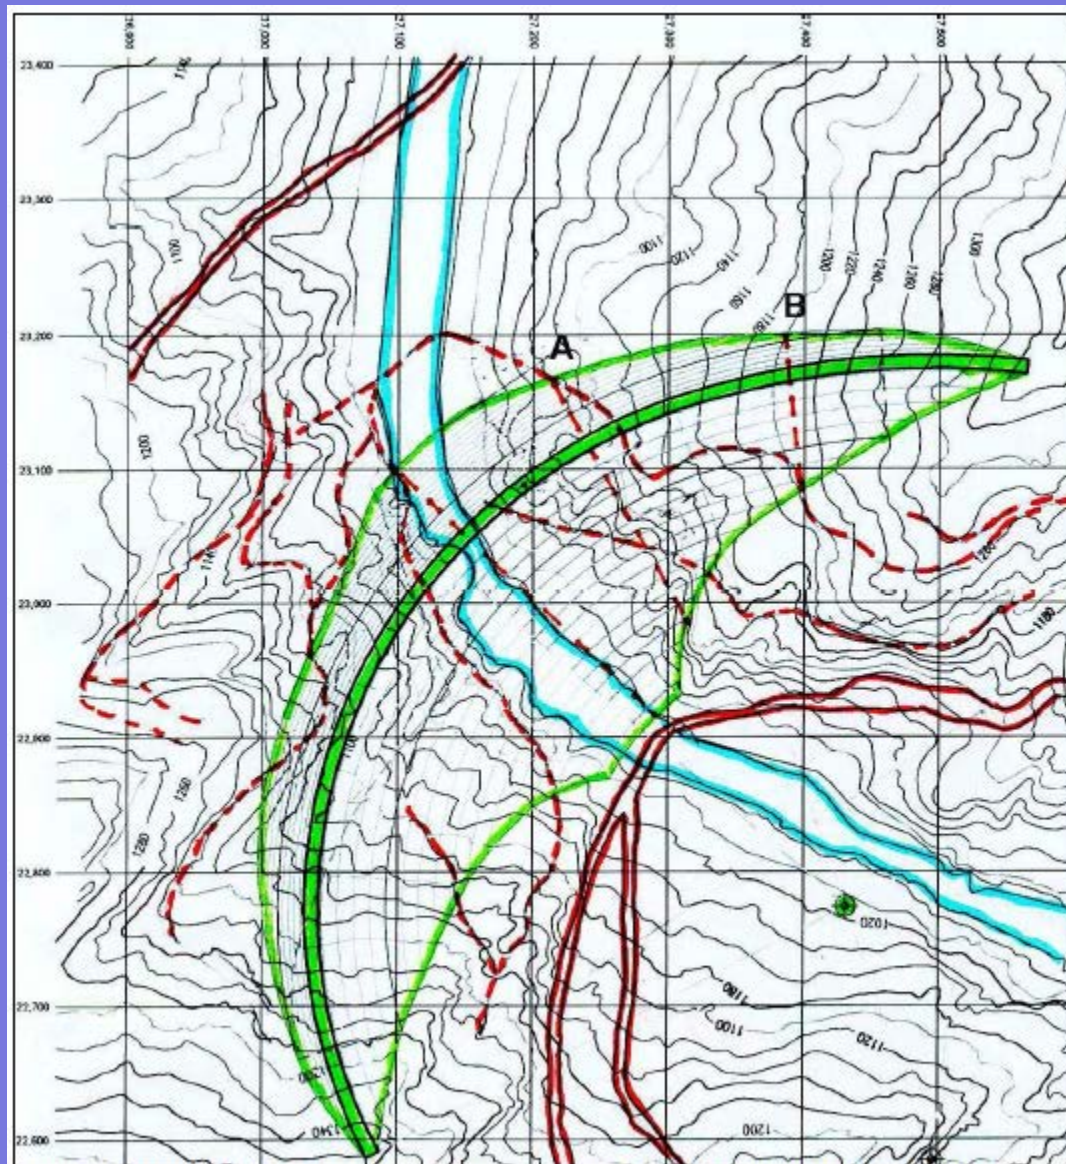
Figure 3.9.2: Tentative layout of concrete arch gravity dam at the Rogun site with traces of geological faults (was abandoned in view of difficulty with the faults)

Initial thoughts
for an arch gravity
dam avoiding
the Ionakhsh
and other fault

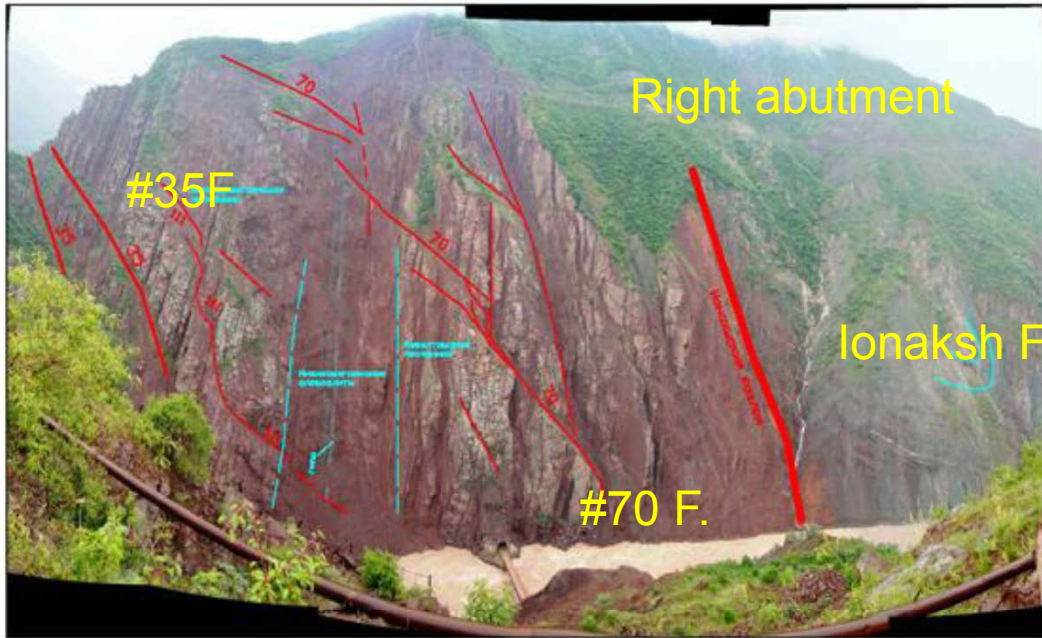
DAM FOUNDATIONS

Concrete dam: not suitable due to high heterogeneity although persistence of strong layers. Presence of active, creeping faults (creep estimated up to a few mm/year).

Embankment dam: can accommodate faults movements, for both earthquake associated displacement and aseismic creep.

Activity of faults needs to be considered also in tunnel design.

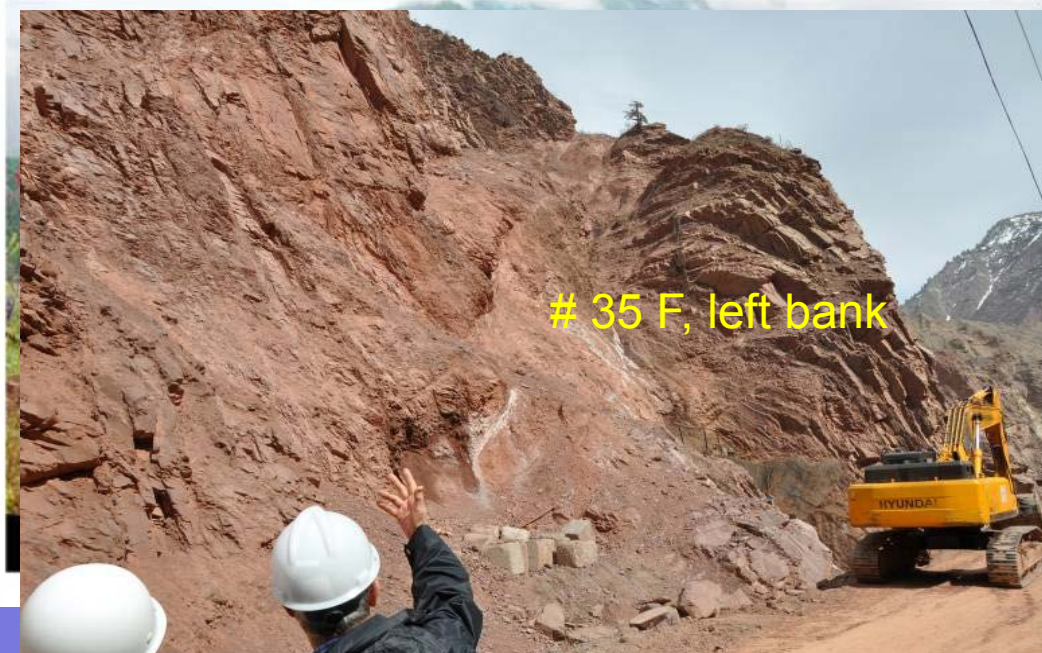
Risk of co-seismic ground rupture causing large displacements along the lonaksh and #35 faults is considered low.

No sign of Quaternary displacements along these fault exist, as reported.

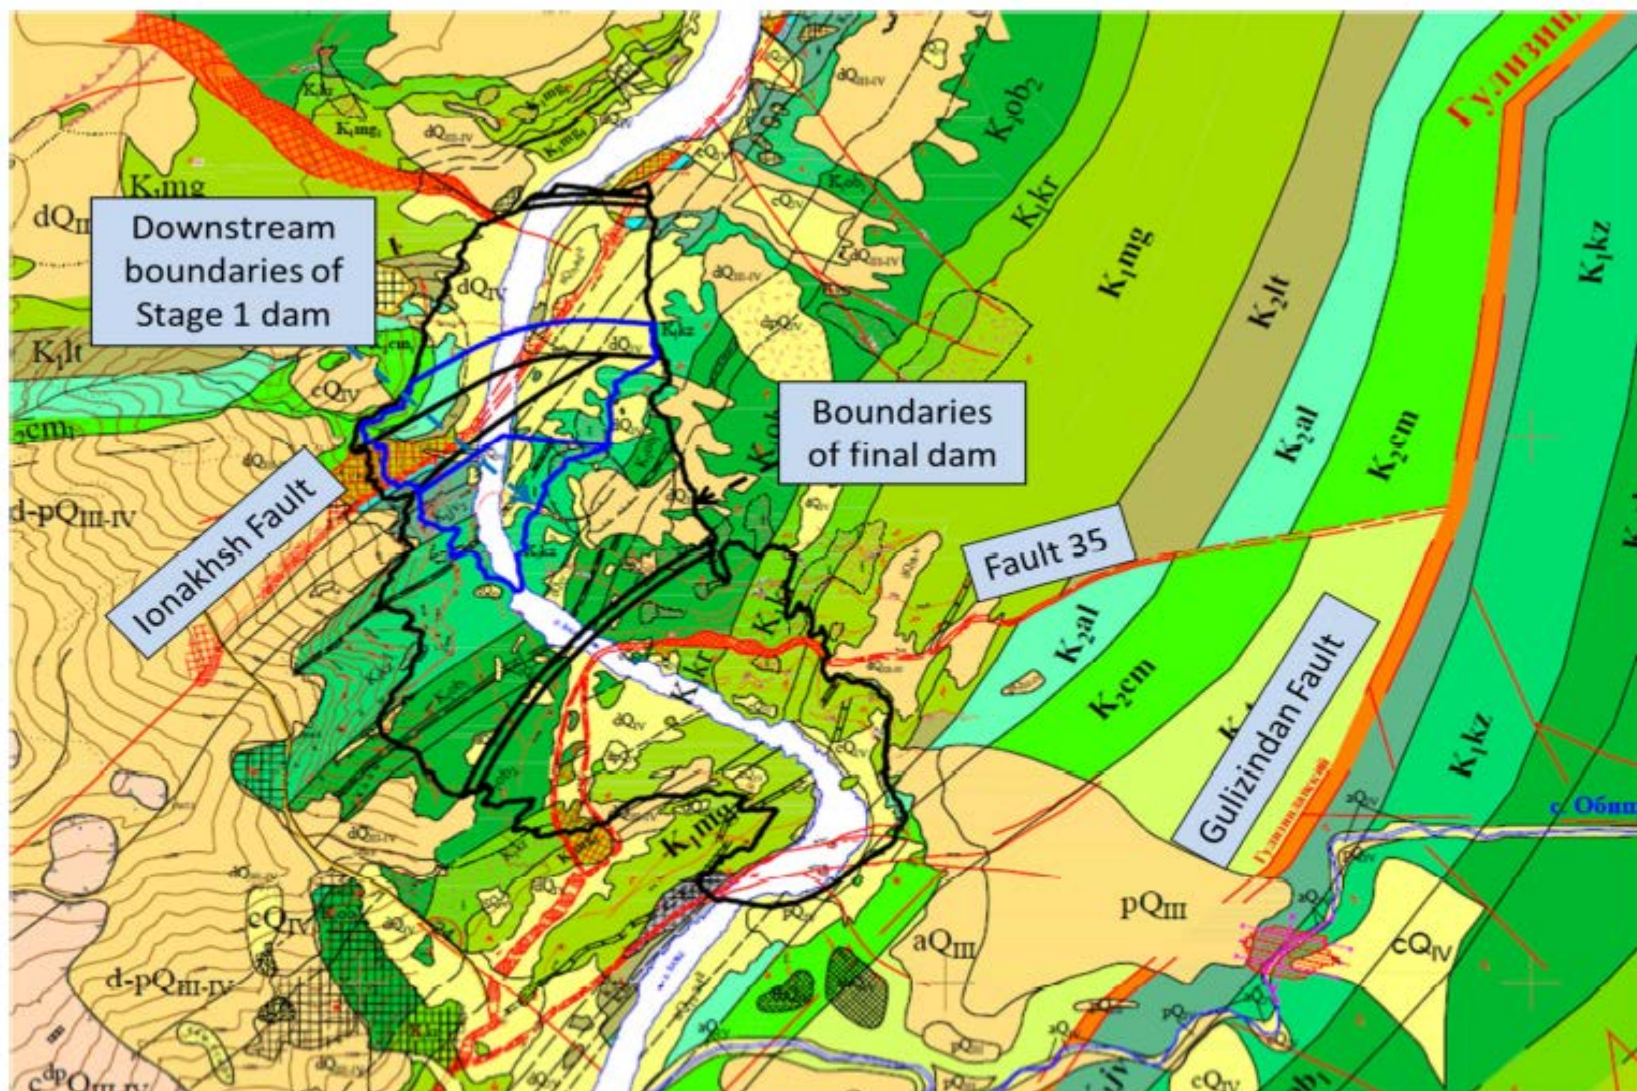
Dam site geological map with Ionakhsh Fault and other main faults; limits of Stage 1 dam are highlighted in blue for the downstream site (upstream, there are same as for the final dam, which will include the Stage 1 dam)

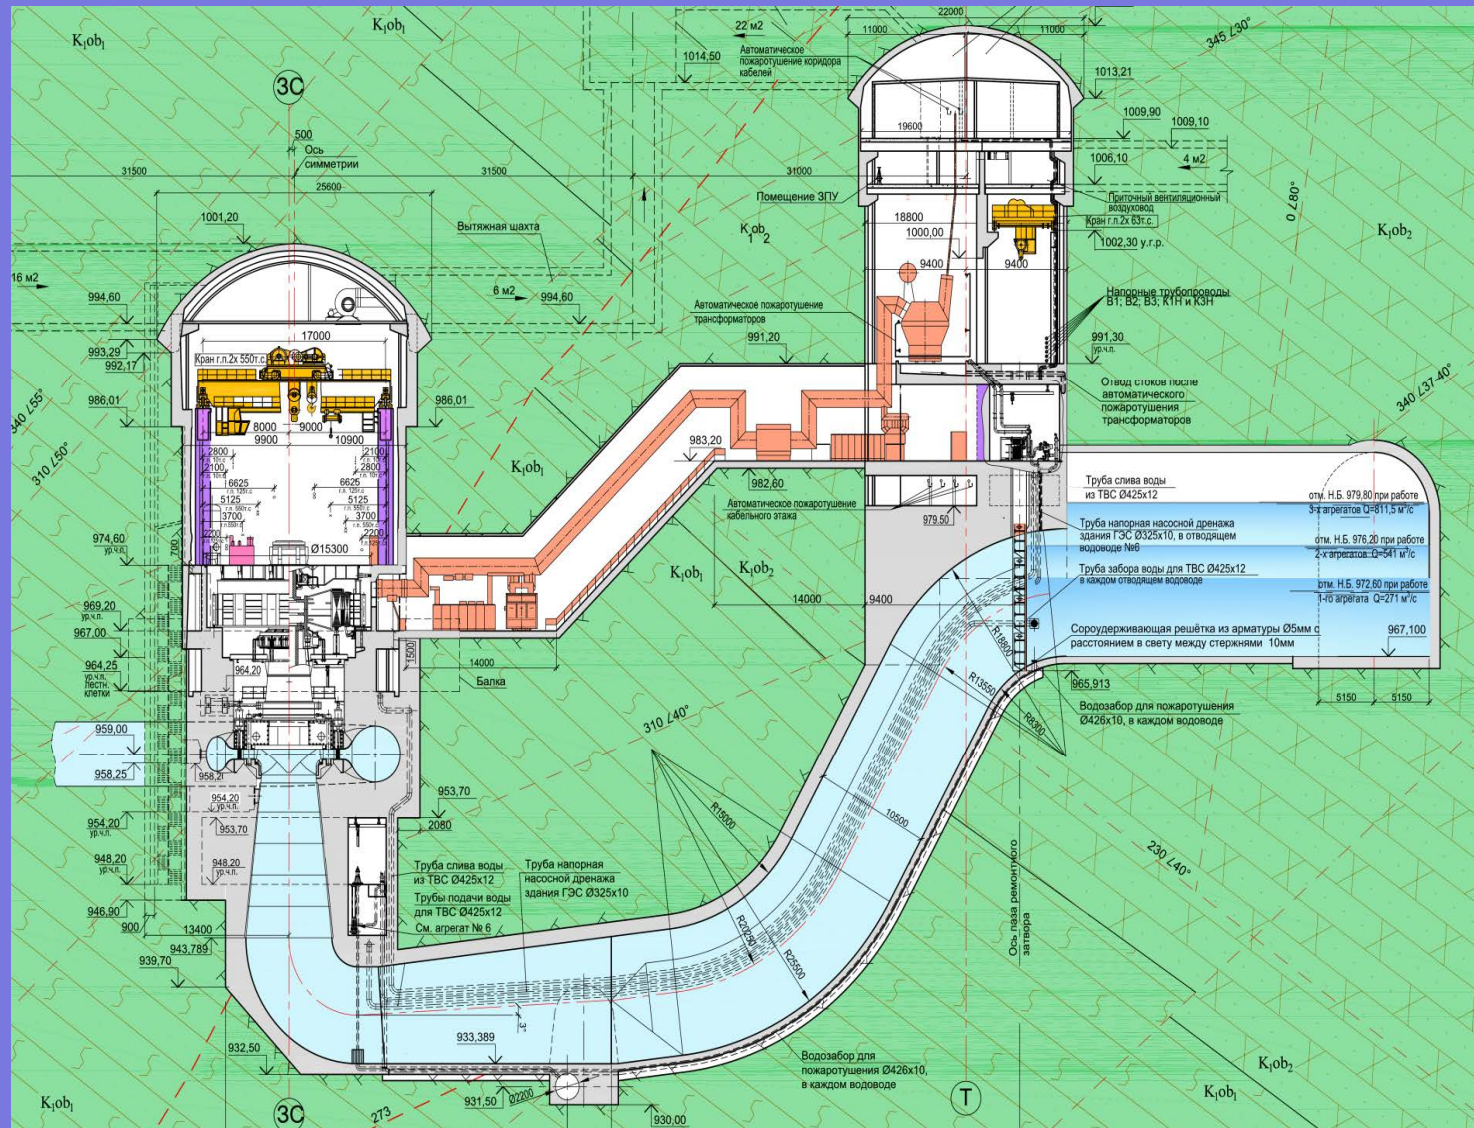
ASSESSMENT OF THE POWERHOUSE CAVERN

- The machine cavern is located in a series constituted by sandstone and siltstone.

It is approximately 21m wide, 69m high and 220m long.

Large amount of excavation have been already conducted, mainly in the siltstone area, where the elevation of the excavated floor is today more than 30m in height.

Time dependent deformations were exhibited since the late 80s and questions were raised about an increasing creep behavior possible to compromise its stability. This is mainly for the siltstone section.

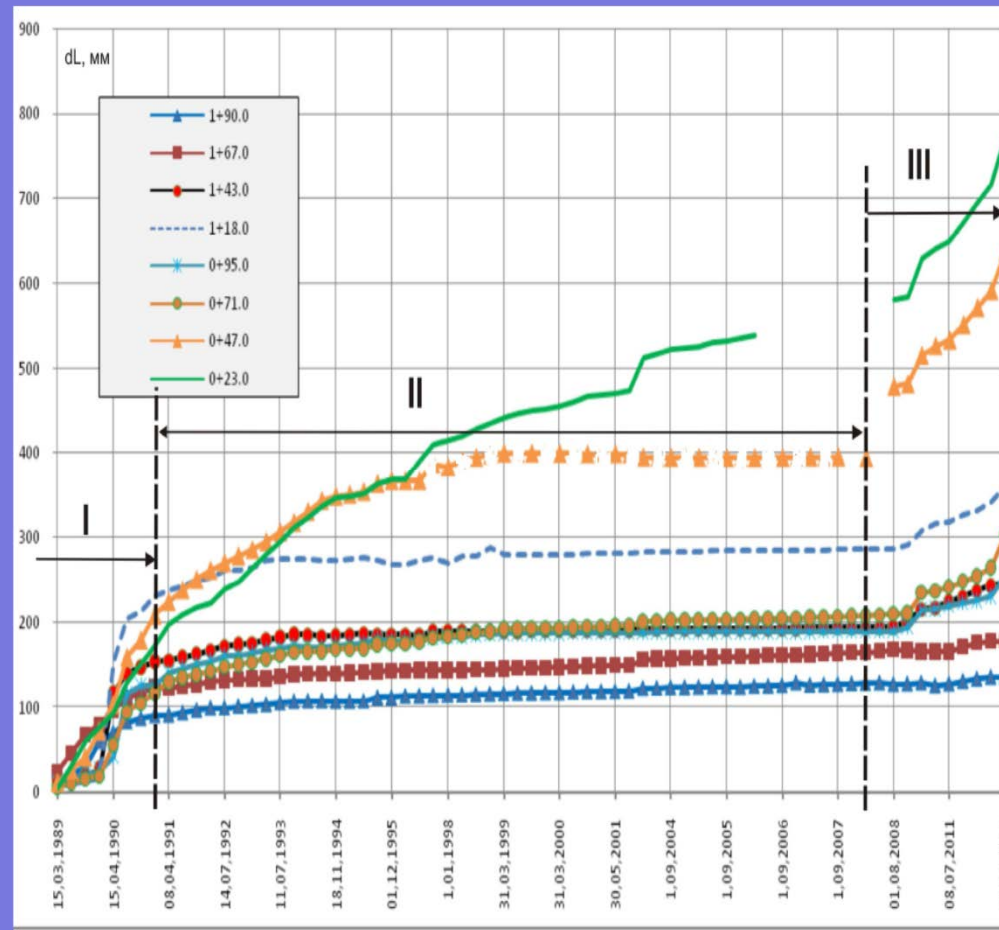
The convergence as presented in the graph of HPI report 2012.

Significant wall closure has been recorded amounting to 600mm in the siltstone sections up to the middle of 2008 and about 750mm up to August 2102.

Note: the scale of time is irregular and the gradient of convergence is actually lower.

The PoE suggested, the possibility of progressive distress of the rock mass in association with the ageing of the strengthening measures applied since the late 80s, to be the reason of the time dependent deformation and not a gradual deterioration of the petrographic quality due to softening of the siltstone. Such a state can be addressed efficiently by additional support in the sidewalls

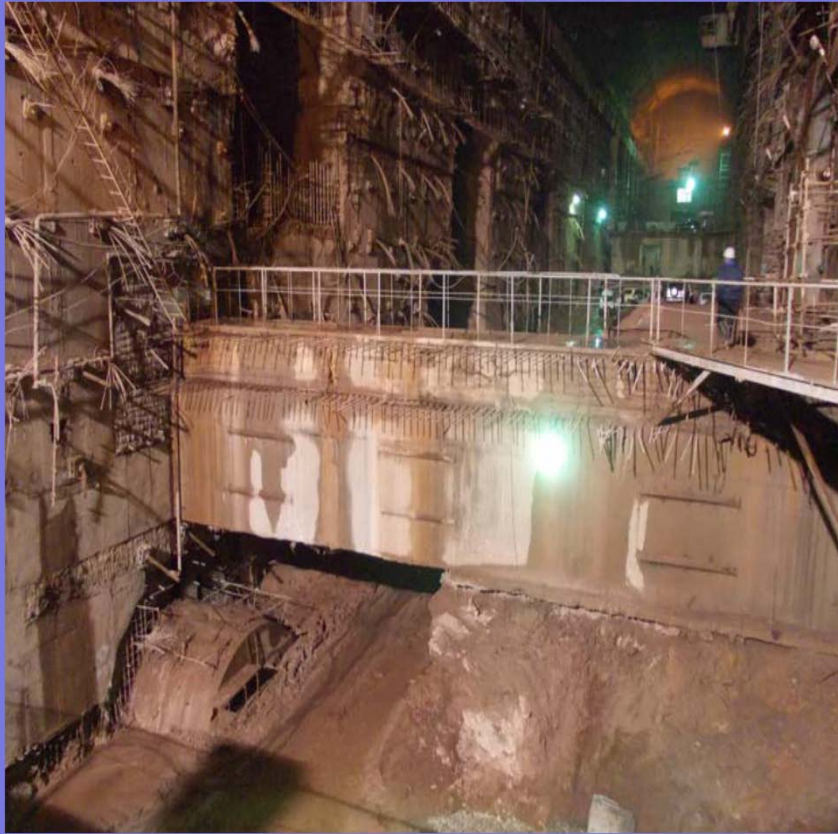
**Placement of struts
to face deformations**

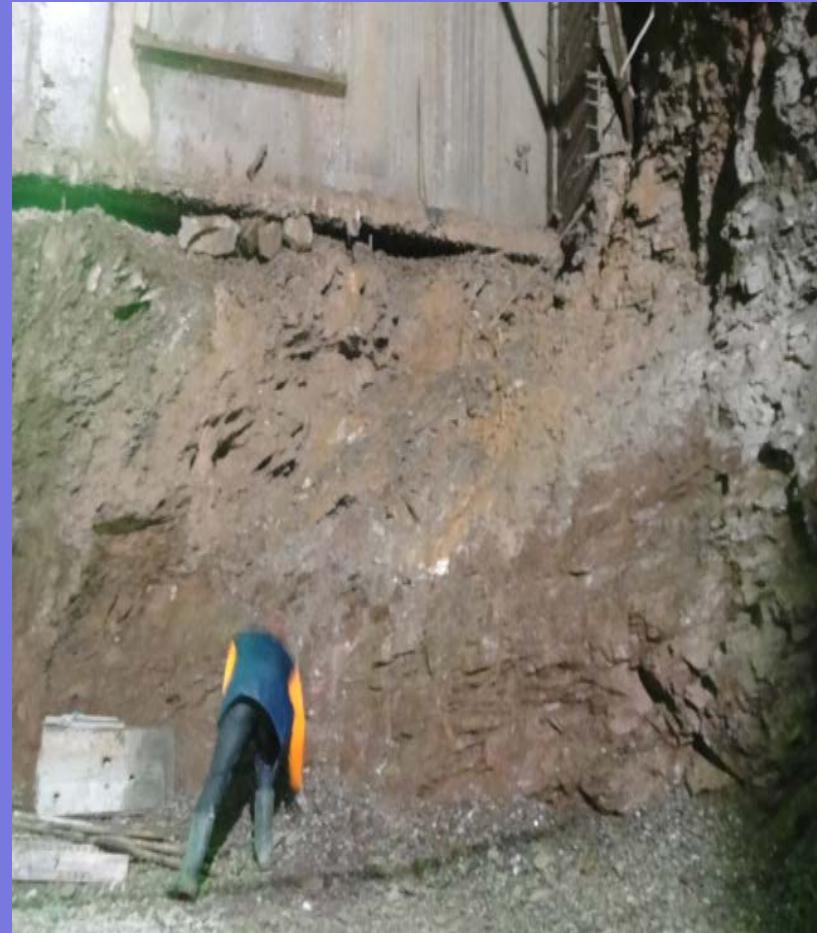
*Distressing of the siltstones
after excavation,
under the concrete struts*

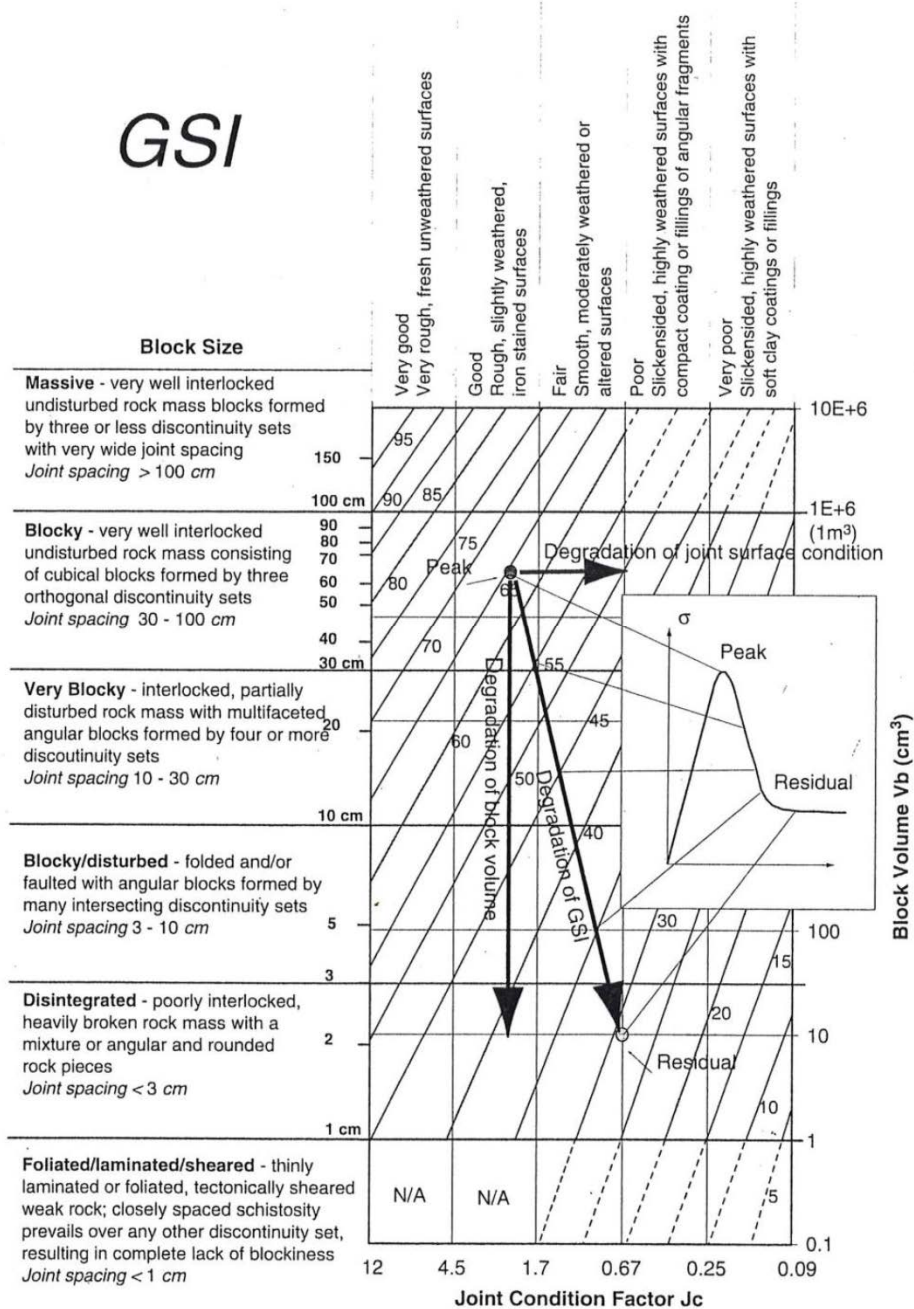
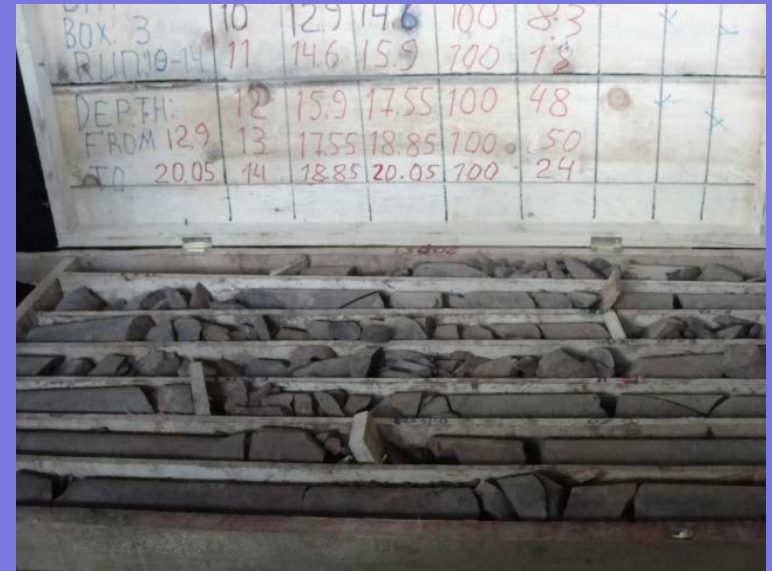
Distressed siltstone
in cavern

A residual GSI
(from Cai et al)

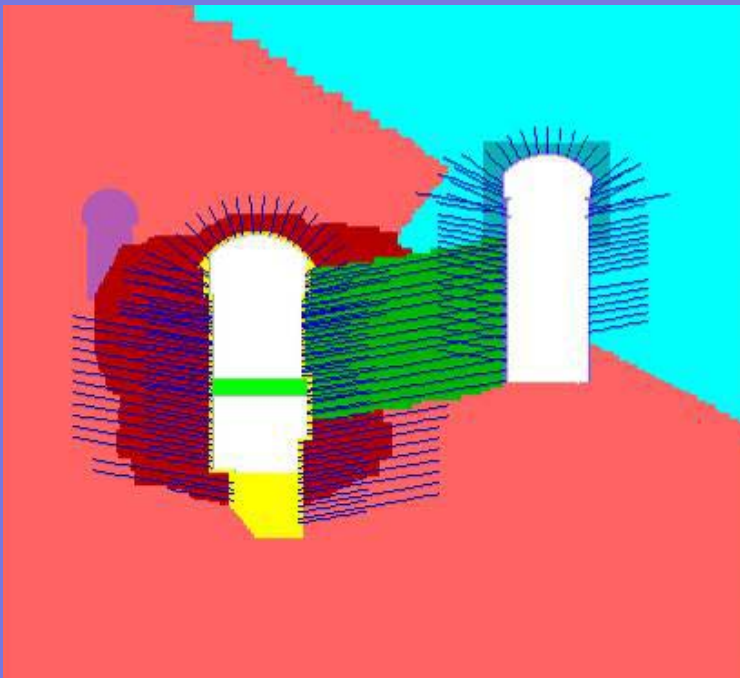
Results of the Powerhouse – Transformer Hall 2D Model

Identification of possible remedial measures and
preliminary evaluation of their behaviour

- **Installation of additional tendons**
- **Multiple Packer Sleeved Pipe System in the pillar between PH and TH**
- **Possibility of struts**
- **Installation of a suitable monitoring system**

Modelling by G. Barla

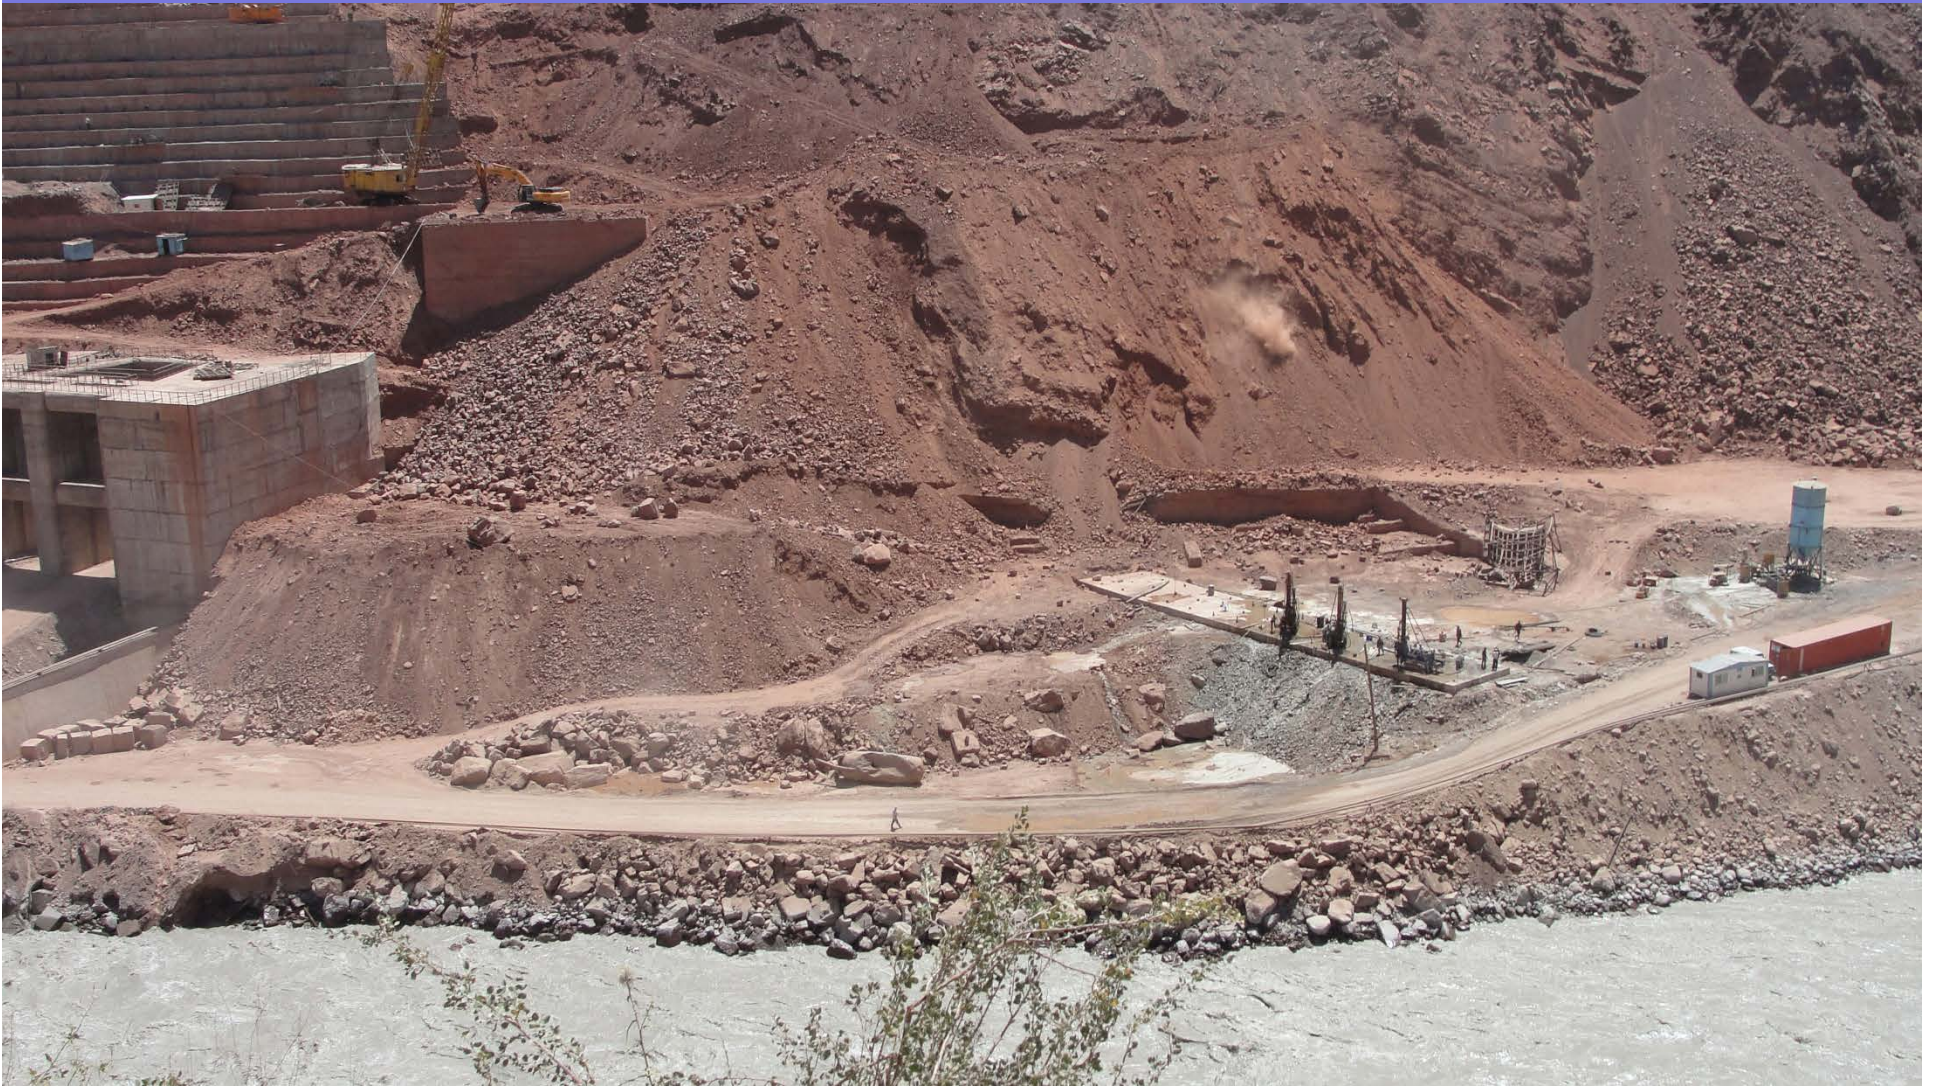
Grouting of the salt zone along the Ionakhsh fault

- Grouting of the rock all around the top of the salt wedge
- Hydraulic barrier: series of boreholes on the downstream side of the salt wedge to maintain reservoir pressure so as to minimize water gradient between the two sides of the salt wedge
- Both measure to be applied One will cover any possible deficiency of the other.
