**The highest dam of the world
in a challenging geological environment**

The proposed Rogun 335m high dam, Tajikistan

Paul G. Marinos, Independent consultant

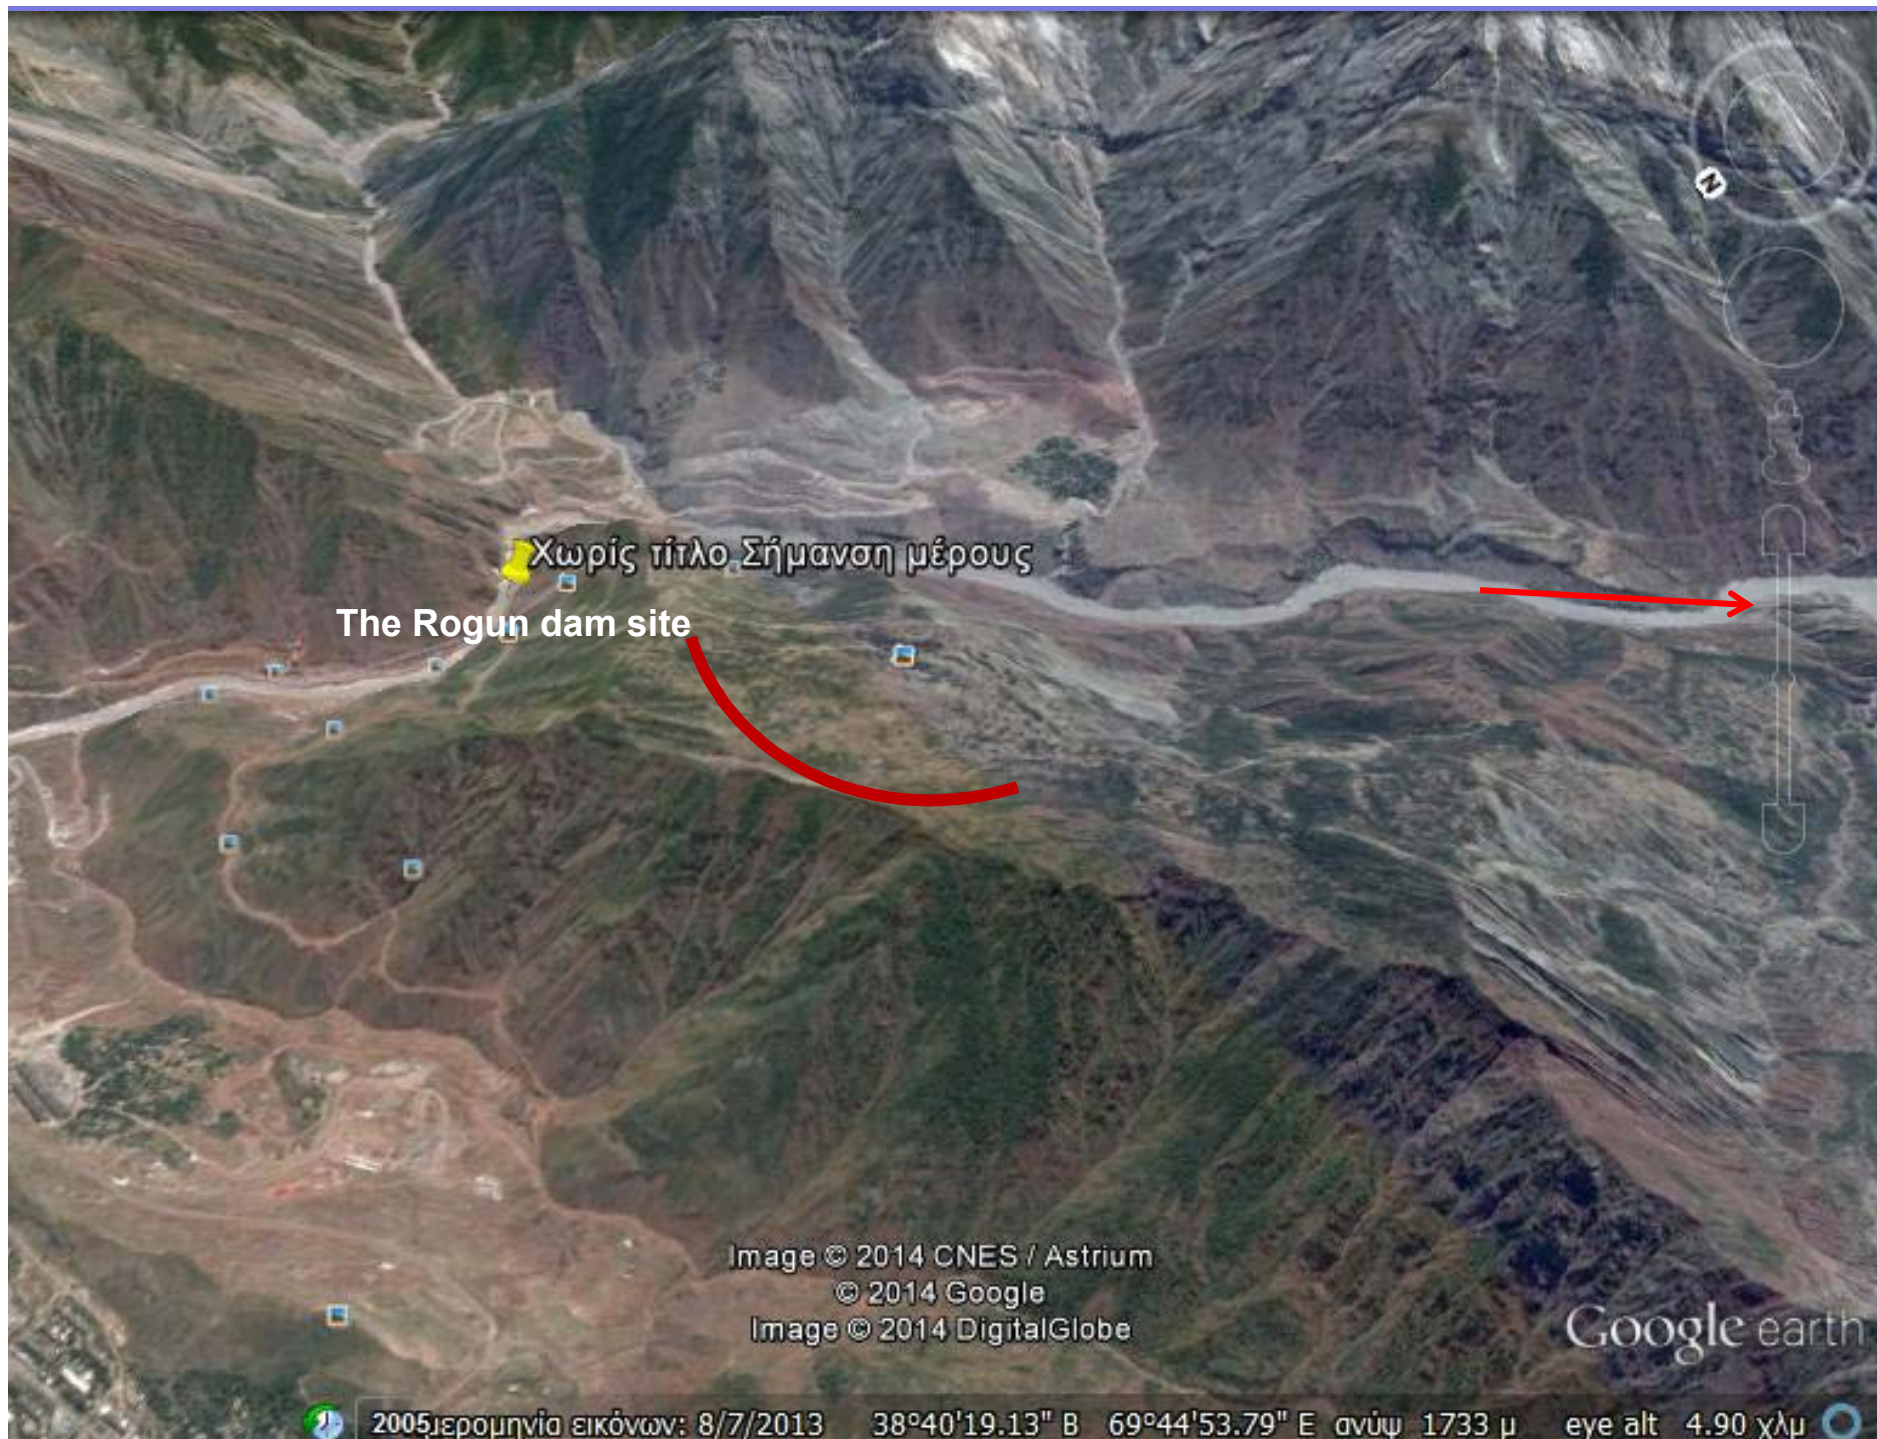
The downstream atypical area at the right valley side

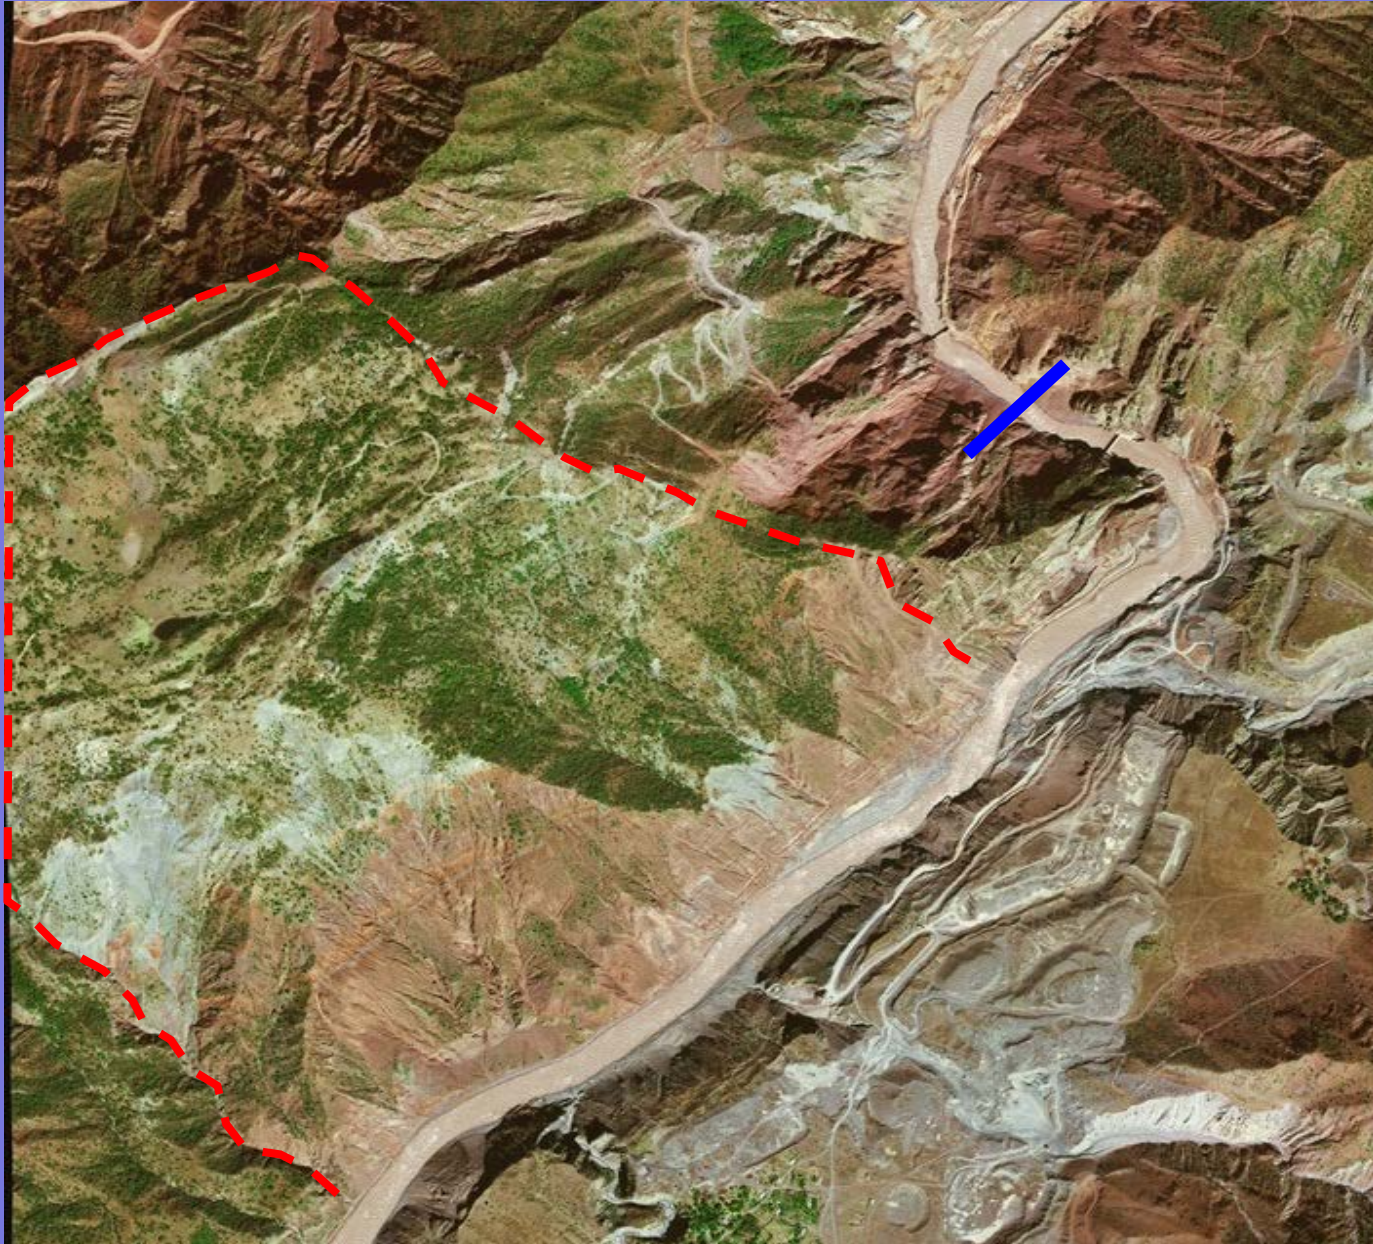
Geological setting of the Right Bank

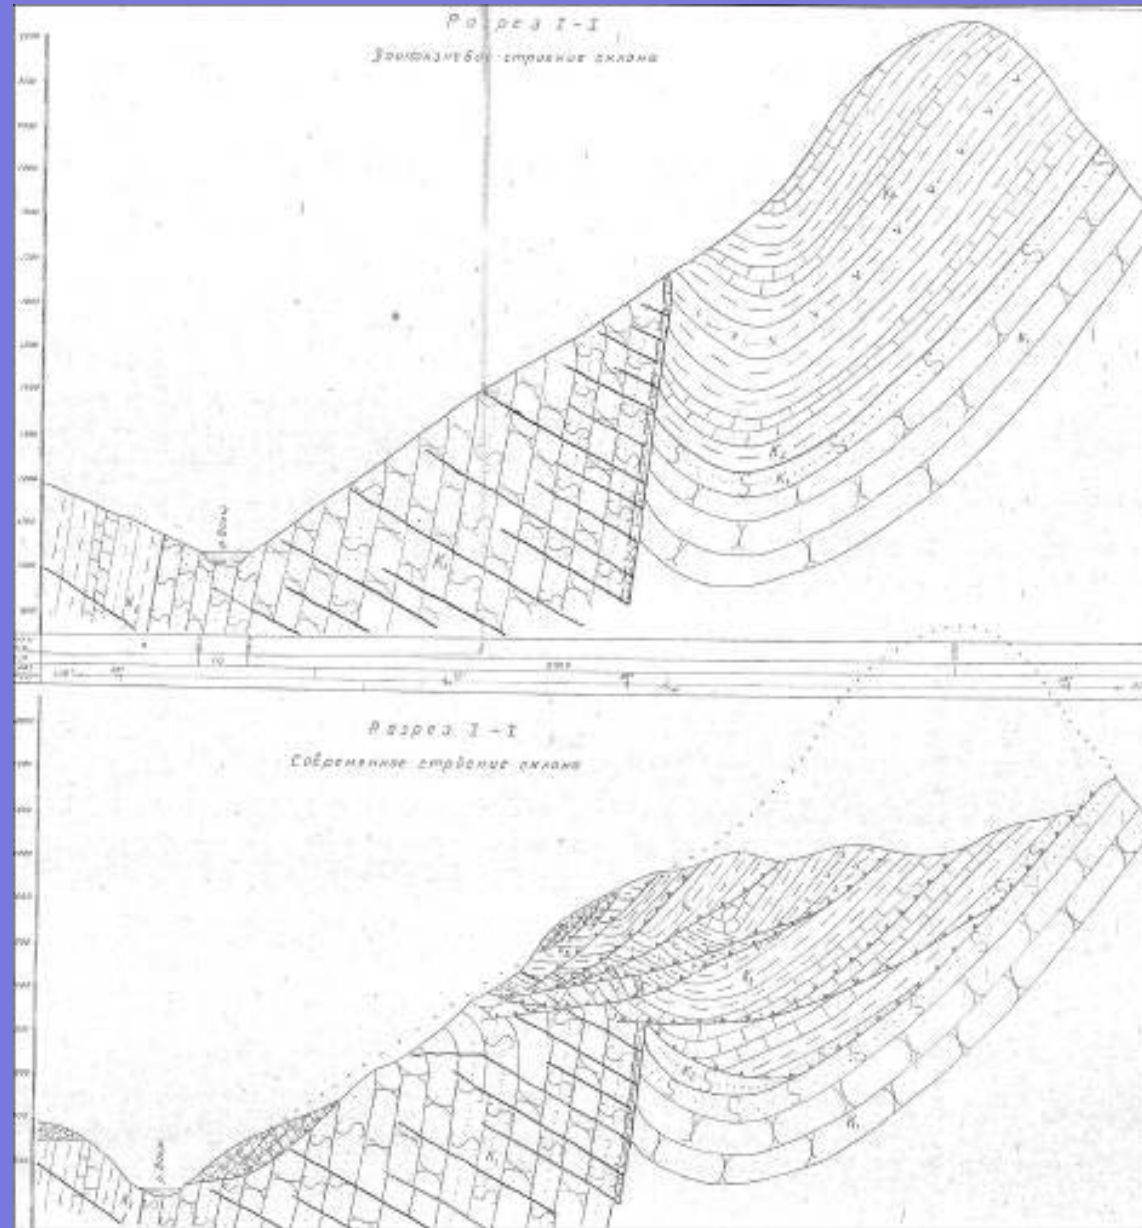
Proposed model
in previous studies

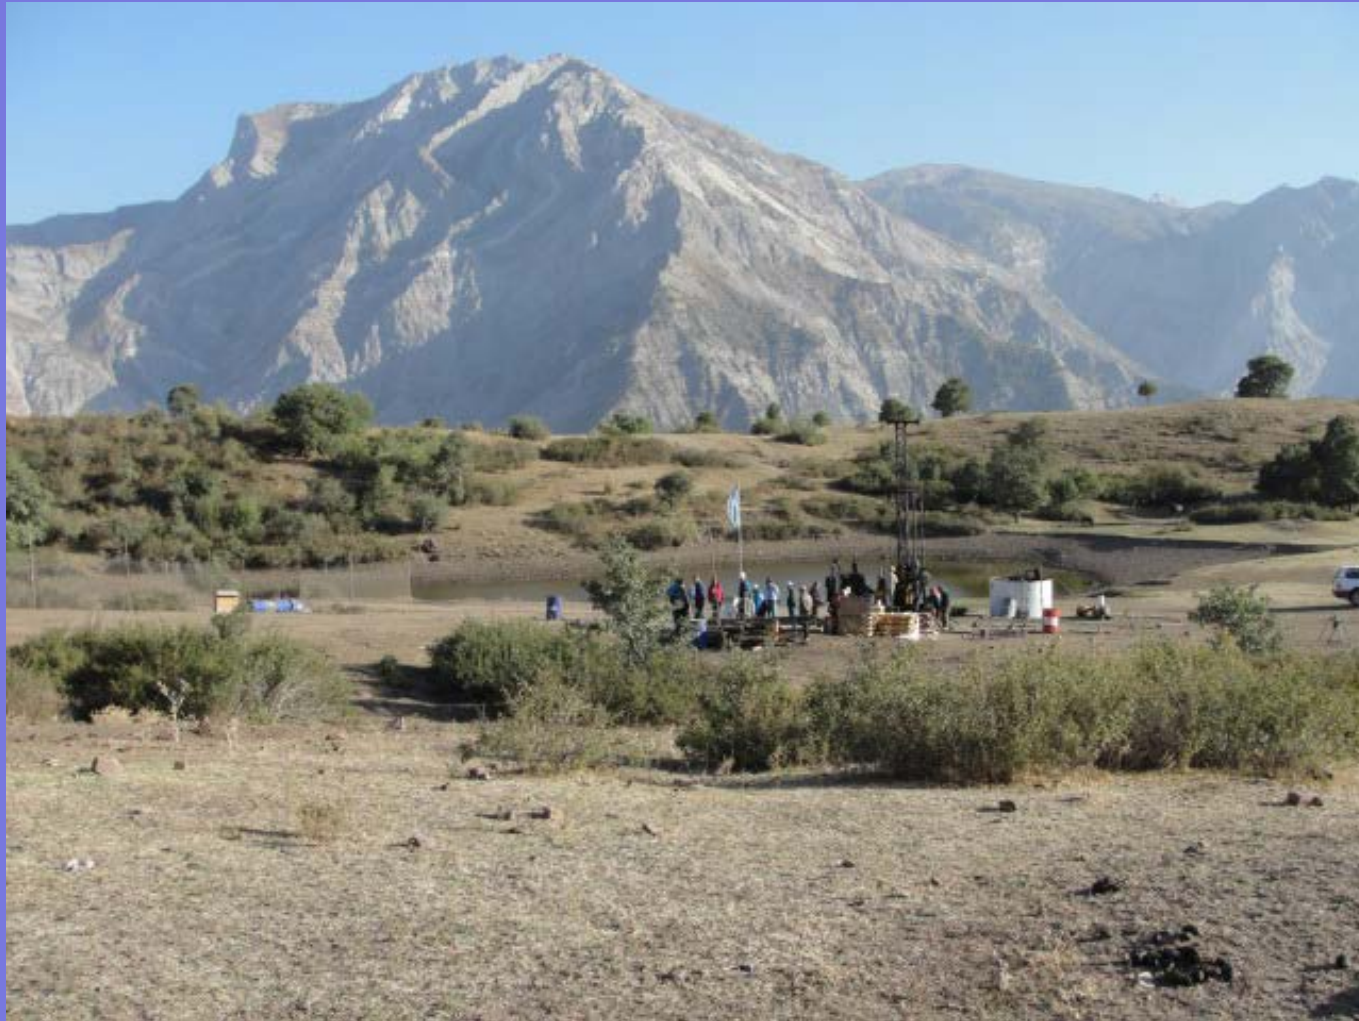
Sinks on the plateau, right valley side downstream of the dam

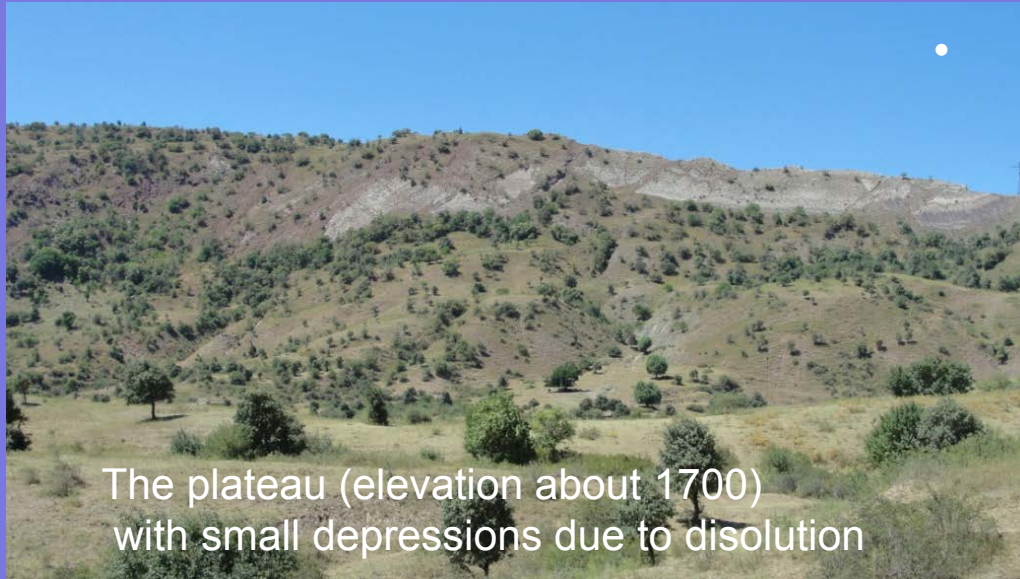
The plateau (elevation about 1700)
with small depressions due to dissolution

- Few rock debris on the surface
- Topography uphill does not suggest large scale movement
- Geophysics in 2005 anticipated shallow overburden;
- Results of 2012 geophysics show compact low specific gravity
- material
- New borehole revealed continuous, undisturbed, compact gypsum/anhydritic deposits in mudstone matrix, starting from shallow depth: the reason of sinks due to dissolution

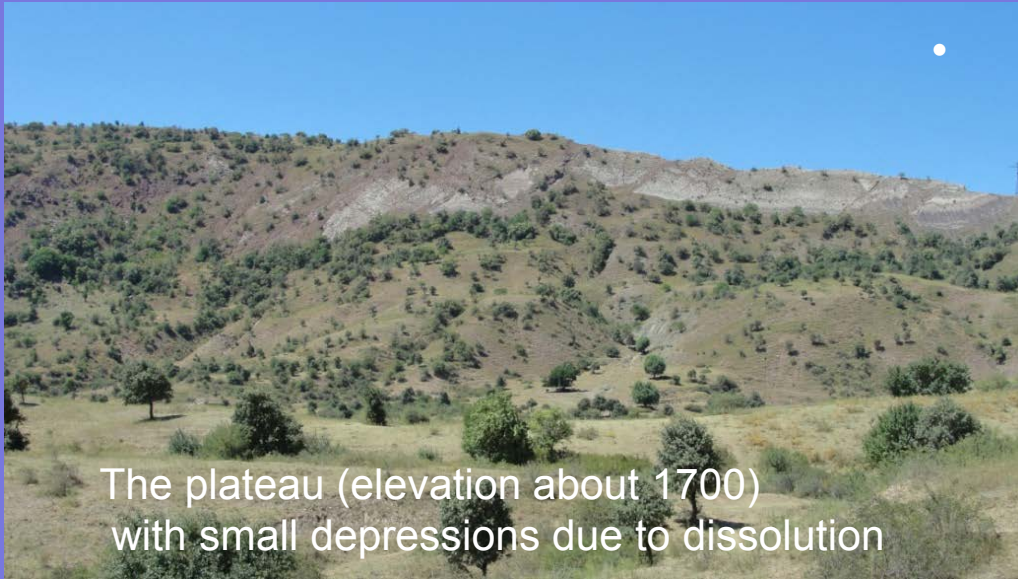
The plateau (elevation about 1700)
with small depressions due to dissolution

**Present assessment:
A tectonic structure,
due to evaporitic
diapyrism
not to a landslide**

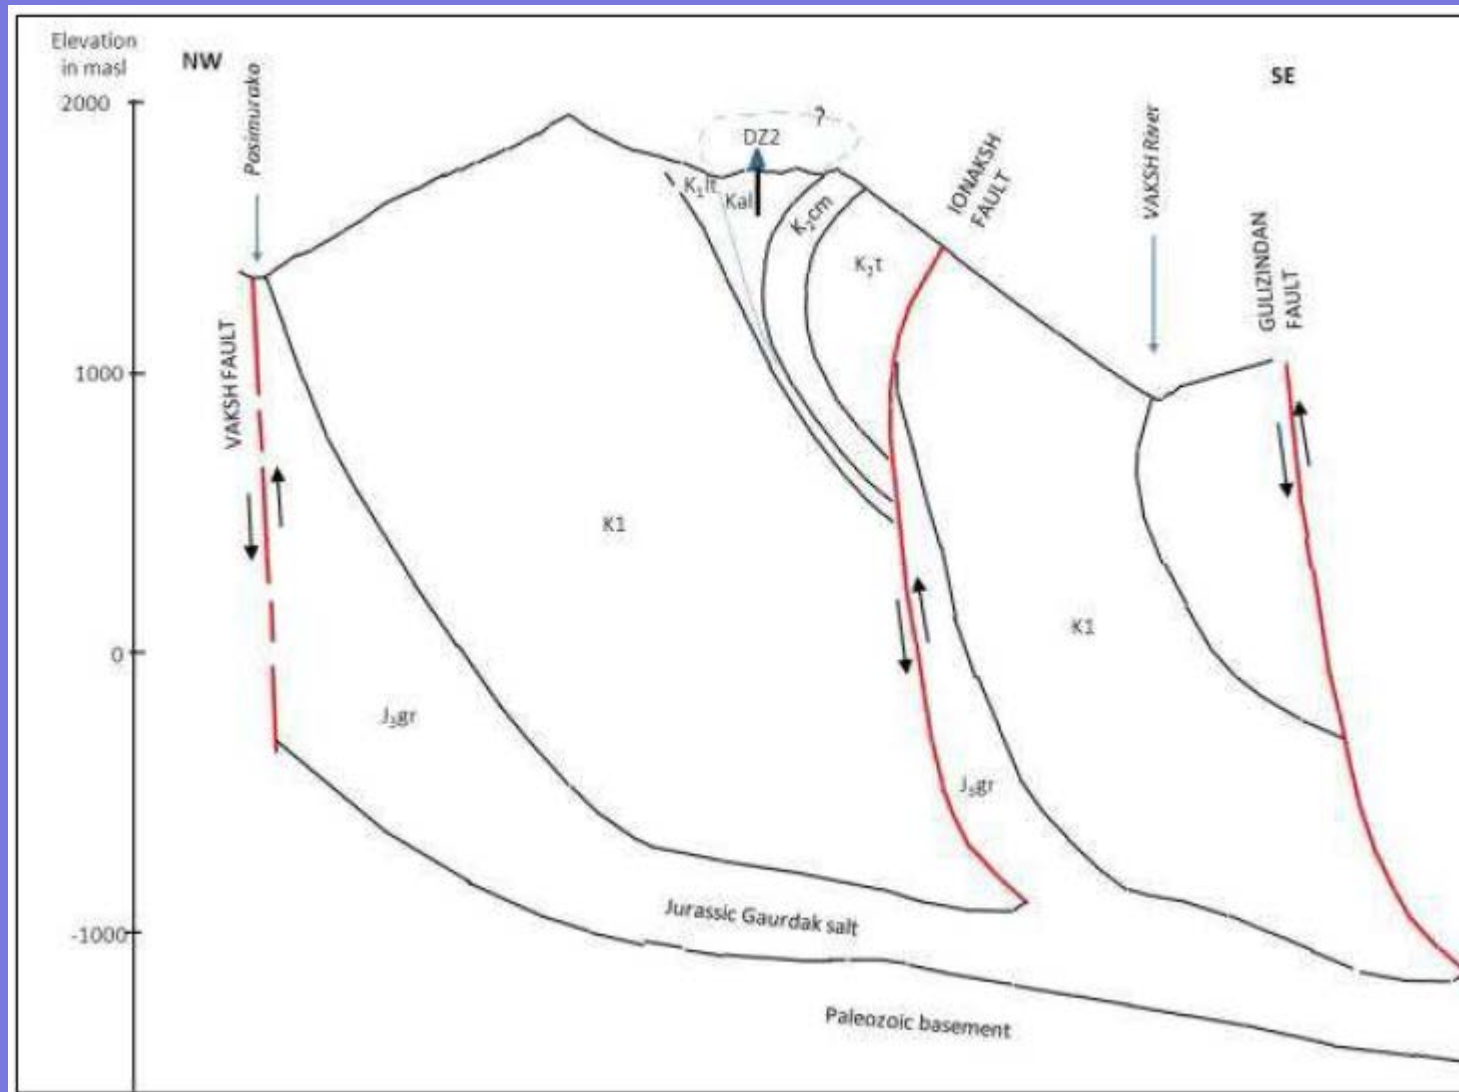
A tectonic structure not a landslide
 Model by the Consultant of TEAS

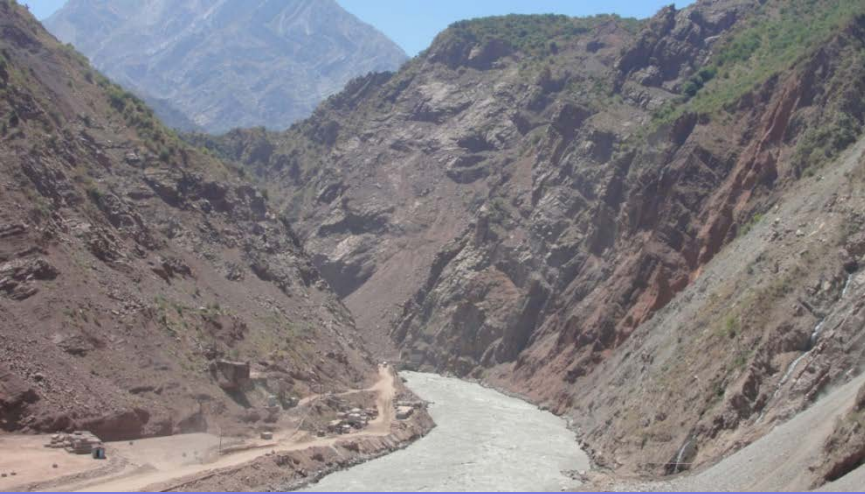
CONDITIONS OF DAM ABUTMENTS

1. Rock mass **permeability** under the dam is not high.
A conservative design in depth of the grout curtain would further **reduce the hydraulic gradient** against any potential impact on the salt wedge upstream.

2. **Narrow saddles** exist on the abutments beyond the dam axis; due to stress relaxation, rock mass is probably more permeable in these zones.
thus **lateral extension of the ground curtain** might be necessary, into the right abutment, depending on the position the pre-reservoir ground water table (hydraulic barrier).

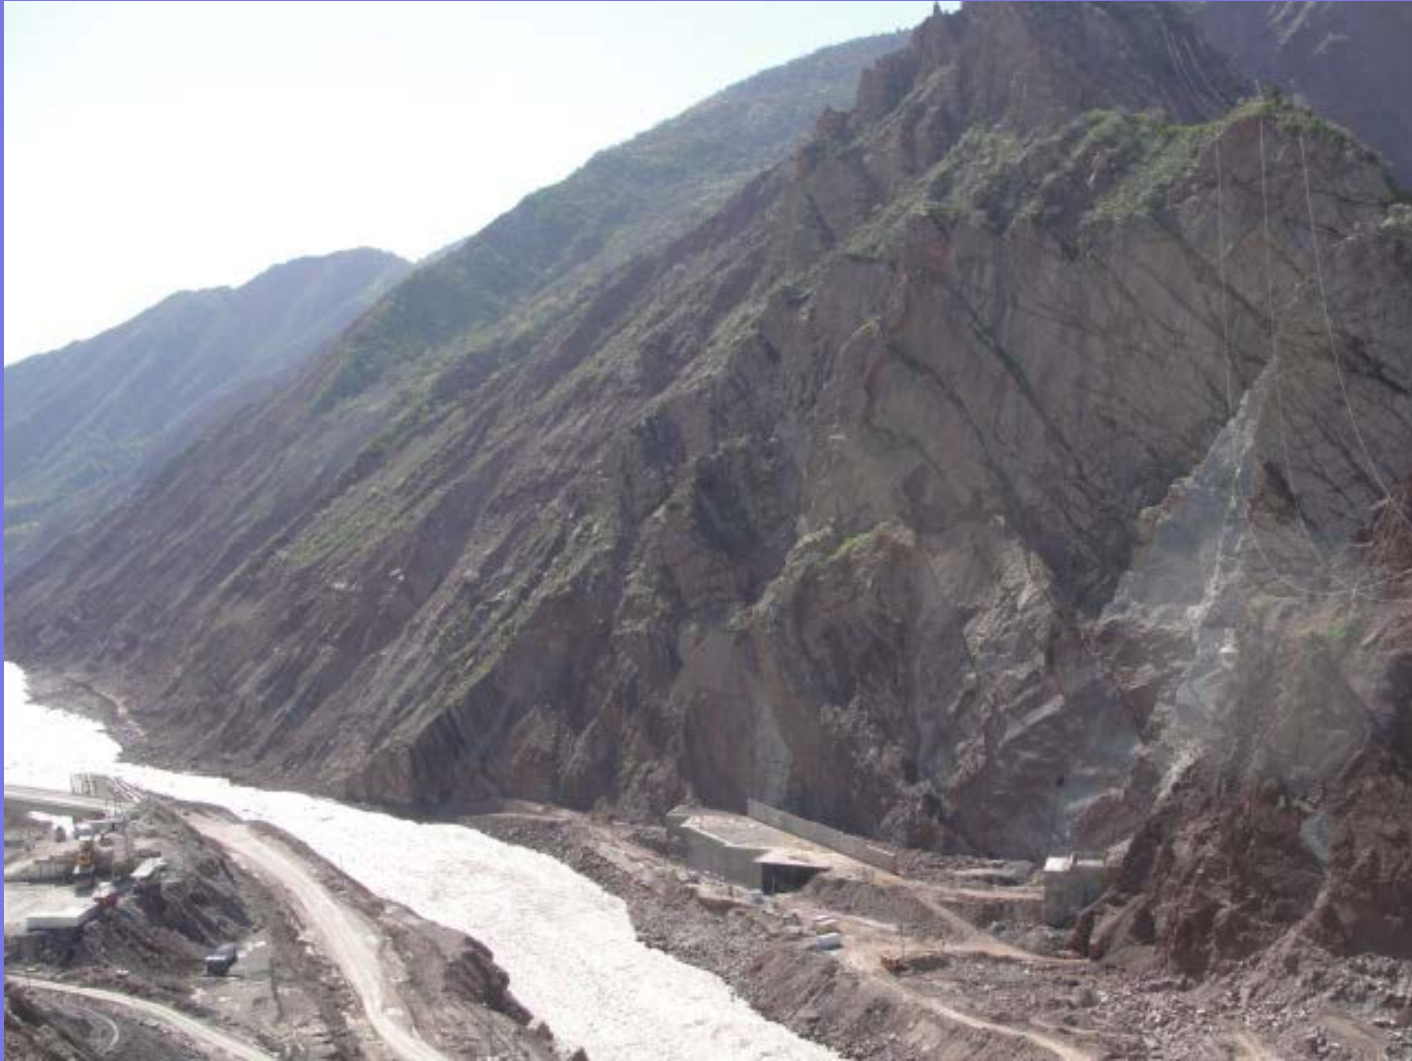
**The portal of the diversion tunnels
just downstream of the Ionakhsh fault**

- The Ionakhsh creeping fault and potential seismic movements
- Salt wedge in the foundations
- Fault No. 35 and potential seismic movements
- Location of intake portal for existing diversion tunnels

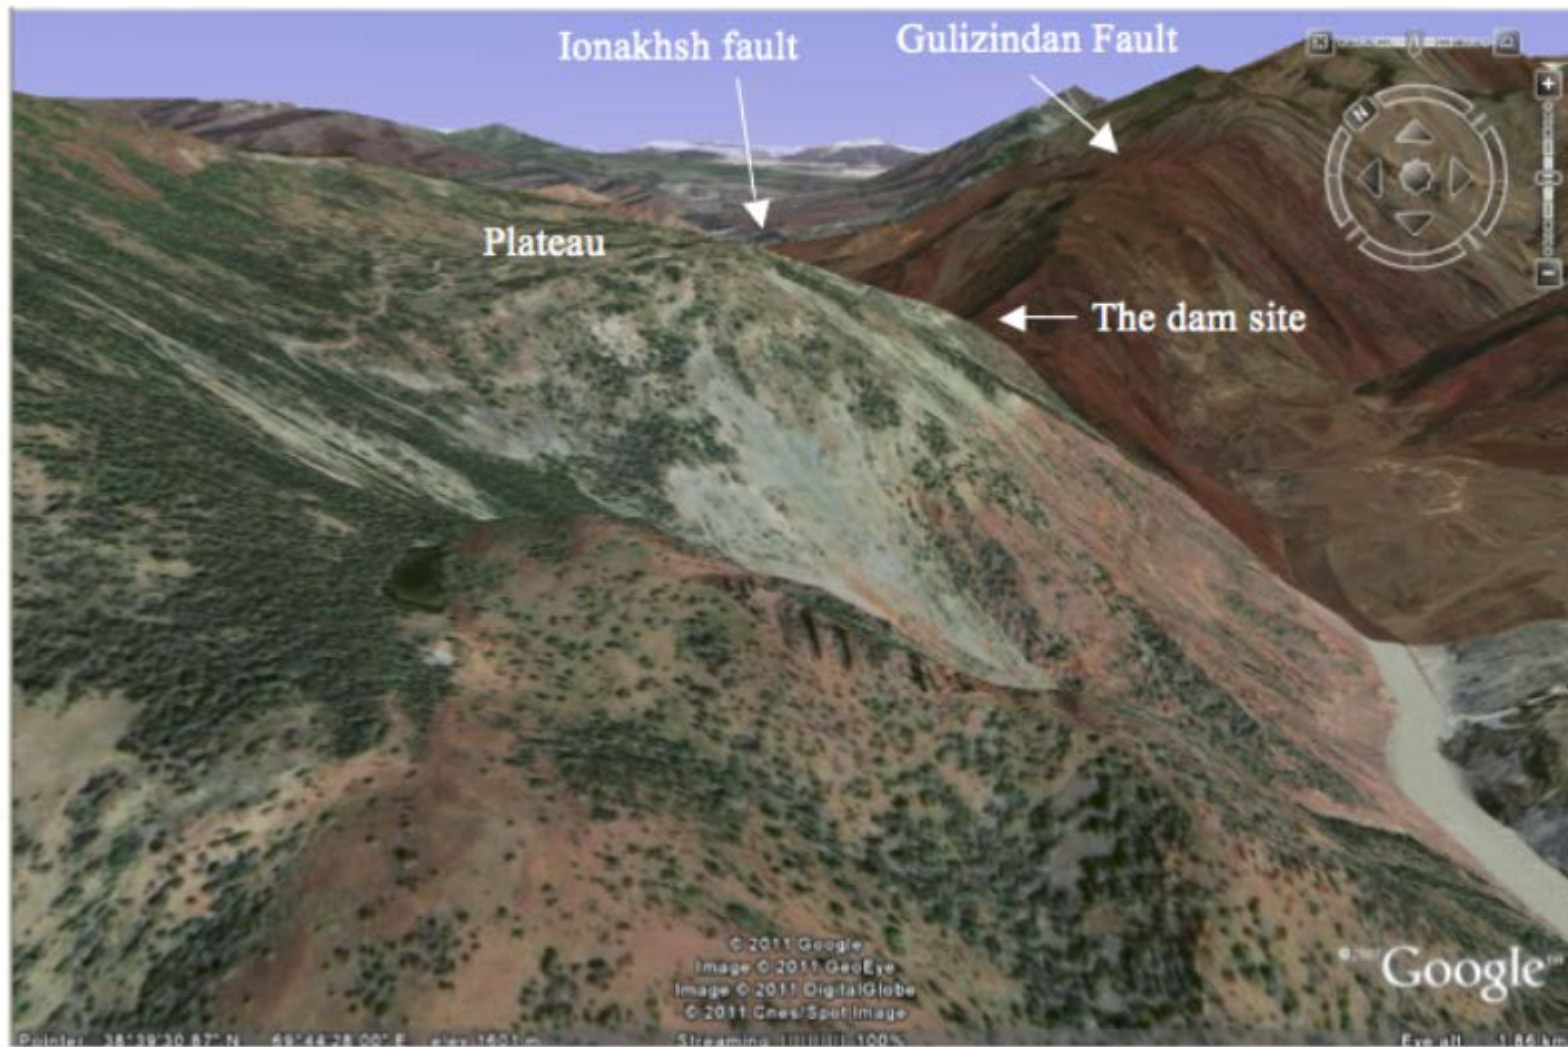
Fig. 7. The plateau at the right side of the valley, downstream of the dam, seen from downstream (photo from Google)

Recent site investigation in the plateau area of the downstream zone

- Geological mapping 1:2000
- 3 boreholes (1 deep 300 - 500m)
- Geophysics
- Geodetic measurements
