Tale of Three Projects

Addressing Dam Safety Concerns within the Muskingum River Basin, OH

**AEG Annual Meeting
September 2015**

**Mike Nield, Geologist
U.S. Army Corps of Engineers
LRH Dam Safety Production Center**

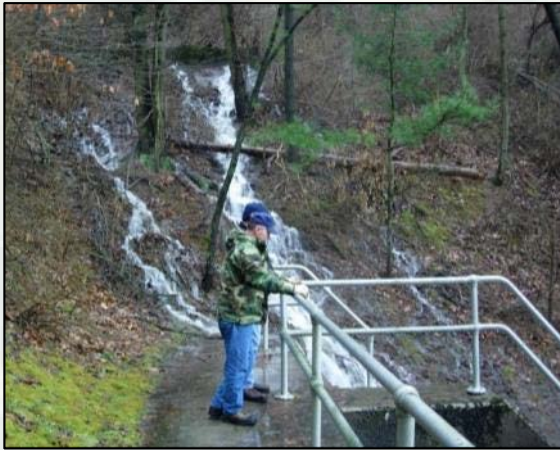
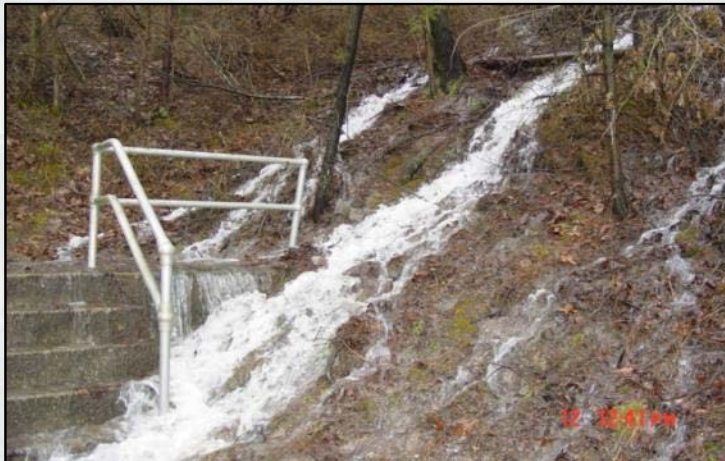
2005 FLOOD EVENT

LEFT ABUTMENT – BEDROCK SEEPAGE

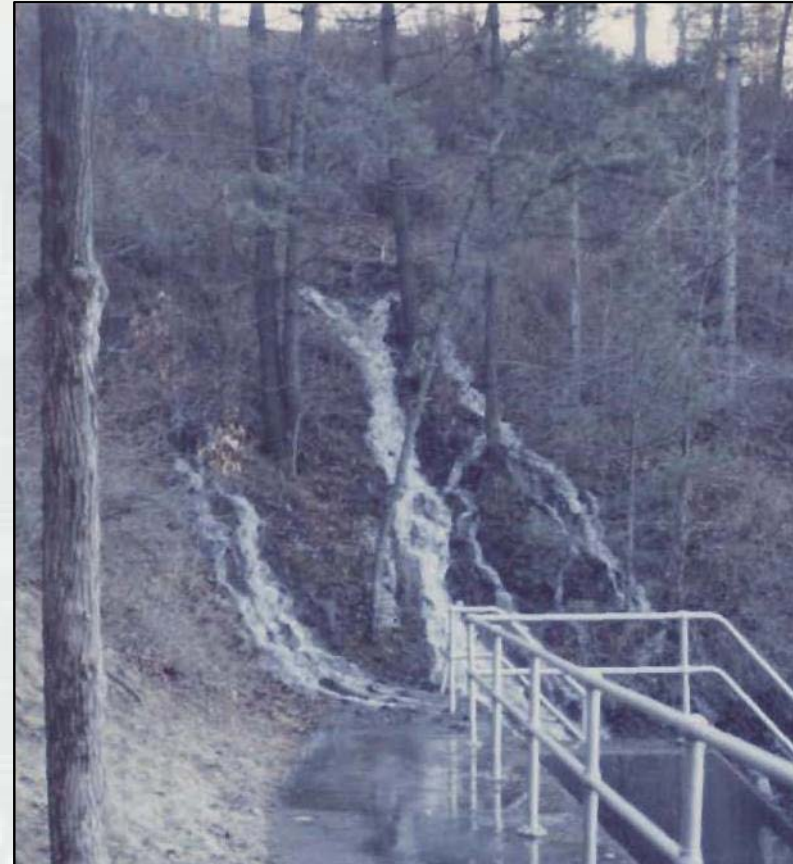
1991 FLOOD EVENT

LOCATION ABOVE STILLING BASIN

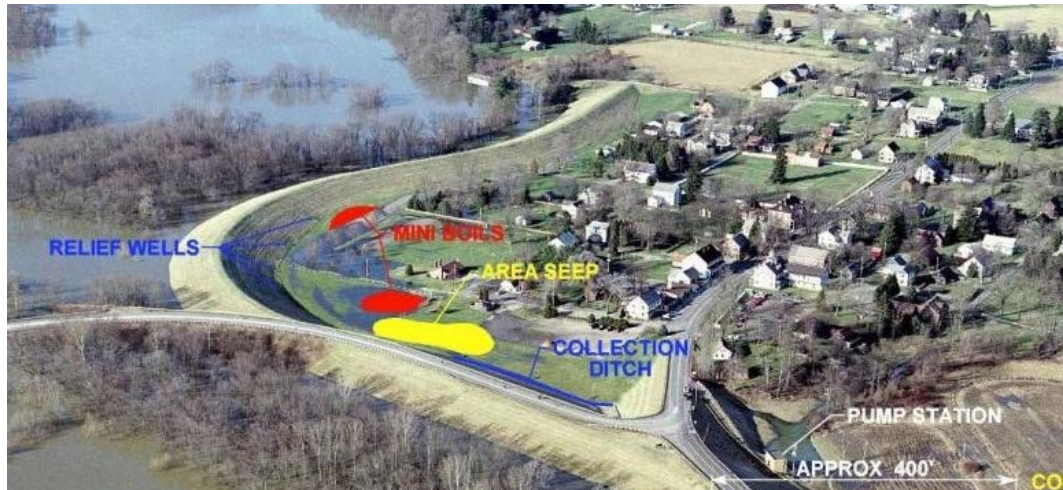
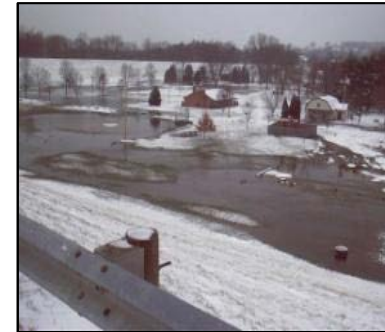
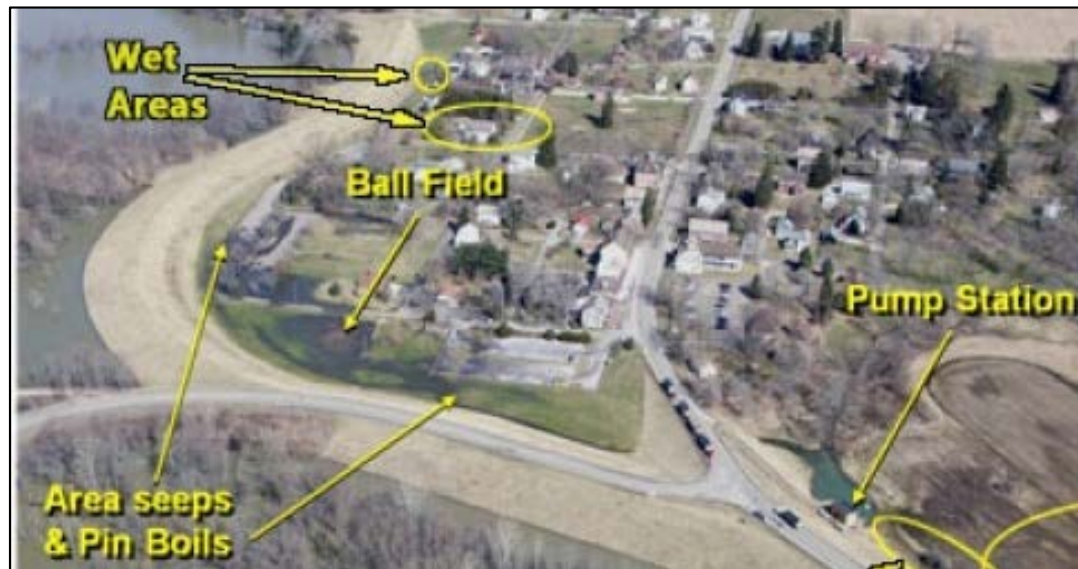
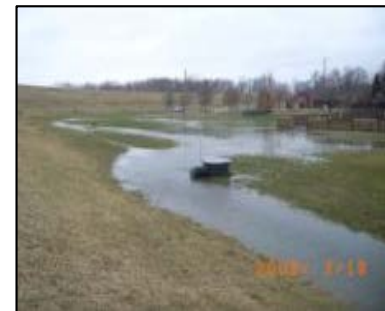
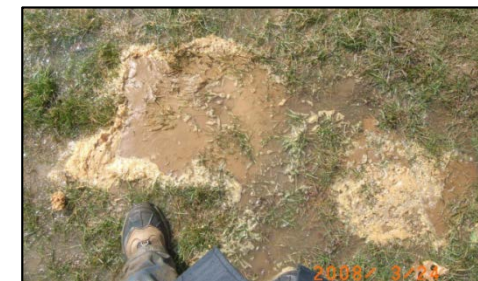
BALL FIELD REACH - SEEPAGE

Seepage within Ball Field Reach of Levee
